Official Accident Report Index Page

GROUND SPOILER ACTIVATION IN FLIGHT/HARD
LANDING VALUJET AIRLINES FLIGHT 558 DOUGLAS
DC-9-32, N922VV NASHVILLE, TENNESSEE JANUARY 7,
1996

Facts of the Accident

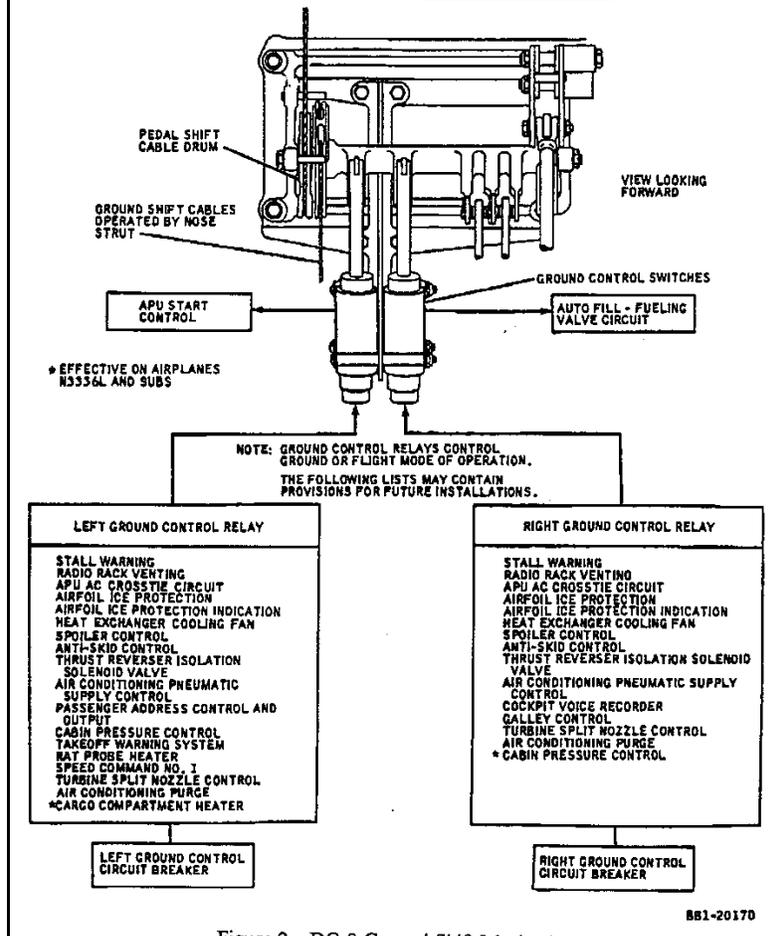
Figure 2--DC-9 Ground Shift Mechanism

The ground shift mechanism, which is actuated by nosegear shock strut extension/compression, controls whether certain aircraft systems operate in the ground or flight mode.²¹ When the nosegear shock strut is compressed by the weight of the aircraft, the ground shift mechanism causes those aircraft systems to be operated in the ground mode. When the nosegear shock strut is extended after takeoff, it triggers the ground shift mechanism, electronically shifting the aircraft systems to the flight mode.²² In addition, when the aircraft is in the flight mode, the ground shift mechanism mechanically centers the nose wheel, locks out the rudder pedal nose wheel steering function, and releases the gear lever anti-retraction mechanism.

According to Douglas representatives, when the nosegear shock strut is underserviced/underinflated, strut extension after liftoff may not be sufficient to activate the ground shift mechanism to shift the aircraft systems into the flight mode and release the gear lever anti-retraction mechanism. Douglas representatives indicated that this is a commonly reported occurrence during cold weather operations. They stated that Douglas had issued numerous service bulletins (SBs) and all operator letters (AOLs) describing the anomaly and recommending maintenance procedures to avoid underserviced/underinflated nosegear shock struts during cold weather operations.²³

It is likely that the nosegear shock strut did not extend far enough to actuate the ground shift mechanism because it was underserviced/underinflated for the cold/winter weather conditions. The en route portion of the flight proceeded uneventfully. When the airplane was about 100 feet above the ground during the approach to Nashville, the pilots reset the ground control relay circuit breakers, thereby unintentionally shifting the airplane systems from the flight mode to the ground mode. The ground spoilers subsequently extended in flight, and the airplane descended suddenly, impacting the ground in the runway approach light area.

Accordingly, the Safety Board believes that ValuJet should develop, immediately, a more extensive and accurate winter operations manual, with corresponding adjustments to maintenance procedures, to reflect the manufacturer's cold weather nosegear servicing procedures. Further, because no airline is exempt from encountering a range of weather extremes, the Safety Board believes that the FAA should require all airlines to review their operations and maintenance manuals and, if necessary, adjust or expand these manuals to reflect the manufacturer's recommended cold weather nosegear servicing procedures.
