Report Number NTSB-AAR-82-8

Report Title Air Florida, Inc., Boeing 737-222, N62AF, Collision with 14th Street Bridge, Near Washington National Airport, Washington, D.C., January 13, 1982.

Report Date August 10, 1982

Report Type Aircraft Accident Report January 13, 1982

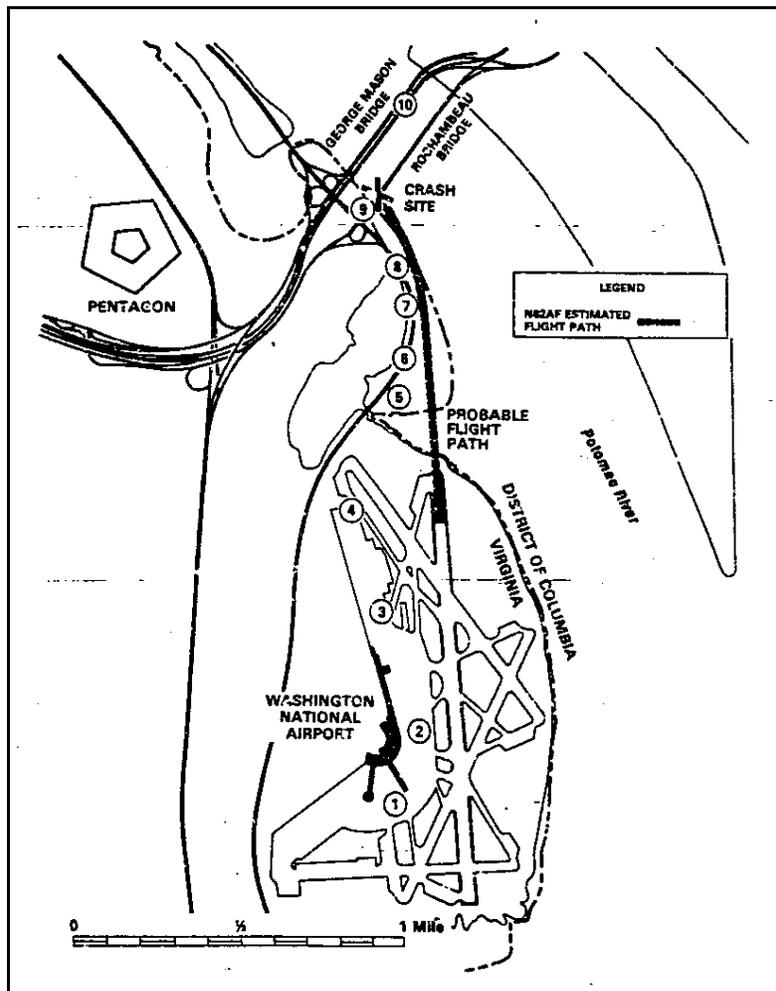
Figure 1.—Flightpath and witness locations.

No witnesses saw the flightcrew leave the aircraft to inspect for snow/ice accumulations while at the gate. Departing and arriving flightcrews and others who saw Flight 90 before and during takeoff stated that the aircraft had an unusually heavy accumulation of snow or ice on it. An airline crew taxiing parallel to, but in the opposite direction of, Flight 90's takeoff, saw a portion of Flight 90's takeoff roll and discussed the extensive amount of snow on the fuselage. The captain's statement to the Board included the following: "I commented to my crew, 'look at the junk on that airplane,'.... Almost the entire length of the fuselage had a mottled area of snow and what appeared to be ice...along the top and upper side of the fuselage above the passenger cabin windows...." None of the witnesses at the airport could positively identify the rotation or liftoff point of Flight 90; however, they testified that it was beyond the intersection of runways 15 and 36, and that the aircraft's rate of climb was slow as it left the runway.

Flightcrews awaiting departure were able to observe only about the first 2,000 feet of the aircraft's takeoff roll because of the heavy snowfall and restricted visibility.

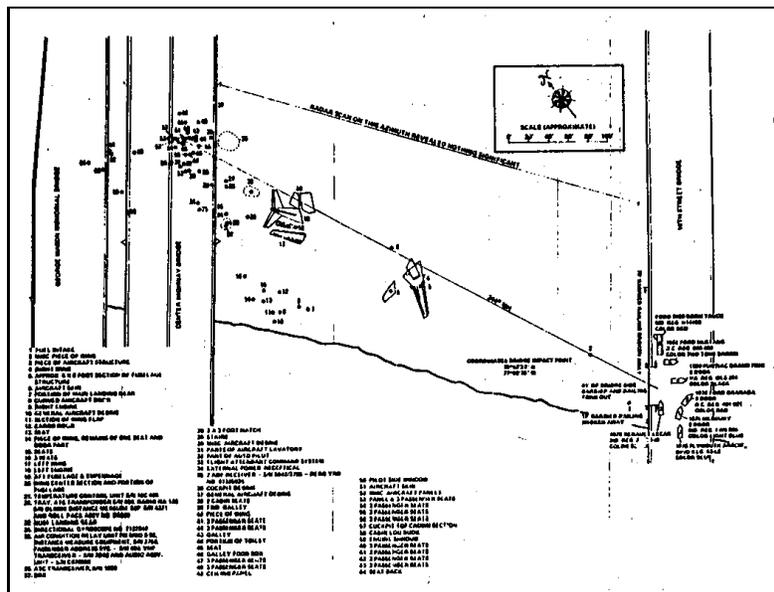
Figure 4. -- Position of Wreckage in the Water.

As the aircraft descended, the right wing was structurally damaged when it hit the boom truck, and shortly thereafter, the aircraft struck the steel barrier and railing on the west side of the 14th Street Bridge at an elevation of about 37 feet mean sea level. Fragments of the right wing remained on the bridge. The remainder of the wreckage sank in the Potomac River in about 25 to 30 feet of water. The wreckage area was confined to the south side of the river between the 14th Street Bridge and the Center Highway Bridge of the George Mason Memorial Bridge. (See figure 4.)

After initial impact, the aircraft broke into several major pieces. The fuselage broke into four major pieces which included: (1) nose section with cockpit; (2) fuselage section between nose section and wing center section; (3) fuselage-to-wing intersection; and (4) aft body structure with empennage attached. The wing structure was separated into three major pieces which included: (1) left wing outboard of the No. 1 engine, including all associated flight control surfaces; (2) wing center section, lower surface, including wing lower surface stubs between the No. 1 engine mounts and the No. 2 engine mounts; and (3) right wing outboard of the No. 2 engine with the outboard 20 feet mostly disintegrated. The left main landing gear was separated from the wing, and the right main gear remained attached except for the wheels and oleo piston. The nose landing gear and its attaching structure were separated from the nose section. Both engines and their pylon structures were separated from the wings. There was no evidence of fire on any of the recovered structure.

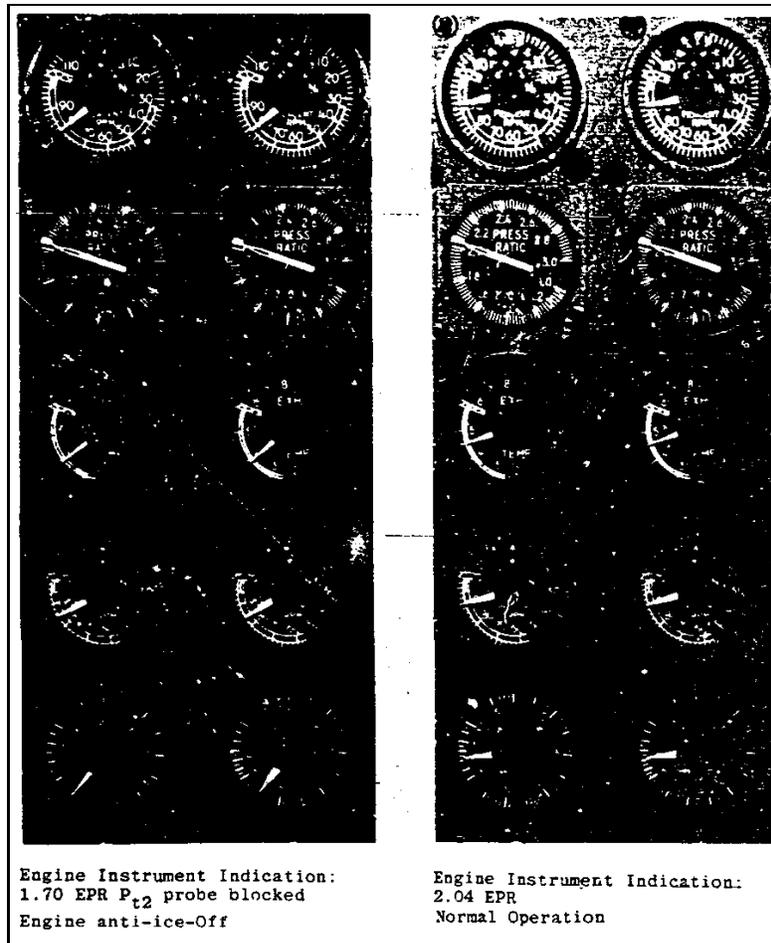
Figure 6.—Comparison of Instrument Readings -- 1.70 HPR vs. 2.04 EPR.

With the engine operating, a false indication of the actual EPR can be indicated in the cockpit when ice blocks the inlet probe. Under this condition, the Pt₂ probe is vented to the nose cone pressure through a siphon-break hole in

the sense line. The interior of the engine nose cone is vented to the engine inlet static pressure, which is lower than the engine inlet total pressure normally sensed by the P_{t2} system. Under severe icing conditions, if the engine inlet anti-icing air bleed system is shut off and the normal P_{t2} sensing port is blocked with ice, the P_{t2} sensor will sense the lower pressure at the vent port in the nose cone. The cockpit indication may become slightly erratic as icing begins to block the probe and will indicate a significantly higher reading when ice fully blocks the probe. Tests have demonstrated that with a blocked probe at takeoff, engine power can indicate an EPR of about 2.04 with the engine actually operating at an EPR ratio of 1.70. Under these circumstances, a pilot would unknowingly attempt takeoff at a considerably lower thrust than desired. However, the pilot has available other indications of engine operation displayed in the cockpit, such as a lower N_1 , N_2 , EGT, and F/F consistent with the reduced engine thrust. (See figure 6.)

Should the pilot activate the engine inlet anti-icing system with a blocked probe, he would immediately notice a substantial drop in the indicated EPR, incorrectly indicating a low engine thrust as long as the normal P_{t2} sensing port remains blocked. This results from the introduction of engine anti-icing air flow into the nose cone and resultant increase in the pressure in the interior of the nose cone. This pressure is higher than that which would be sensed at the normal P_{t2} port. Falsely low indicated EPR's have been detected by pilots when they found that they were unable to set takeoff power without exceeding redline N_1 , N_2 , and EGT.

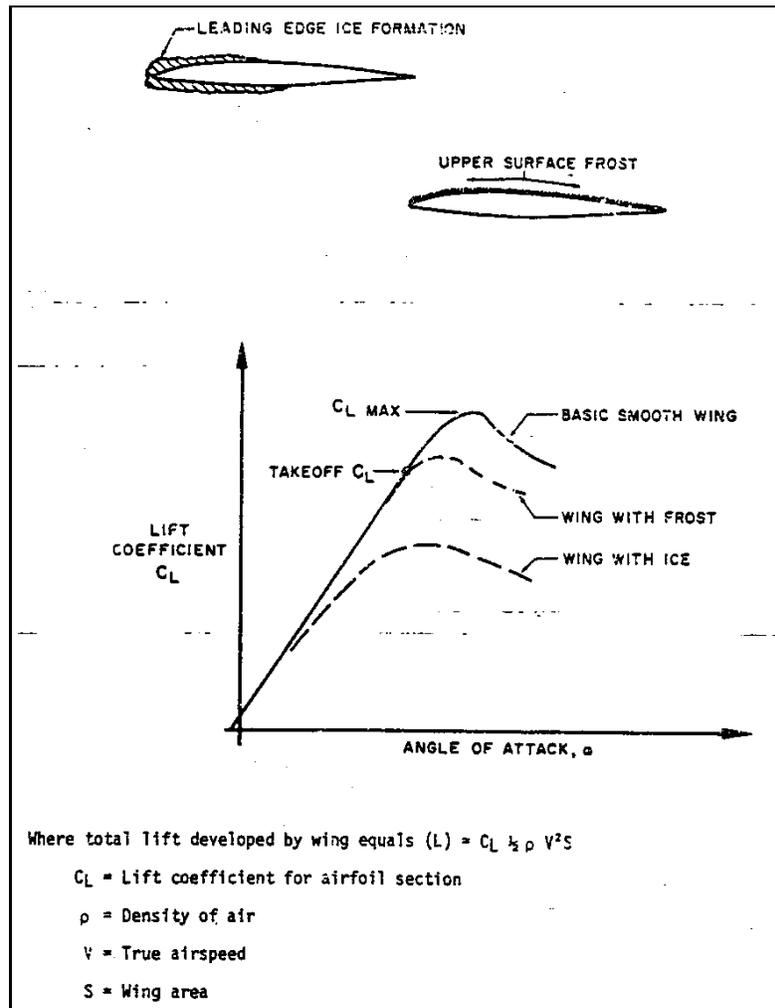
Figure 10.--Effect of Ice and Frost on Aircraft Performance. (From Aerodynamics for Naval Aviators (NAVWEPS 00-80T-80).

Most air carrier aircraft are equipped with a stickshaker or some other type of alarm to alert the pilot that his aircraft is approaching the stall angle of attack. In the B-737, the stickshaker is activated when a fuselage-mounted vane aligns itself with the airflow and reaches a preset angle of attack which is less than the stall angle of attack. The normal alarm margin is equivalent to about 10 percent of the stall airspeed. Since the stall warning activation is

independent of the actual airflow conditions on the wing, the angle of attack at which it will activate is not affected by snow or ice contamination on the wing. However, if the wing's lift-producing efficiency is reduced by such contamination, the aircraft will be maintaining a higher than normal airspeed when flown at the angle of attack at which the stickshaker will activate in order to compensate for the degraded efficiency of the wing. Thus, the stickshaker will activate at a higher-than-normal airspeed. Furthermore, the angle of attack margin, and thus the airspeed margin, between stall warning, stall buffet, and stall will be reduced significantly or negated entirely.

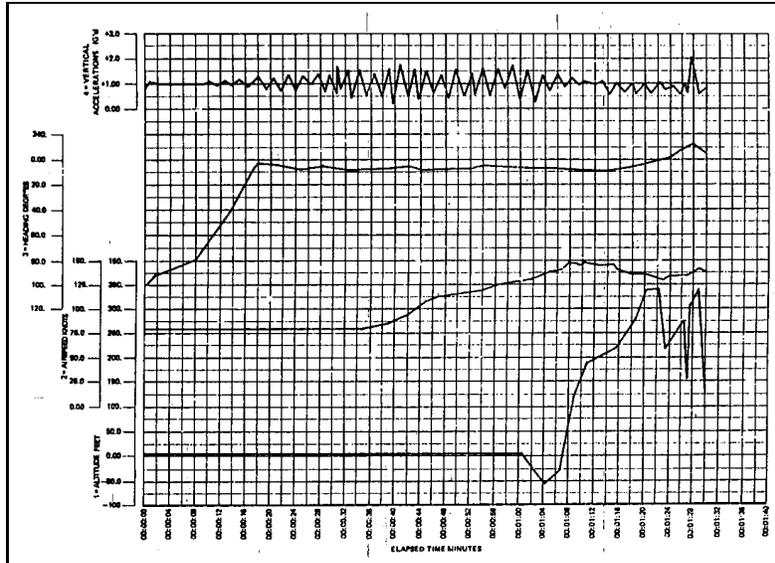
Appendix E Flight Data Recorder Graph

The recorders were only superficially damaged. The foil recording medium was removed from the FDR and examination disclosed that all parameters and binary traces were present and active. The altitude and airspeed traces were derived from the aircraft central air data computer. Other data recorded were magnetic heading, vertical acceleration, and radio transmitter (microphone) keying, all as a function of time. (The FDR readout is presented in appendix E.)

A timing discrepancy was found in the FDR which made it necessary to evaluate carefully all values obtained from this unit. The first two radio transmissions were timed correctly and matched the timing obtained from the CVR and the ATC transcript within 1 second. The third transmission ("okay") came only a measured 3 seconds after

takeoff acknowledgement, instead of the 6 seconds indicated by the other sources. This discrepancy affected all recorded traces simultaneously and probably occurred a number of times throughout the accident flight. Examination of data from previous flights showed that it was irregular in occurrence and duration; the foil slowed for short periods of time then speeded up, thus rendering the overall timing correct while leaving short-term timing errors. This was caused by a malfunction of the foil takeoff drive system. Therefore, FDR data were considered reliable only if validated by the other two data sources.

The FDR showed a sharp decrease and then a gentle rise in the altitude trace beginning at 1600:31.6 (0002:00.6); this is characteristic of the change in static pressure caused by aircraft rotation. Airspeed at this time was recorded as 130 knots. The V_2 callout occurred at 1600:37, and the sound of the stall warning (stickshaker) began 2 seconds later and continued until impact.
