02/19/85 China Airlines

Official Accident Report Index Page

Report Number	NTSB/AAR-86/03
Access Number	PB86-910403
Report Title	China Airlines Boeing 747-SP, N4522V, 300 Nautical Miles Northwest of San Francisco, California, February 19, 1985
Report Date	March 29, 1986
Organization Name	National Transportation Safety Board Bureau of Accident Investigation Washington, D.C. 20594
WUN	4333A
Sponsor Name	NATIONAL TRANSPORTATION SAFETY BOARD Washington, D. C. 20594
Report Type	Aviation Accident Report February 19, 1985
Distribution Status	This document is available to the public through the National Technical Information Service, Springfield, Virginia
Report Class	UNCLASSIFIED
Pg Class	UNCLASSIFIED
Pages	48
Keywords	Loss of engine thrust, inflight upset, distraction, instrument scan, failure to monitor instruments, over reliance on the autopilot.

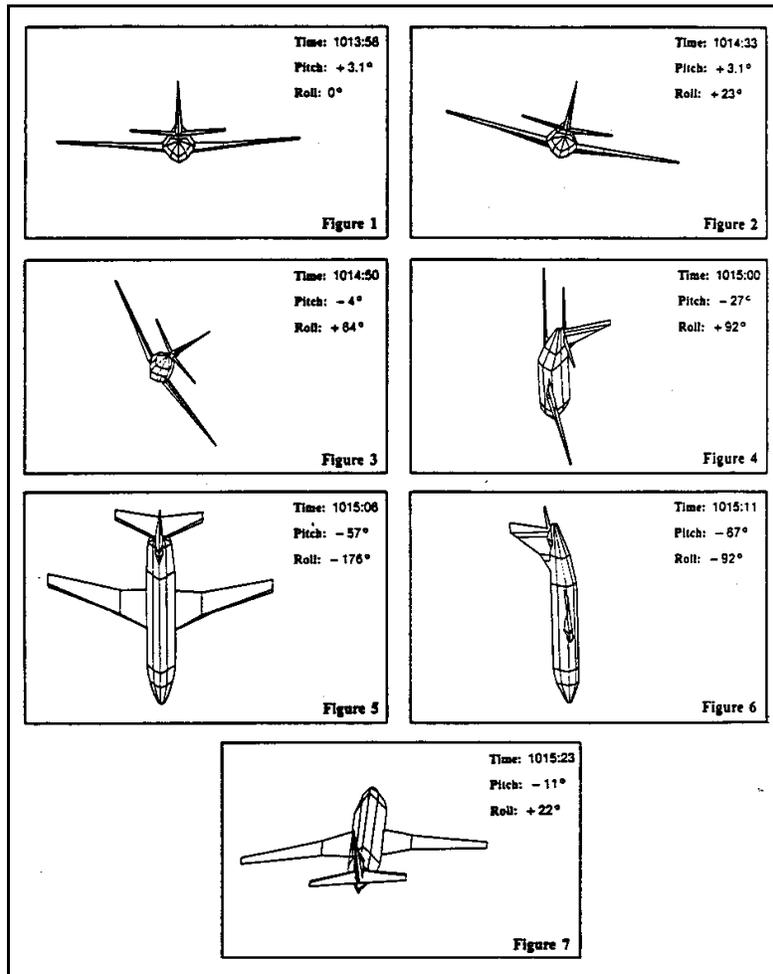
Figures 1.--Excerpts from Computer Animation.

Between 1011:10 and 1012:38, the airspeed fluctuated between 248 KIAS and 253 KIAS and then stabilized at about 250 KIAS. The airplane's roll angle increased from 0.3° to about 2° left-wing-down and the control wheel began deflecting left until, at 1012:30 it stabilized at about a 7° left-wing-down deflection.
