# 02/24/89 United Airlines

## Official Accident Report Index Page

<b>Report Number</b>	NTSB/AAR-90/01
<b>Access Number</b>	PB90-910401
<b>Report Title</b>	Title and Subtitle Aircraft Accident Report--United Airlines Flight 811, Boeing 747-122, N4713U, Honolulu, Hawaii, February 24, 1989
<b>Report Date</b>	April 16, 1990
<b>Organization Name</b>	National Transportation Safety Board Office of Aviation Safety Washington, D.C. 20594
<b>WUN</b>	5059B
<b>Sponsor Name</b>	NATIONAL TRANSPORTATION SAFETY BOARD Washington, D.C. 20594
<b>Report Type</b>	Aircraft Accident Report February 24, 1989
<b>Distribution Status</b>	This document is available to the public through the National Technical Information Service, Springfield, Virginia 22161
<b>Report Class</b>	UNCLASSIFIED
<b>Pg Class</b>	UNCLASSIFIED
<b>Pages</b>	72
<b>Abstract</b>	<p>This report explains the sudden opening of an improperly latched cargo door in flight on United Airlines flight 811 near Honolulu, Hawaii, on February 24, 1989. The safety issues discussed in the report include the design and certification of the Boeing 747 cargo doors; the operation and maintenance of the cargo doors; portable emergency oxygen bottles; stora

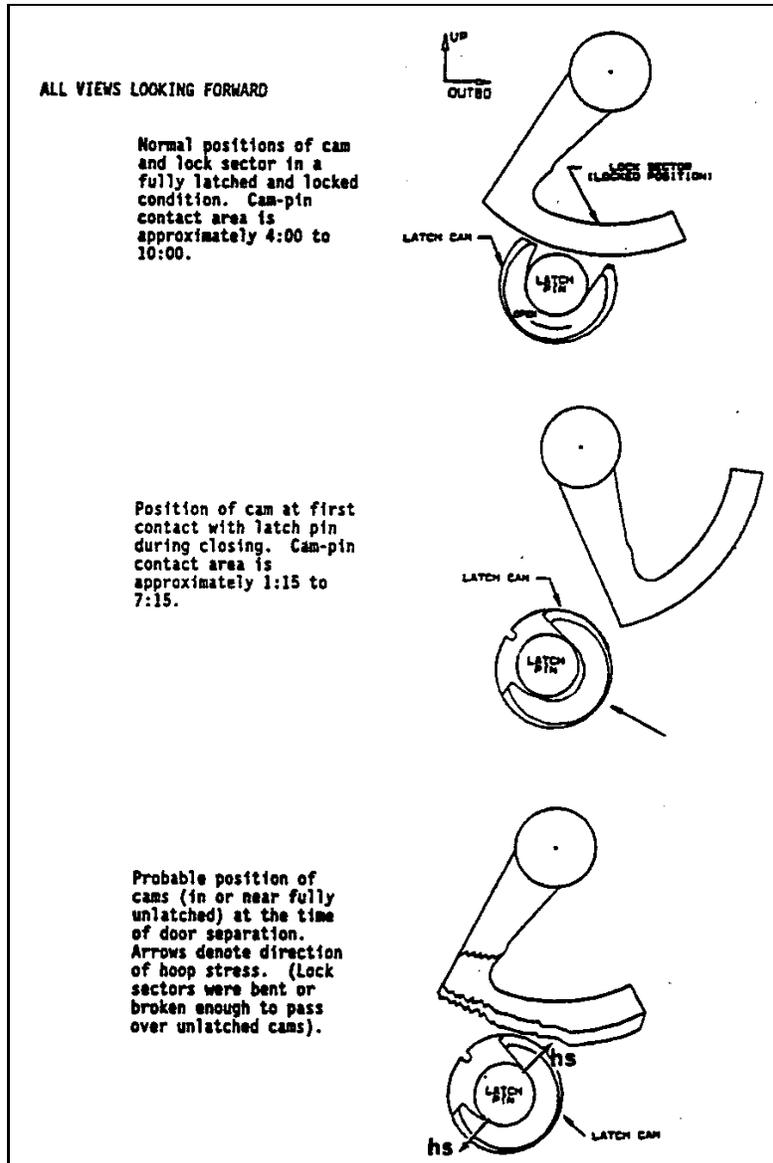
Figure 6.--Latch pin number 6.

In general, all of the forward door cargo latch pins had smooth wear over the entire portion of the pin area contacted by the cams during normal closing and opening of the door. The pins also had distinct roughened (smeared) areas between the 6:15 and the 7:30 positions(See **Figure 7**). The roughened areas had evidence of "heat tinting" and transfer of cam material to the surface of the pins. On pins 1 and 8 the roughened areas extended past the pin bottom to the 5:00 position. The 7:30 position approximately corresponds to the area on the pin where the lower surface of the cam would be relative to the pin when the latch cams are in the unlatched or nearly unlatched position.

Note the rough and smooth areas and the steps indicating the contact area with the latch cam.
