## Official Accident Report Index Page

NORTHWEST AIRLINES FLIGHT 18 BOEING 747-251B,  
N637US NEW TOKYO INTERNATIONAL AIRPORT NARITA,  
JAPAN MARCH 1, 1994

| <b>Report ID</b> | NTSB/SIR-94/02 |

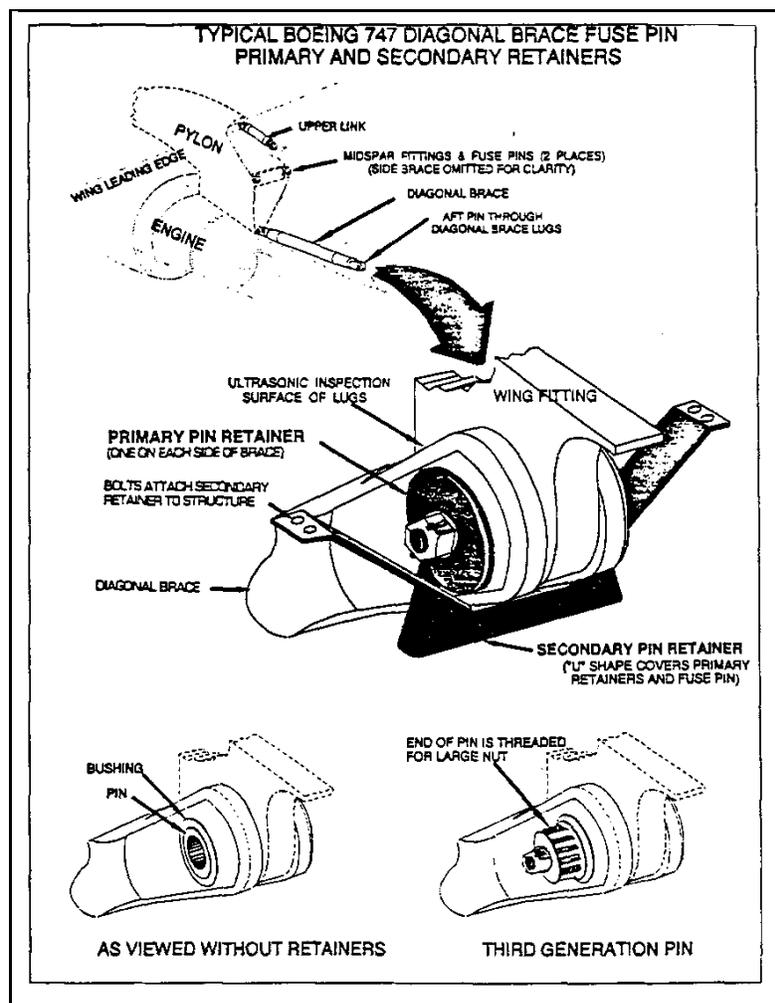
Figure 2.--Diagonal brace attachment details.

Prior to this landing, at some unknown time, the aft fuse pin on the pylon diagonal brace had migrated out of its fitting. The pin was found loose in the pylon structure. It was intact, undamaged, and had no evidence of preexisting defects. The aft diagonal brace fuse pin is normally retained by both a primary retainer (two washer-like retainer caps and a through bolt) and a secondary retention clip (a bolt-on C-shaped bracket). (See figure 2). However, a search of the airplane pylon and engine area, as well as the runway surface at Narita, revealed neither the aft diagonal brace fuse pin primary nor secondary retaining devices.

The No. 1 pylon aft diagonal brace primary fuse pin retainer was removed for some unknown reason, at some unknown time, during the "C" check. It was not reinstalled. The secondary retainer was removed in accordance with step 4 of the CITEXT card, but was not reinstalled, as required by step 10 of that card. Specifically, the mechanic was instructed, in part, to: "Reinstall fuse pin secondary retainer at forward and aft lug locations if removed per step 4 above." The Safety Board believes that the failure to reinstall the primary and secondary fuse pin retainers on the pylon of engine No. 1 was the result of a series of errors.

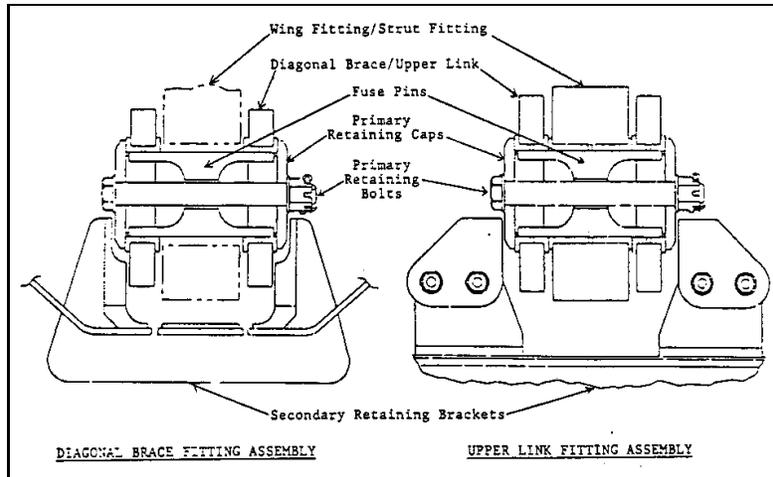
Figure 3.--Diagonal brace and upper link fitting assemblies.

The fractured forward upper link fuse pin from the No. 1 pylon was recovered in three pieces and was retained by the JAAIC for metallurgical examination. Examination of the pin revealed that it fractured in static overload and that there was no evidence of preexisting fatigue.
