03/18/89 Evergreen International Airlines

Official Accident Report Index Page

Report Number	NTSB/AAR-90/02
Access Number	PB90-910402
Report Title	Evergreen International Airlines, McDonnell Douglas DC-9-33F, N931F, Saginaw, Texas, March 18, 1989
Report Date	April 23, 1990
Organization Name	National Transportation Safety Board Office of Aviation Safety Washington, D.C. 20594
WUN	5094A
Sponsor Name	NATIONAL TRANSPORTATION SAFETY BOARD Washington, D.C. 20594
Report Type	Aircraft Accident Report March 18, 1989
Distribution Status	This document is available to the public through the National Technical Information Service, Springfield, Virginia 22161
Report Class	UNCLASSIFIED
Pg Class	UNCLASSIFIED
Pages	85
Abstract	This report explains the crash of an Evergreen International Airlines McDonnell Douglas DC-09-33F, N931F, in Saginaw, Texas, on March 18, 1989. The safety issues discussed in the report include the cargo door closing procedures on DC-9 airplanes; the external cargo door markings on DC-9 airplanes; the door warning switch electrical wiring on DC-9 airplanes; and the actions of the carrier and the Federal Aviation Administration concerning these issues preceding the accident.

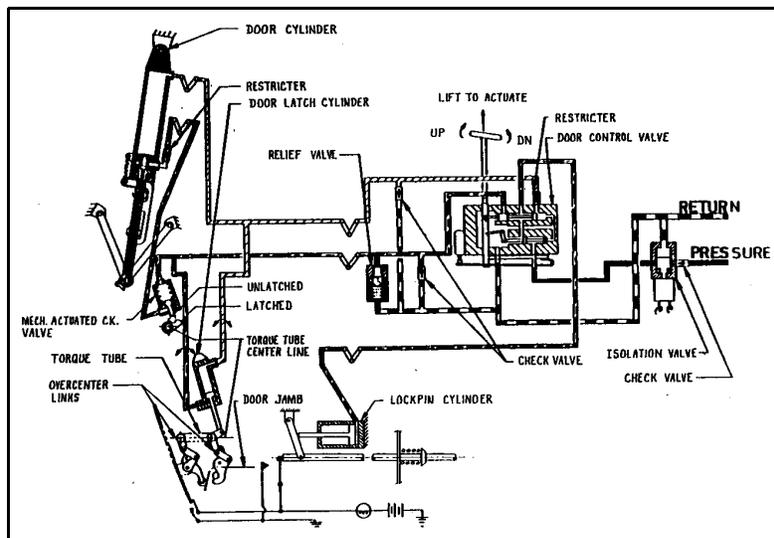
Figure 1.--Hydraulic routing within the cargo door hydraulic system.

1. The cargo door control valve - This valve was found in the "valve neutral" position (as opposed to the "door open" or the "door closed" position) within the wreckage. Damage to the valve did not allow testing in the "door open" or "door closed" positions. The valve was disassembled at its manufacturer's facility and no anomalies were found. **See Figure 1** for a cut-away diagram of this valve in its three operating positions.

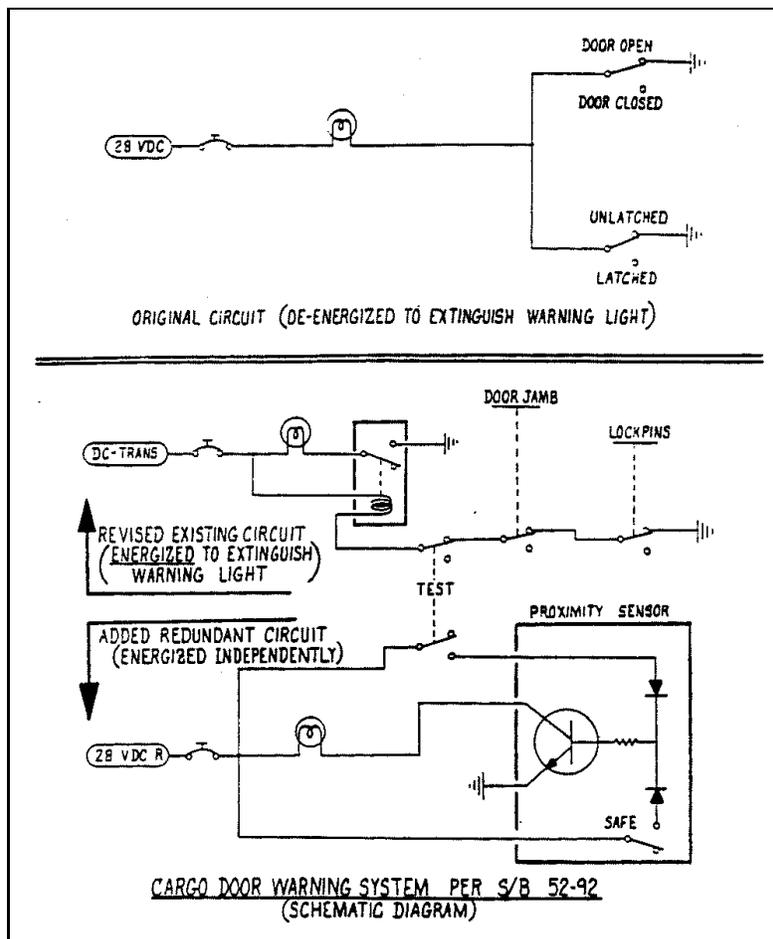
Figure 3.--Cargo door warning switch electrical diagrams.

The SB modification eliminates an undesirable failure mode of the original cargo door cockpit warning light system wherein a failure of either the door jamb switch or the lockpin

switch to close will remain undetected and the cockpit warning light will appear to function normally; that is, the light would illuminate when the other functional switch closes and extinguish when it opens. Thus, if the lockpin switch is the one failed, the door will appear safe when closed even though it is not fully latched and locked. The modification to the existing circuit consists of adding a relay which must be energized with 28 volts dc to extinguish the cockpit warning light. The door jamb and lockpin switches are rewired in a series circuit so that electrical continuity through both switches will energize the relay. With the logic of the switches inverted and placed in series instead of parallel, a failure of either switch to close will result in an illuminated warning light.

The cargo door latch limit switch/wire/cannon plug assembly was wired into the door warning system in the original configuration without the benefit of SB 52-92 improvements. The original configuration called for this switch and the door jamb limit switch to be connected in parallel to the MAIN CARGO DOOR open warning light on the annunciator panel in the cockpit. See figure 3. The female connector to this switch was damaged and a small amount of corrosion on the connector was evident. The unit was x-rayed and disassembled. The L-lever of the switch would not fully depress the micro-switch plunger of the assembly and electrical continuity could not be established.

- g. SB 52-92 - Issued on April 7, 1976, with revision 2 on November 21, 1985 - This SB recommended a modification of the original cargo door cockpit warning light system electrical circuit and the addition of a redundant independently energized warning light and circuit.
