05/09/76 Imperial Iranian Air Force (IIAF)

Official Accident Report Index Page

Report Number	NTSS-AAR-78-12
Report Title	Investigation Report--Wing Failure of Boeing 747-131, Near Madrid, Spain, May 9, 1976
Report Date	October 6, 1978
Organization Name	National Transportation Safety Board Bureau of Technology Washington, D. C. 20594
WUN	2479
Sponsor Name	NATIONAL TRANSPORTATION SAFETY BOARD Washington, D. C. 20594
Report Type	Special Investigation Report May 9, 1976
Distribution Status	This document is available to the public through the National Technical Information Service, Springfield, Virginia 22151
Report Class	UNCLASSIFIED
Pg Class	UNCLASSIFIED
Pages	43
Price	H03.A01
Keywords	Aircraft accident; lightning strike; explosion; fuel flameability; wing failure; gust overload; fuel ignition.
Abstract	On May 9, 1976, an Imperial Iranian Air Force Boeing 747-131 crashed as it approached Madrid, Spain. Witnesses observed lightning strike the aircraft followed by fire, explosion, and separation of the left wing. The report includes fire pattern studies, structural failure descriptions, trajectory analysis, fuel flammability calculations, gust loading analysis, and an analytical treat

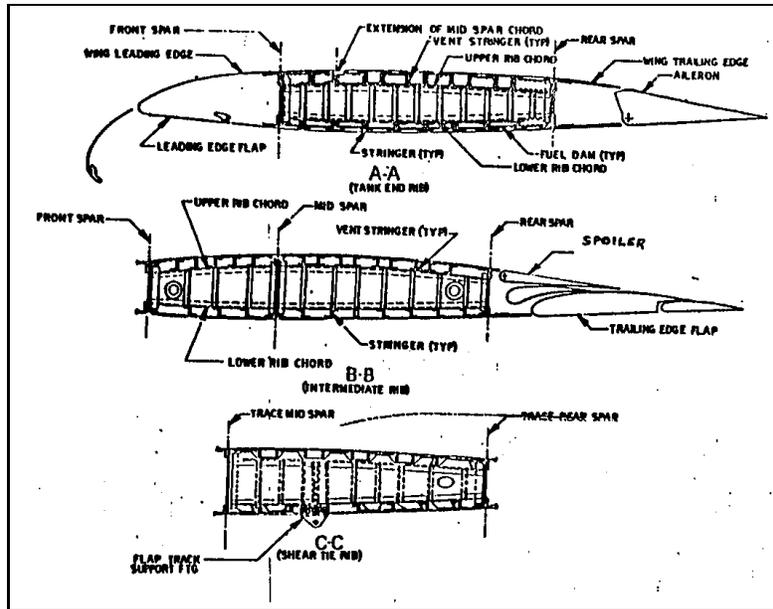
Pitting and localized burn areas typical of lightning attachment damage were found on the left wingtip and on the vertical fin at the VOR antenna. The left wing had separated into 15 major pieces before ground impact and parts of it were found at each location of wreckage. (See drawing on page 31.)

The left wing outboard of the No. 1 engine position separated in three major pieces and along three lines of fracture. The left wingtip, a piece about 20 ft long, separated on a line parallel to the fuselage centerline and roughly halfway between the end of the wing and the No. 1 engine. A second line of separation was just outboard of the No. 1 engine and ran parallel to the rib centerlines. The third line of separation spanned between the first two and ran along the front spar. The wingtip, consisting of the high frequency antenna and coupler, also separated from the wing.
