Report Number NTSB-AAR-79-17

Report Title American Airlines, Inc. DC-10-10, N110AA, Chicago-O'Hare International Airport Chicago, Illinois, May 25, 1979

Organization Name National Transportation Safety Board Bureau of Accident Investigation Washington, D.C. 20594

Report Type Aircraft Accident Report May 25, 1979

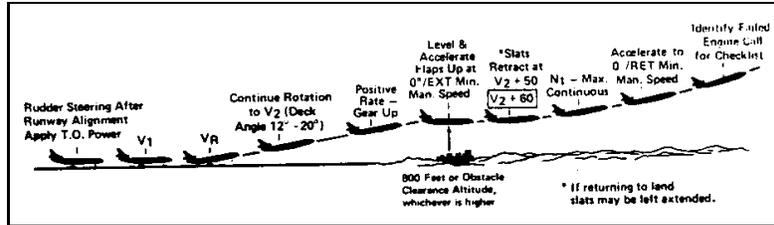
Figure 14. Diagram of AAL emergency procedure.

This procedure assumes indication of engine failure where the take-off is continued. Each take-off should be planned for the possibility of an engine failure. Normal take-off procedures ensure the ability to handle an engine failure successfully at any point.

If an engine failure occurs when making a Standard Thrust take-off, Standard Thrust on the remaining engines will produce the required take-off performance. If deemed necessary, the remaining engines may be advance to Maximum Take-Off Thrust.

On July 23, 1979, American Airlines issued Operations Bulletin No. DC-10-73 which amended the procedure. The bulletin states, in part:
