**Report Number** NTSB/AAR-86/02

**Report Title** Air Canada Flight 797, McDonnell Douglas DC-9-32, C-FTLU, Greater Cincinnati International Airport, Covington, Kentucky, June 2, 1983 (Supersedes NTSB/AAR-84/09)

**Report Type** Aircraft Accident Report June 2, 1983

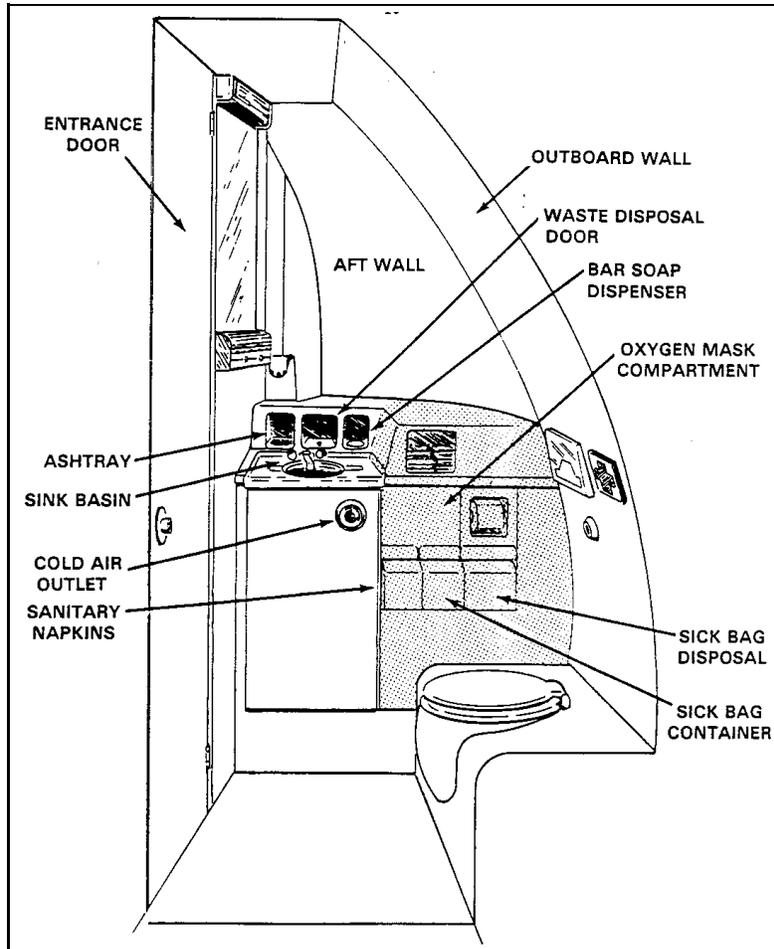
Figure 9.--Diagram of aft lavatory, viewed aft.

The aft lavatory was damaged extensively by fire and heat. Most of the lavatory's interior walls had been burned away. The entry door, which had been kept closed, was destroyed except within 16 inches of the floor. The aft pressure bulkhead and fuselage skin which comprised the outermost portion of the lavatory enclosure were intact, but were buckled and discolored to dark brown.

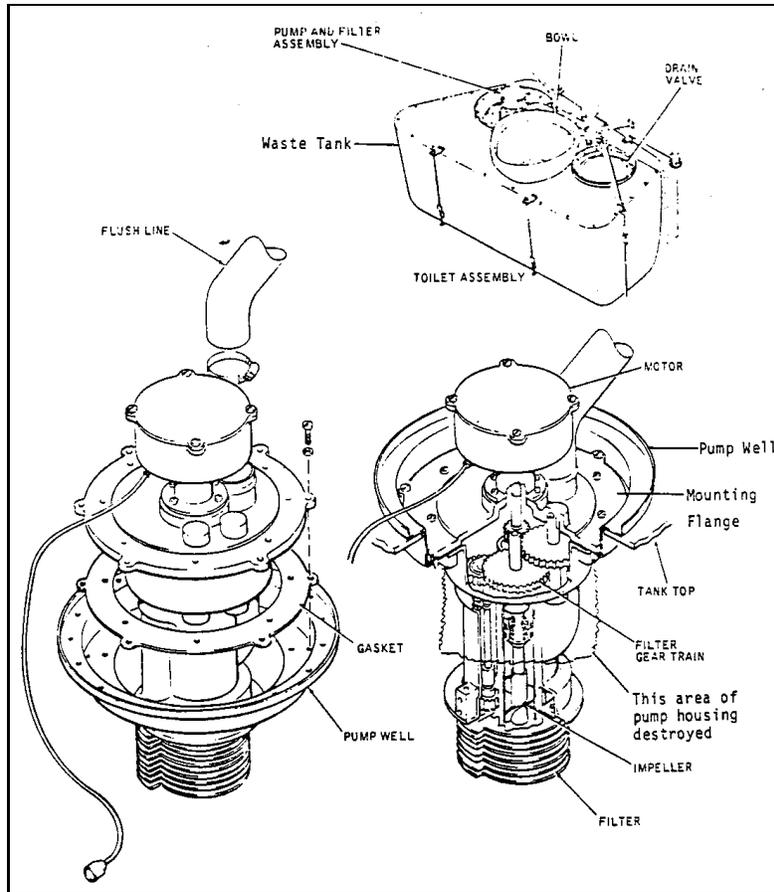
**Figure 11.—Lavatory pump and filter system.**

The flush motor was found attached to its mounting flange which was attached to the pump well. The flush motor assembly was found in approximately its normal position in the waste tank next to, but detached from, the flush pump and filter assembly. The motor housing was completely melted. Large concentrations of molten metal were found on the forward side of the mounting flange facing the toilet bowl, and on the aft side where the 3-phase electrical leads enter the motor housing. A portion of the wiring harness which supplies a.c. power to the flush timer, flush motor, and flush button was encased in the molten metal on the aft side of the motor. The rotor section of the flush motor was encased in molten metal above the field windings; however, the rotor did not appear to have been damaged extensively by heat. (See figure 11).

The flush pump and filter assembly found in the waste tank was partially intact. The filter and pump mechanisms, which apparently had been located below the water line in the waste tank, were in good condition. Above the water line, the plastic housing for the pump and filter was melted away. This housing also encloses the filter gear train and is part of the assembly used to mount the pump and filter to the pump well. The exposed shaft and gears showed heat damage. The gears, which make up the filter gear train that connects the motor to the pump and filter, were found lying in the waste tank. The plastic mounting ring, which mates the pump and filter housing to the pump well, was found intact among the debris in the waste tank. There was some slight melting of the top surface of the mounting ring. All of the components of the flush motor and pump assembly were removed for further examination.

When the flush motor and its associated mounting were removed from the toilet tank, two wires in the motor harness and all of the wires in the power harness broke just aft of the motor housing due to brittleness. To facilitate removal of the flush motor assembly, the remaining wires of the motor harness were cut a few inches aft of the motor housing and tagged for identification.
