Official Accident Report Index Page

UNCONTAINED ENGINE FAILURE/FIRE VALUJET AIRLINES
FLIGHT 597 DOUGLAS DC-9-32, N908VJ ATLANTA,
GEORGIA JUNE 8, 1995

Accident NTSB ID	96-03
Airline	ValuJet Airlines
Model aircraft	DC-9-32, N908VJ
Aircraft manufacturer	Douglas
Engine type	JT8D-9A
Engine manufacturer	Pratt & Whitney
Date	06/08/95
Time	1855
Location	Atlanta, GA
Country	USA
IFR or VFR?	VFR
Injuries	7
Fire during flight?	-
Fire on the ground?	Y
Probable cause	The failure of Turk Hava Yollari maintenance and inspection personnel to perform a proper inspection on a 7th stage high compressor disk, thus allowing the detectable crack to grow to a length at which the disk ruptured, under normal operating conditions, propelling engine fragments into the fuselage; the fragments severed the right engine main fuel line, which resulted in a fire that rapidly engulfed the cabin area.
Contributing causes	The lack of an adequate record keeping system and the failure to use "process sheets" to document the step-by-step overhaul/inspection procedures contributed to the failure to detect the crack and, thus, to the accident.

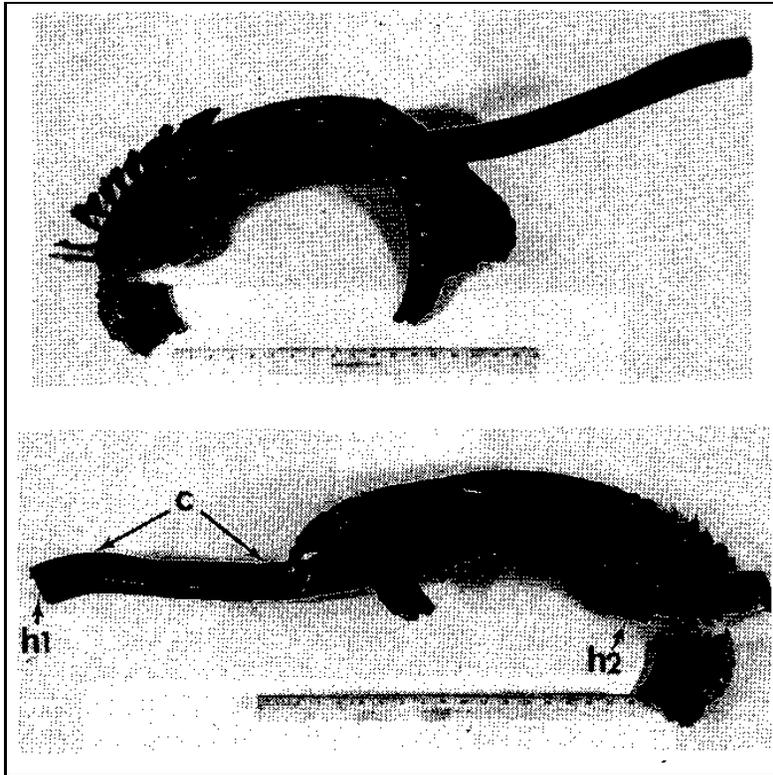
Figure 4—Overall views of 7th stage compressor disk as received

Only two pieces of the fractured 7th stage HPC disk, SN G78851, were recovered.¹⁰ One piece, about half of the disk, was found resting on the accessory gearbox, visible through the circumferential tear in the cowling. The section of disk, which previously formed the bore for the missing half of disk, was straight and extended tangentially from the inner diameter of the disk. The straightened section of disk bore protruded radially out through the circumferential opening in the compressor case and nacelle at the 5 o'clock position. The 7th stage compressor blades retained in the disk were bent opposite the direction of rotation.

Thirty-three 7th stage compressor blades were retained in the larger piece of the 7th stage disk, which was found inside the engine. An arc of 8 and an arc of 11 adjacent blades were bent opposite the direction of rotation. An arc of 14 blades was transversely fractured, adjacent to the blade platform.

The larger piece of the recovered disk was fractured circumferentially (see arrows "c," **figure 4**), which is typical of overstress. About ¼ of the disk outward (toward the rim) of the bore was separated and not recovered. There was a radial fracture of the disk bore at the position shown by arrows "h1" and "h2" in **figure 4**. Examination of these fractures showed that they were matching overstress separations and therefore accounted for the complete separation of the bore section of the disk.

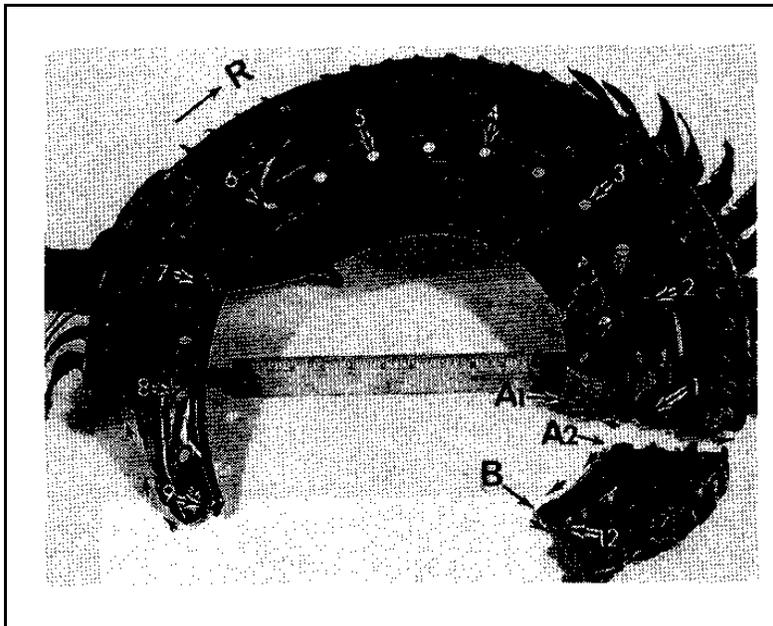
Figure 5—View looking forward showing bulk of the 7th stage compressor disk

Figure 5 shows the aft face of the two recovered pieces situated relative to each other by fracture matching. The SR holes are shown by arrows "1" through "9" and arrow "12" in **figure 5**. The SR hole numbering was arbitrarily begun at the radial fracture plane indicated by arrows "A1" and "A2" in **figure 5** and progressed sequentially counterclockwise looking forward around the disk (as shown in **figure 5**). The missing section of web would have contained SR holes "10" and "11" in the above numbering sequence, and three tierod holes.

Fatigue cracking was also evident radiating outboard from other SR holes, indicated by arrows "4," "6," "8," "9," and "12" in **figure 5**. The largest of these fatigue cracks was 5 mm (0.20 inch) outboard from its respective hole. Most of the secondary cracks appeared to initiate at well-defined corrosion pits in the hole wall with the largest and deepest pit measuring 0.01-inch wide at the hole wall and being about 0.003-inch deep. Magnified examination of the cross section of the crack disclosed a surface deposit on the pit cavity wall and hole wall surfaces indicative of the nickel-cadmium plating.
