07/19/89 United Airlines

Official Accident Report Index Page

Report Number	NTSB/AAR-90/06
Access Number	PB90-910406
Report Title	United Airlines Flight 232, McDonnell Douglas DC-10-10, Sioux Gateway Airport, Sioux City, Iowa, July 19, 1989
Report Date	November 1, 1990
Organization Name	National Transportation Safety Board Office of Aviation Safety Washington, D.C. 20594
WUN	5158D
Sponsor Name	NATIONAL TRANSPORTATION SAFETY BOARD Washington, D.C. 20594
Report Type	Aircraft Accident Report July 19, 1989
Distribution Status	This document is available to the public through the National Technical Information Service, Springfield, Virginia 22161
Report Class	UNCLASSIFIED
Pg Class	UNCLASSIFIED
Pages	126
Abstract	This report explains the crash of a United Airlines McDonnell Douglas DC-10-10 in Sioux City, Iowa, on July 19, 1989. The safety issues discussed in the report are engine fan rotor assembly design, certification, manufacturing, and inspection; maintenance and inspection of engine fan rotor assemblies; hydraulic flight control system design, certification, and protection from uncontained engine debris; cabin safety, including infant restraint systems; and aircraft rescue and fire

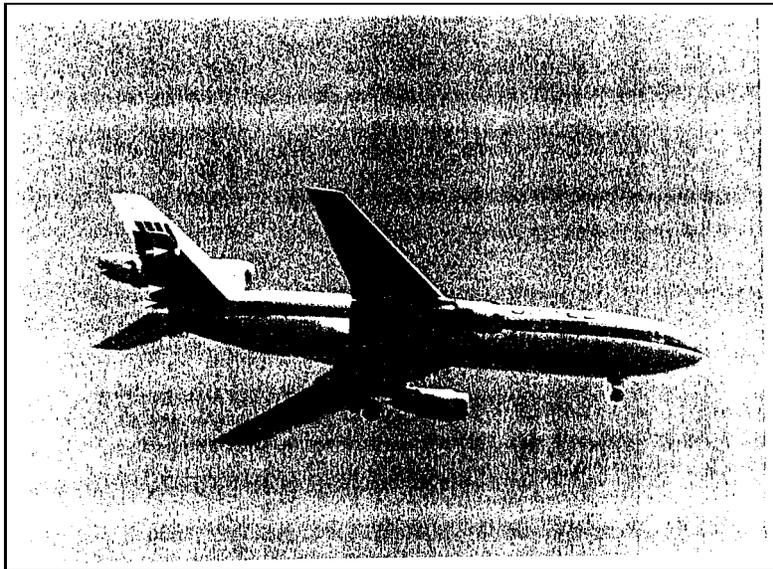
Figure 3.--Photo (C. Zellmer) taken while flight 232 was approaching Sioux Gateway Airport.

Photographs of the airplane were taken by observers on the ground during its final approach to Sioux Gateway Airport. They showed that the No. 2 engine fan cowling and the fuselage tail cone were missing. The remainder of the No. 2 engine appeared intact. Postcrash examination of the wreckage revealed that the No. 2 engine fan rotor components forward of the fan forward shaft, as well as part of the shaft, had separated from the engine in flight.(See **figure 3**, **figure 4**, **figure 5**).

Arrows indicate damage to the right horizontal stabilizer. It is also evident that the No. 2 engine fan cowling door and the tail cone are missing.

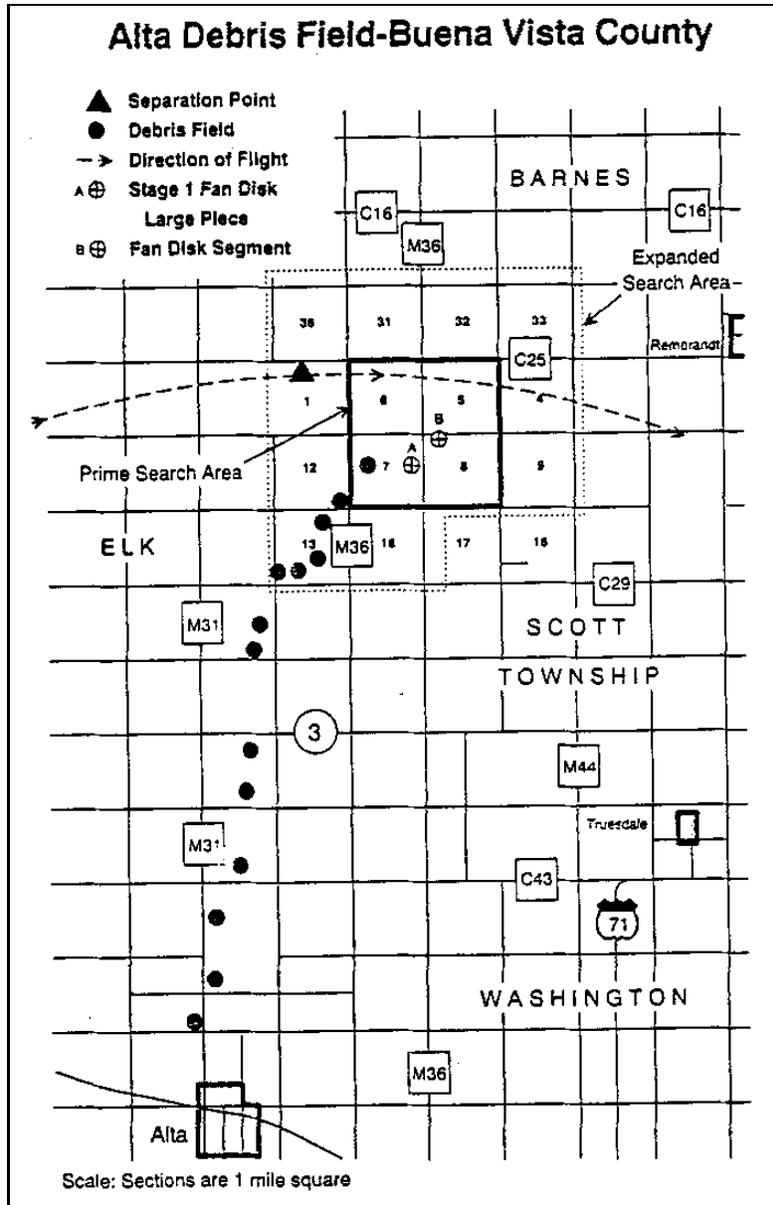
Figure 11. --Trajectory information/Alta debris field.

Also found near Alta soon after the accident were parts of the tail engine adapter assembly, consisting of adapter ring and bellmouth assemblies, an anti-ice pneumatic tube, a starter air tube, three cowl hold-open rods, two hydraulic system accumulators from the No. 2 engine-driven hydraulic pumps, fan blade fragments, two pieces of insulated metal braid-covered hydraulic hose clamped together, and a segment of aluminum material broken out of the large structural "banjo" forging from the airplane inlet duct structure.

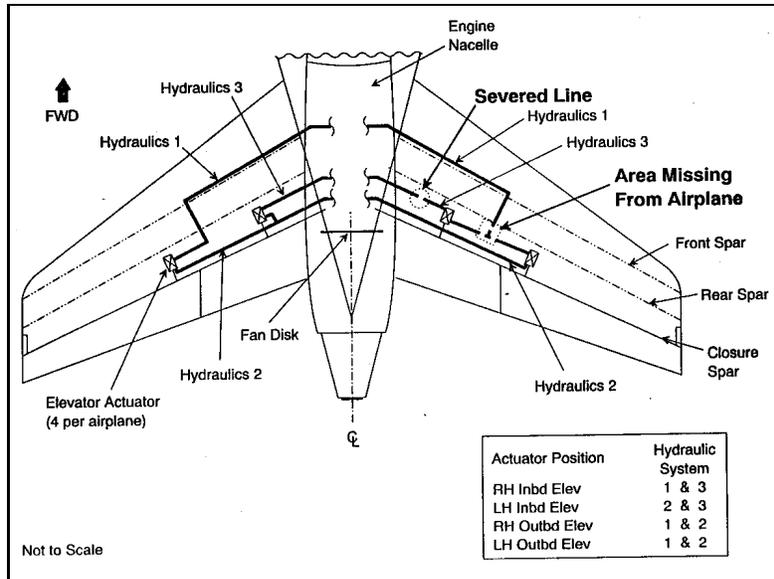
Figure 14.--N1819U, planform of horizontal stabilizer hydraulic system damage.

During reconstruction of the empennage, it was noted that a portion of the right horizontal stabilizer was not recovered at the Sioux City Airport. A photograph taken from the ground prior to impact shows that this section was missing before impact. The missing area contained the No. 1 hydraulic system tubing that supplies hydraulic fluid to the right inboard and outboard elevator actuators. (See **figure 13** and **figure 14**).

Examination of the empennage wreckage revealed that the No. 3 hydraulic system pressure line was severed in the inboard area of the right horizontal stabilizer. Holes penetrating the stabilizer skins were found in the upper and lower surfaces in the area of the severed line. The pressure line was severed with a gap of approximately 2.5 inches. The return line had penetrated the horizontal stabilizer and had separated from the adjacent fitting. Material adhering to severed areas of the damaged hydraulic lines of the No. 3 hydraulic system was identified by X-ray energy dispersion examination as titanium alloy. The entry hole where the object passed through the top skin and doubler was 5.5 inches by 2.25 inches and roughly rectangular. The hole size did not match the dimensions of any piece of the stage 1 fan disk; however, the hole size and shape were comparable to the dimensions of a fan blade base platform.

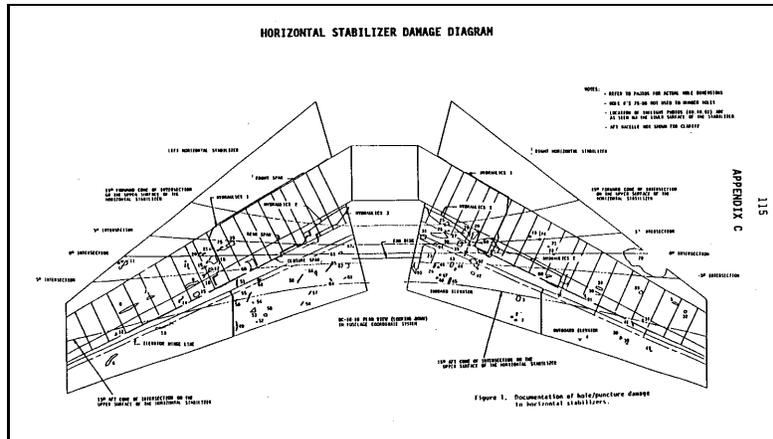
HORIZONTAL STABILIZER DAMAGE DIAGRAM

Four punctures on the vertical stabilizer were noted as probable fragment damage prior to ground impact. Documentation of hole/puncture damage to the horizontal stabilizers is contained in Appendix C. There were 79 punctures recorded from fragment damage and one large hole, about the same size as the large piece of recovered fan disk. The flight control surfaces were recovered in the aircraft wreckage and had varying degrees of damage that could have occurred before or after impact.

The remaining smaller holes were examined to determine if they had been caused by engine hardware and to verify elements of the aircraft control systems that had been damaged. The diagram shown in appendix C was prepared.
