07/30/71 Pan American World Airways, Inc.

Official Accident Report Index Page

Report Number	NTSB-AAR-72-17
Catalog Number	PB-.211 457
Report Title	Pan American World Airways, Inc., Boeing 747, N747PA, Flight 845, San Francisco, California, July 30, 1971
Report Date	May 24, 1972
Organization Name	Bureau of Aviation Safety National Transportation Safety Board Washington, D. C. 20591
Sponsor Name	NATIONAL TRANSPORTATION SAFETY BOARD Washington, D. C. 20591
Report Type	Aircraft Accident Report July 30, 1971
Distribution Status	Release to Public Unlimited Distribution
Report Class	UNCLASSIFIED
Pg Class	UNCLASSIFIED
Pages	57
Price	P3.00
Keywords	Takeoff, ALS structure, takeoff reference speeds, flap configuration, runway length, preferential runway criteria, NOTAM data, AIRAD data, ATIS information, airport restrictions, communications breakdown, evacuation

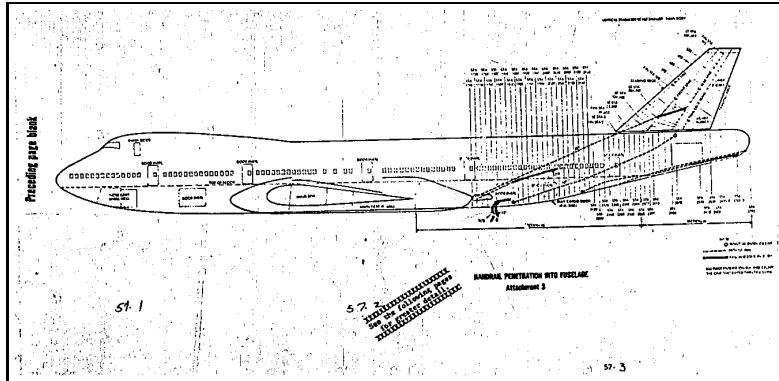
HANDRAIL PENETRATION INTO FUSELAGE Attachment 3

The body landing gears of PA 845 struck the pilings and railings of the approach light pier at the end of the runway during takeoff. Hydraulic systems Nos. 1, 3, and 4 failed immediately thereafter. The right body gear was forced aft and upward into the aft cargo compartment and passenger cabin floor. The left body gear was broken loose and was dangling beneath the aircraft. The bulkhead, to which the body gear was mounted, had failed on both sides of the fuselage. The No. 1 hydraulic system lines for both body gear extend and retract mechanisms were mounted on this bulkhead and were severed during the impact with the ALS structure.
