Official Accident Report Index Page

ATLANTIC SOUTHEAST AIRLINES, INC., FLIGHT 529
EMBRAER EMB-120RT, N256AS CARROLLTON, GEORGIA
AUGUST 21, 1995

| Report ID | NTSB/AAR-96/06 |

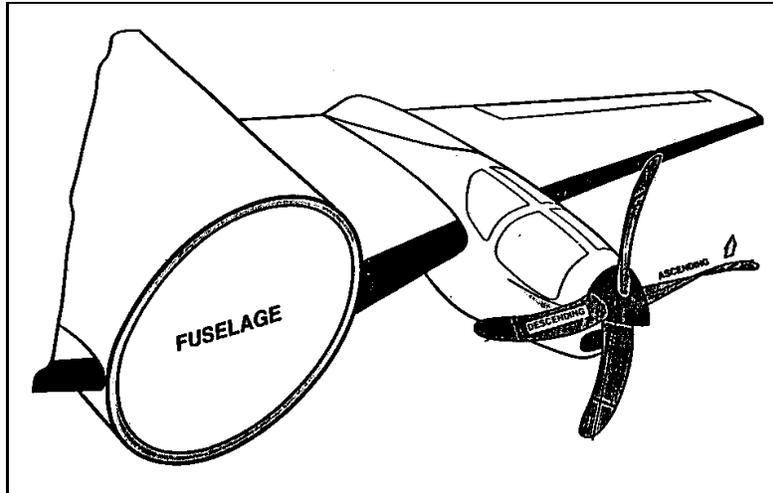
Figure 1.--Propeller installation - left wing.

Investigators found the left engine propeller assembly early in the ground debris path. The propeller hub contained three complete blades and about 1 foot of the inboard end of the fourth blade protruding from the hub. The remainder of the fourth blade was not at the accident site. (See Section 1.12 for more wreckage information.)
