09/06/85 Midwest Express Airlines, Inc.

Official Accident Report Index Page

Report Number	NTSB/AAR-87/01
Access Number	PB87-910401
Report Title	Midwest Express Airlines, Inc. DC-9-14, N100 ME, General Billy Mitchell Field, Milwaukee, Wisconsin, September 6, 1985
Report Date	February 3, 1987
Organization Name	National Transportation Safety Board Bureau of Accident Investigation Washington, D.C. 20594
WUN	4267-A
Sponsor Name	NATIONAL TRANSPORTATION SAFETY BOARD Washington, D. C. 20594
Report Type	Aircraft Accident Report September 6, 1985
Distribution Status	This document is available through the National Technical Information Service, Springfield, Virginia, 22161
Report Class	UNCLASSIFIED
Pg Class	UNCLASSIFIED
Pages	105
Keywords	removable sleeve spacer; high pressure compressor spacer; improper use of flight controls

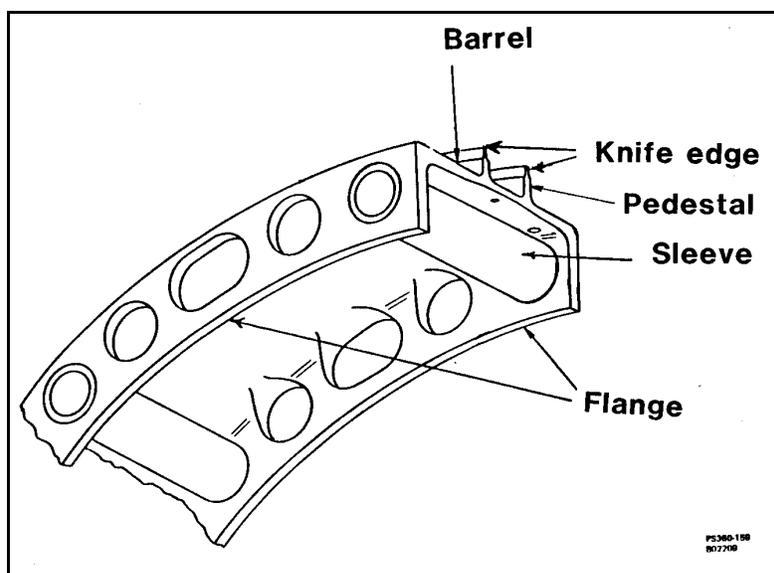
Figure 1.—Main features of a removable sleeve compressor spacer.

A "Reject" stamp dated October 9, referred to a damaged knife edge airseal. The airseal was reworked by blending⁹ the damaged area. The tubes were removed and the spacer nickel cadmium (NiCd) coating was stripped. The inside diameter was grit-blasted. The spacer was then examined using fluorescent magnetic particle inspection (FMPI) equipment and passed inspection.

There was no record of the nature of the previous damage which had necessitated the rework. The specifications regarding airseal blending of the 9-10 spacer allowed machining down to the inside radius, above the pedestal, to a maximum width of 2 inches in one area, or a maximum width of 4 inches for all areas. There is no record of the amount of blending that was performed.

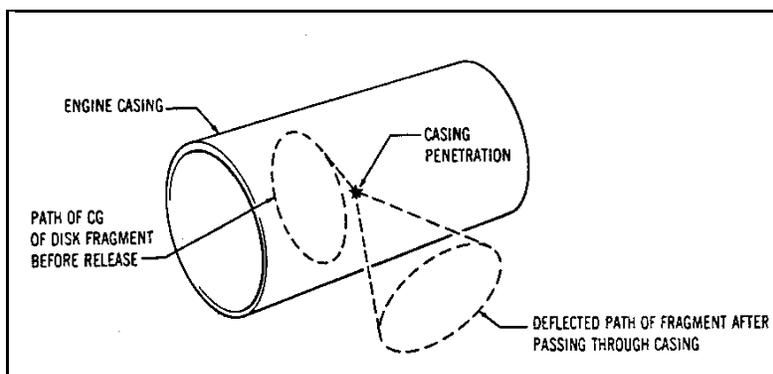
Figure 2.--Deflection path of uncontained engine parts.

Pratt & Whitney representatives testified at the public hearing that their experience had shown that the initial trajectory of uncontained rotating turbojet engine parts may be estimated by assuming that the parts (or fragments thereof) were initially ejected tangentially from their previous plane of rotation, through holes in the case and cowling. This is consistent with the aforementioned research findings. The initial trajectory path may be estimated by aligning a straight object, such as a broomstick, through the hole in the engine case from which the parts were ejected, to the outer diameter of the spacer or rotor that failed (the "broomstick" method). Pratt & Whitney reported that its previous service history of uncontained compressor spacer failures in JT8D-7 and JT8D-1 engines revealed that in incidents where the fuselage was penetrated by ejected spacer pieces, the holes in the fuselage were nearly directly in line with the penetrations of the engine case and tangent to the outer edge of the failed rotating part.

Using the broomstick method and relying on the Pratt & Whitney service experience, the initial trajectory of the ejected right engine spacer pieces was determined to be at an angle of about 20° to the right of vertical, away from the fuselage. Based on the calculated climb performance of N100ME (50 feet per second) before the right engine failed, the pitch attitude of the aircraft was determined to be 12° nose-up at the moment of the failure. The engines of the DC-9-14 were mounted to the engine pylons at another 3° nose up. Thus, the ejected engine parts were assumed to have a rearward component, based on the rearward alignment of the engine, 15° nose-up horizontal. A wind factor, based on a wind from 220° at 17 knots, was assumed.

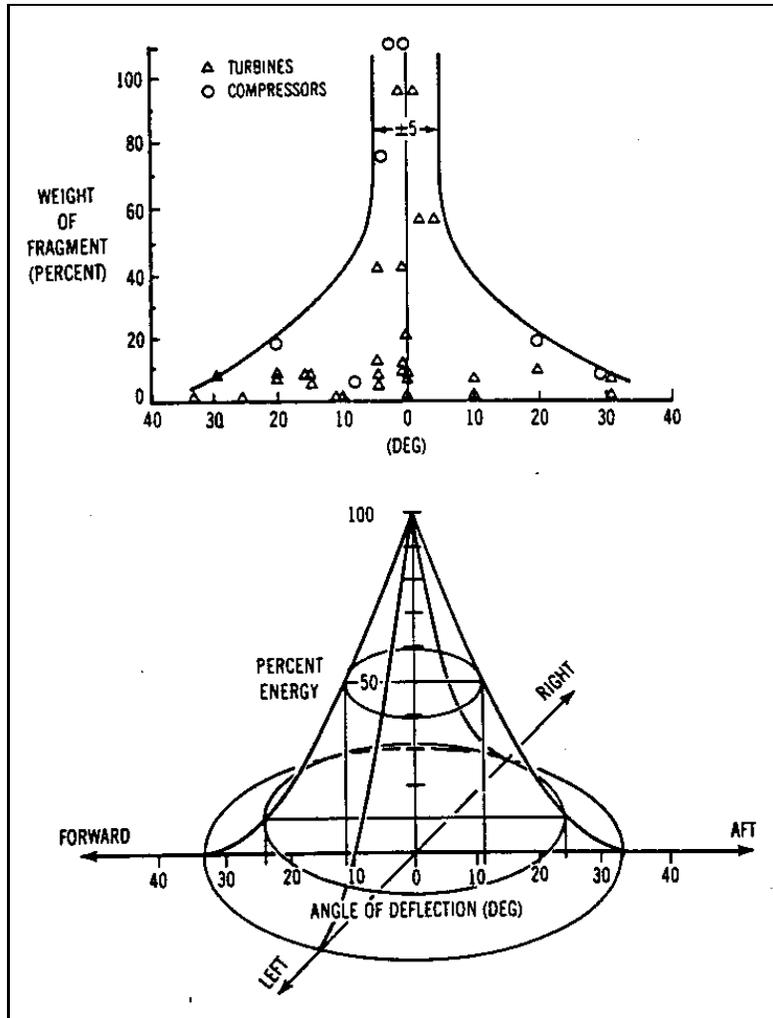
Figure 3.--Dispersion of uncontained engine parts.

The recovered spacer and compressor blade parts were measured to determine drag reference areas, using a factor of 0.635²⁰ to allow for tumbling of parts. Thus, the drag reference areas for the largest spacer part, weighing 1.03 pounds; a smaller spacer part, weighing 0.07 pound; and a compressor blade piece, weighing 0.035 pound were determined to be 0.138, 0.03, and 0.019 square foot, respectively. A flat plate drag coefficient of 1.0 was assumed. For the purpose of determining potential tangential velocities, initial ejection speeds between 0 and 800 feet per second (fps) were considered. (Pratt & Whitney determined that the rim tangential velocity of the operating high pressure compressor spacer had been 800 fps.)

The heaviest part would have been most sensitive to the exit velocity and angle. The lighter parts would have been more sensitive to wind factors. It was found that the predicted central point of ground impact would have been about 400 feet rearward and 200 feet left of the aircraft at the time the parts were ejected from the right engine, assuming that the parts were ejected while the airplane was about 450 feet above the ground, left of the runway centerline and at 168 knots. The calculated ejection point was consistent with the point at which parts were determined to have been ejected, based upon the timing of the "clunk" on the CVR tape; the correlation of FDR, CVR, and recorded radar data; and the locations of the recovered engine parts.

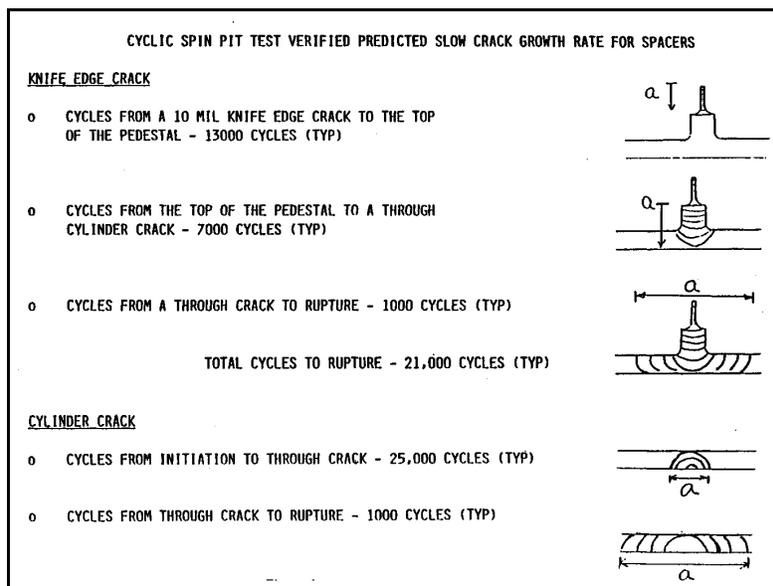
Figure 4.--Cyclic spin test results.

The cyclic spin test indicated that a 10-mil crack originating in the cylinder wall typically required 25,000 cycles to become a cylinder-through-crack, and then another 1,000 cycles to rupture. (Pratt & Whitney cyclic spin test results are shown in figure 4.) In each example, a 10-mil crack was assumed as the initiating crack length.

Pratt & Whitney reported that the growth of spacer knife-edge cracks is retarded when the cracks begin to propagate into larger cross sections. The spin test showed that about 3,000 cycles are needed to propagate a knife-edge crack from the thin knife edge to the thicker pedestal section of a compressor spacer.

Based upon an analytical model developed from the 1980 cyclic spin pit data, Pratt & Whitney concluded that, at approximately 3,000 test cycles before (imminent) rupture of a 7-8 stage spacer, a fatigue crack initiating in a knife edge would have extended to a length of at least 0.20 inch. A crack of this size would extend through the knife

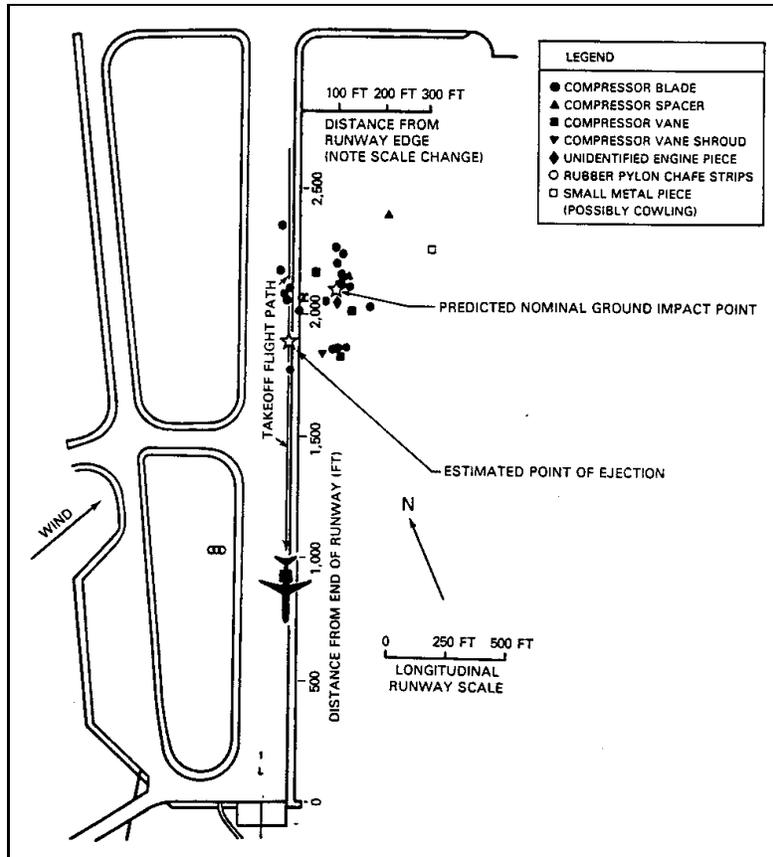
Figure 6. --Calculated nominal ground impact point and actual locations of engine debris adjacent to runway 19R.

Calculations showed that, from the point at which spacer parts were actually ejected from the right engine, the distribution of the parts found near runway 19R was as predicted for undeflected parts existing the right engine. **(See figure 6.)** The ejection paths of a few spacer pieces and compressor blades pieces could not be resolved because those parts were not found. However, based on the paths of the recovered debris, the Safety Board concludes that part of the spacer was probably ground into tiny, harmless pieces during the rupture and that part of the unaccounted for spacer pieces and blades might have been missed, despite a thorough search for engine debris in the grass adjacent to the runway.

Calculations showed that the deflection of engine parts by the engine casing or cowling would have resulted in the absorption of energy of the deflected parts, thereby reducing the velocity substantially and limiting the potential to produce any damage of consequence to the fuselage or to the control systems. For example, engine containment tests have shown that ejected engine debris which is deflected more than 33° loses virtually all of its energy.

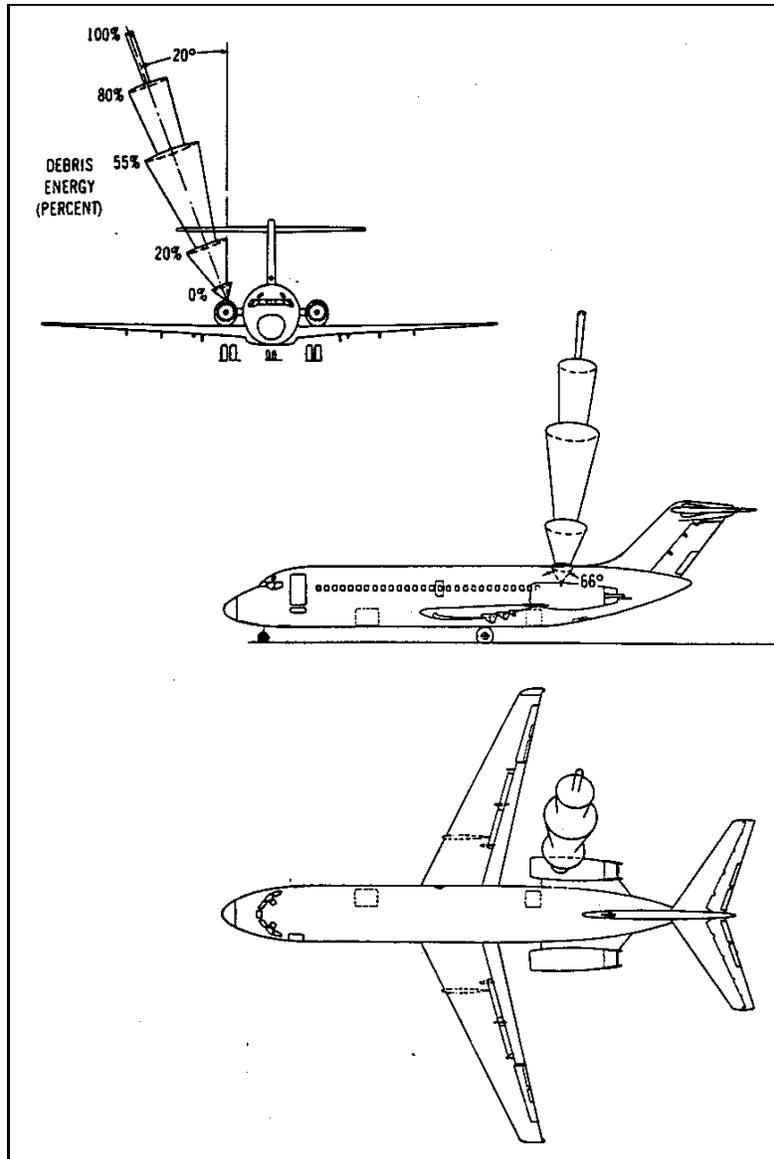
Figure 7.--Three-view drawing of a DC-9 series 10 airplane with various debris patterns and corresponding percentage of energy loss.

Figure 7 shows that undeflected parts are initially ejected in a direction approximated by the broomstick method; in this case, 20° outboard of vertical (away from the airplane fuselage) with high energy and speed. To have struck the Midwest Express fuselage, the parts would have had to have been deflected in excess of 65° and thus virtually all energy would have been lost.

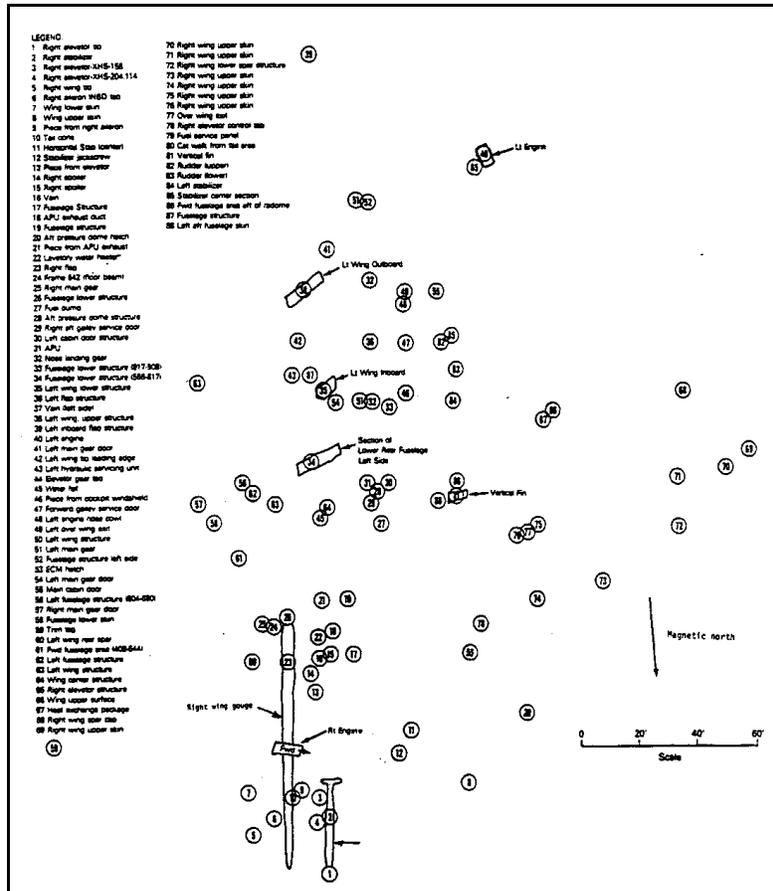
Appendix D Wreckage Diagram

Engine-related parts from the right engine were found up to 200 feet to the left side and between 7,400 and 8,200 feet south of the north end of runway 19R. The parts included compressor blades from the 9th and 10th stages of a Pratt & Whitney JT8D engine and parts, which totaled 90 percent, by weight, of a 9th to 10th stage (9-10) high pressure compressor spacer. With the exception of the engine-related parts found on and adjacent to runway 19R, the wreckage of N100ME was recovered from the airplane impact area. (See appendix D.)

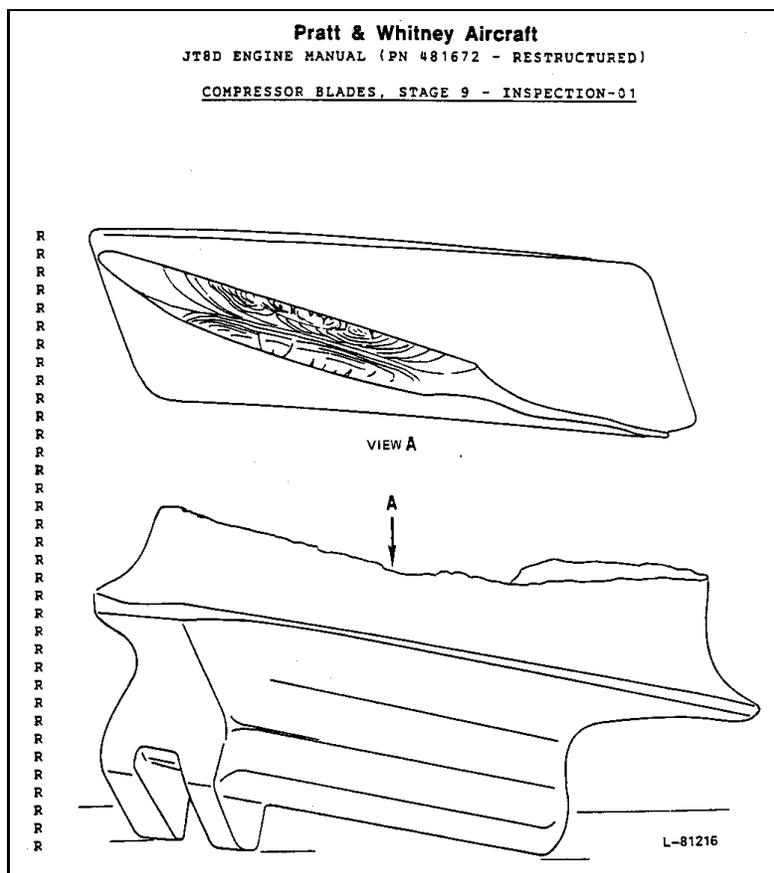
1. Blade fractures and airfoil cracks.
2. The following information specifically applies to engines which have been removed due to stalls, but also should be followed as a general inspection.
3. Evidence of fracture or cracking in either 8th or 9th stage blades is justification to scrap all blades of both stages.
 - a. Inspect for fractures originating in airfoil just above root platform (Figure 801). Such fractures without evidence of foreign object damage and exhibiting multiple origins on fracture surface as shown in View A in Figure 801, indicate excessive blade airfoil stress. Because of this severe stress environment and resultant loss in material strength, remaining 8th and 9th stage blades should be scrapped when this condition is observed.

- b. Inspect blade airfoils for cracking in area just above platform. Any blade exhibiting cracking in this area also indicates excessive blade stress. See Figure 802. Remaining 8th and 9th stage blades should be scrapped regardless of whether or not they exhibit cracking.
