Official Accident Report Index Page

BRITT AIRWAYS, INC., d/b/a CONTINENTAL EXPRESS
FLIGHT 2574 IN-FLIGHT STRUCTURAL BREAKUP
EMB-120RT, N33701 EAGLE LAKE, TEXAS SEPTEMBER 11,
1991

Report ID	NTSB/AAR-92/04
Pages	87
Day or night?	Day
Flight number	2574
Flight origin	Laredo International Airport, TX
Flight destination	Houston Intercontinental Airport
Description	The aircraft experienced a structural breakup in flight and crashed in a cornfield near Eagle Lake, Texas. The horizontal stabilizer, or top of the T-type tail, had separated from the fuselage before ground impact. Examination revealed that the 47 screw fasteners that would have attached the upper surface of the leading edge assembly for the left side of the horizontal stabilizer were missing. They had been removed the night before during scheduled maintenance.

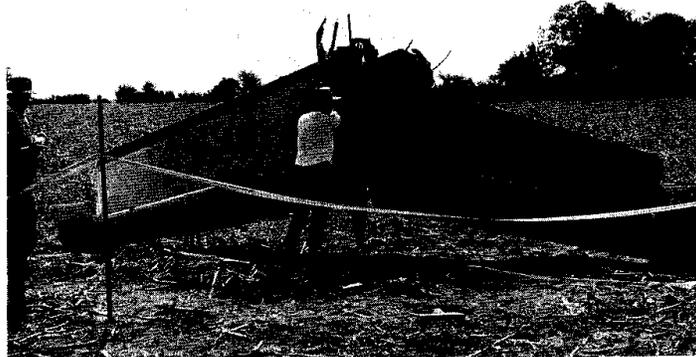
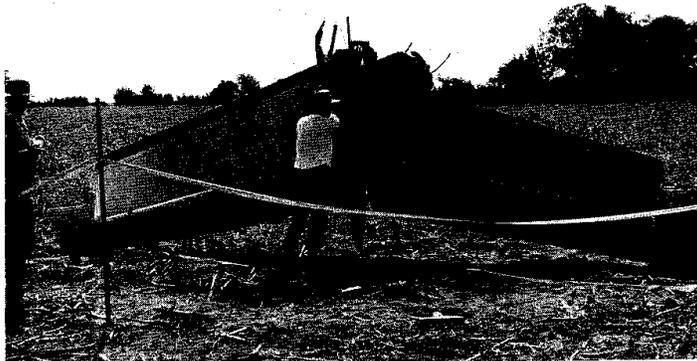
Figure 1a.--View of horizontal stabilizer from underside.

During the Safety Board's examination of the wreckage, none of the 47 screws that would have attached the upper surface of the leading edge assembly for the left side of the horizontal stabilizer was found. There was no evidence of distress in the upper attachment holes for the left side leading edge assembly or indication that the attaching screws were installed when the left side leading edge assembly separated from the horizontal stabilizer. In addition, a "lip" was formed on the forwardmost frame on the left lower side of the horizontal stabilizer spar cap. That frame (spar cap), with receptor holes for the lower attaching screws, was the area into which the screws mounted the underside of the left side leading edge assembly to the stabilizer. This lower frame area showed signs of distress. **Figure 1a, figure 1b, figure 1c, figure 1d** show the condition of the left horizontal stabilizer leading edge.

The lower attachment screws remained installed, but the leading edge assembly had separated from the stabilizer, with the exception of a small portion of composite structure remaining below the two farthest inboard screw heads. The spar cap on the lower left side of the horizontal stabilizer showed evidence of being pulled down so that it would project into the wind stream along with the leading edge. This pulling damage is consistent with the left side leading edge assembly having been ripped down and away from the lower attaching screws as it separated from the horizontal stabilizer. This evidence was consistent with screws missing on the top side of the left leading edge assembly, and the lower attaching screws holding fast, pulling down the frame (spar cap) on the lower side of the stabilizer, and thereby forming the lip.

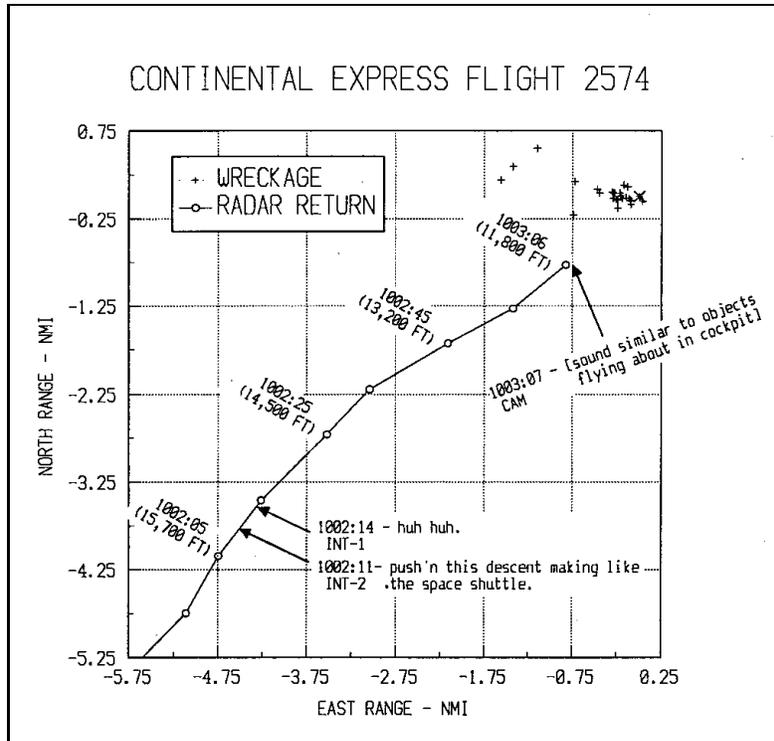
Figure 2.--Radar-derived ground track, CVR sounds, and wreckage distribution.

The airplane was flying to the northeast on a 44-degree heading at the time radar contact was lost at 1003:06 CDT. **Figure 2** shows the radar-derived ground track of flight 2574, selected sounds from the CVR, and the wreckage distribution.

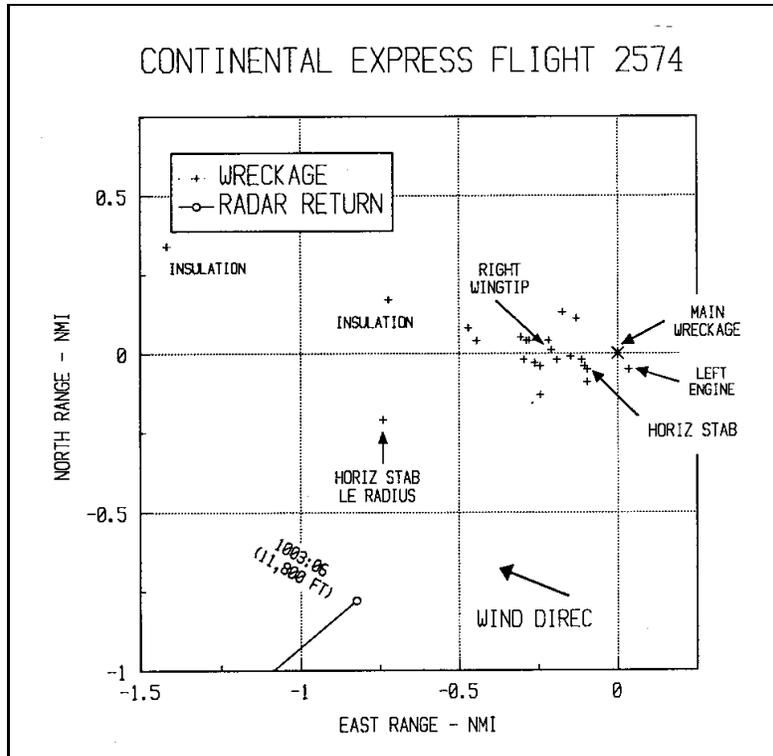
Figure 3.--Closeup view of part of ground track and wreckage distribution.

Figure 3 provides a closeup view of part of the ground track and wreckage distribution. The piece of airplane structure farthest from the main wreckage was the left side leading edge (LE) of the horizontal stabilizer. The LE was the first piece of structure along the flight's northeasterly ground track, preceding the next piece by roughly 1/2 of a nautical mile.

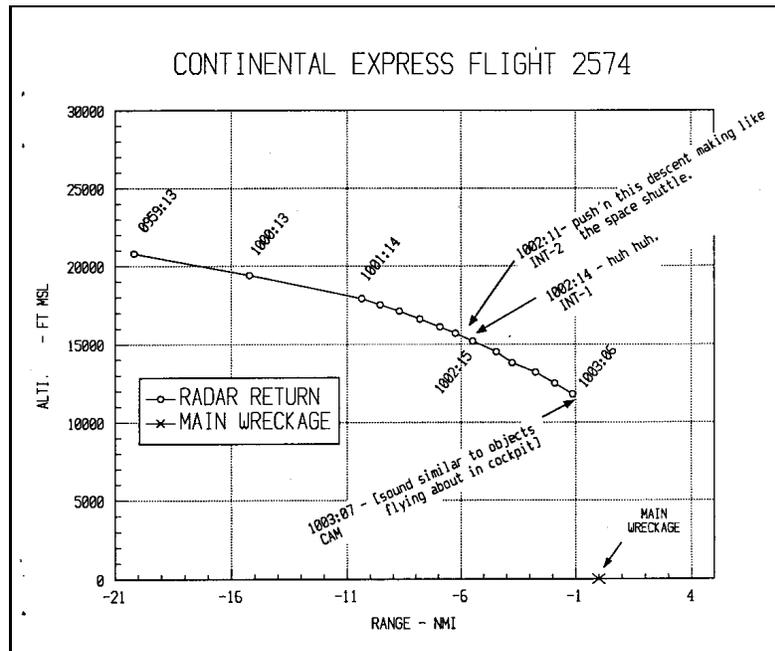
Figure 4.--Radar-derived descent profile.

Figure 4 shows the radar-derived descent profile. The last radar contact occurred as flight 2574 was descending through 11,800 feet. The radar-derived rate of descent during the final minute was approximately 4,000 feet-per-minute, which is consistent with FDR data from the airplane.

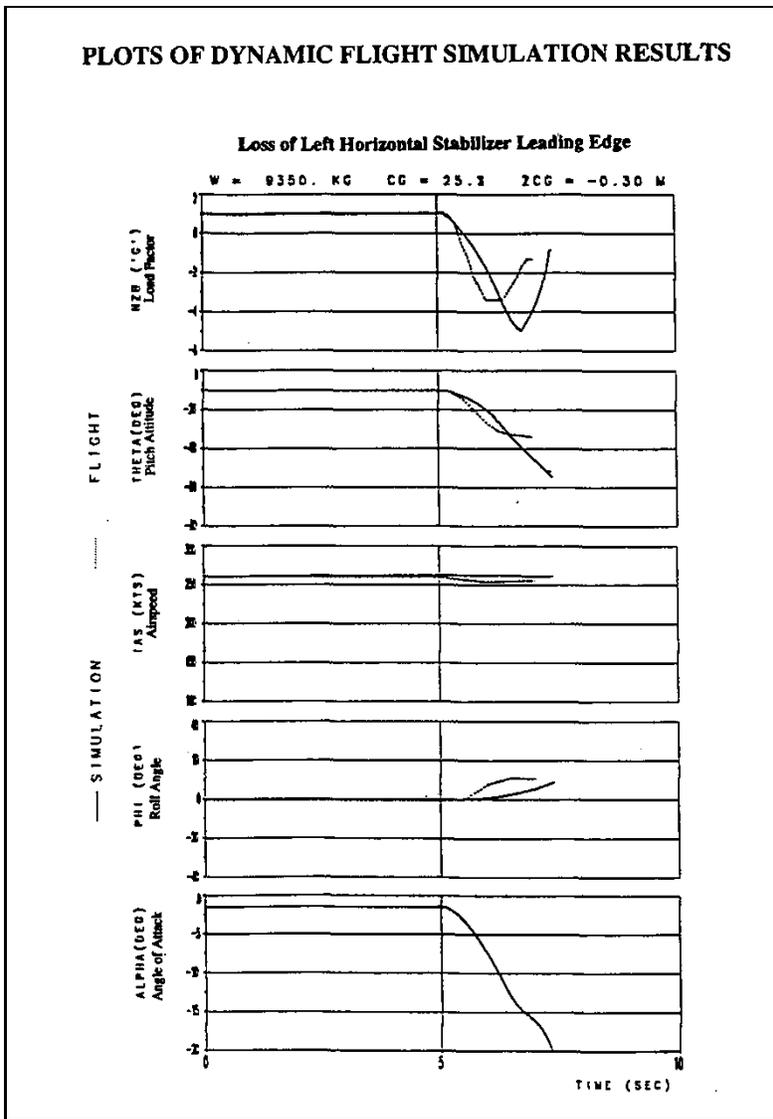
Loss of Left Horizontal Stabilizer Leading Edge

Despite the limitations of flight dynamics predictions, airplane movements during the first 6 1/2 seconds after the upset were consistent with the forces expected following a loss of the left side horizontal stabilizer leading edge. The FDR recorded a nose-left heading change and lateral acceleration that are consistent with an airplane sideslip caused by a drag imbalance between the left (higher drag) and right sides of the airplane. The higher drag on the left side of the airplane was most likely because of the missing leading edge of the left horizontal stabilizer spar. The airplane also reached and maintained 10 degrees to 15 degrees of right roll during the 6 1/2 second interval after upset. The flight dynamics simulation produced a right roll after the upset because of the unbalanced downforce produced by the asymmetrical horizontal stabilizer.
