09/20/81 World Airways, Inc.

Official Accident Report Index Page

Report Number	NTSB-AAR-82-1
Access Number	PB82-910401
Report Title	Airways Inc., Flight 32, McDonnell Douglas DC-10-30CF, N112WA, Over North Atlantic Ocean, September 20, 1981.
Report Date	January 12, 1982
Organization Name	National Transportation Safety Board Bureau of Accident Investigation Washington, D.C. 20594
WUN	3378A
Sponsor Name	NATIONAL TRANSPORTATION SAFETY BOARD Washington, D. C. 20594
Report Type	Aviation Accident Report
Sup Notes	The subject report was distributed to NTSB mailing lists: 1A, 8A and 8B.
Distribution Status	This document is available to the public through the National Technical Information Service-Springfield, Virginia 22161 (Always refer to number listed-in item 2)
Report Class	UNCLASSIFIED
Pg Class	UNCLASSIFIED
Pages	54
Keywords	DC-10, galley lift system, design deficiencies, operations procedures.

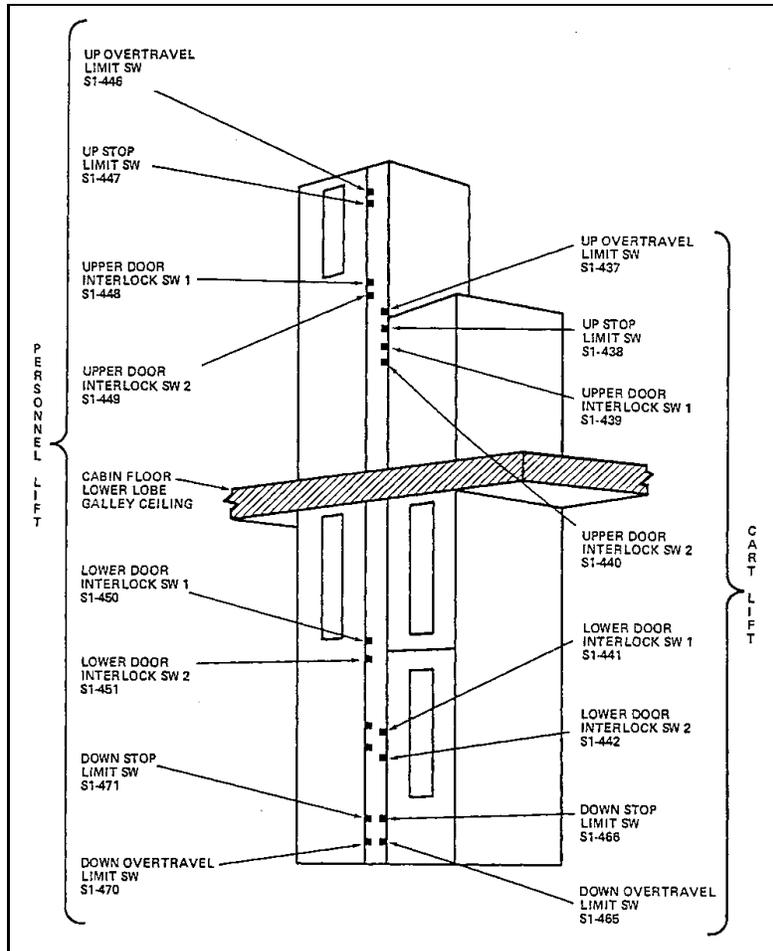
Figure 1.--Galley lift system with electrical switch locations.

Limit Switches - The range of travel of the lifts is controlled by limit switches installed within the wire duct attached to the forward side of one of the vertical lift tracks. There are two sets of two limit switches for each lift; one set located in the service center and one set in the lower galley. One switch is a normal stop switch and the other limit switch is for overtravel in the event the normal switch fails to operate. The limit switches are actuated by a cam plate mounted on the side of the lift. The cam plate has a machined offset to prevent actuation of the overtravel limit switch unless the normal switch fails to operate. In addition to the limit switches, mechanical stops are installed in the vertical lift tracks to stall and shut off the gear motors if both limit switches malfunction.(See **figure 1.**)

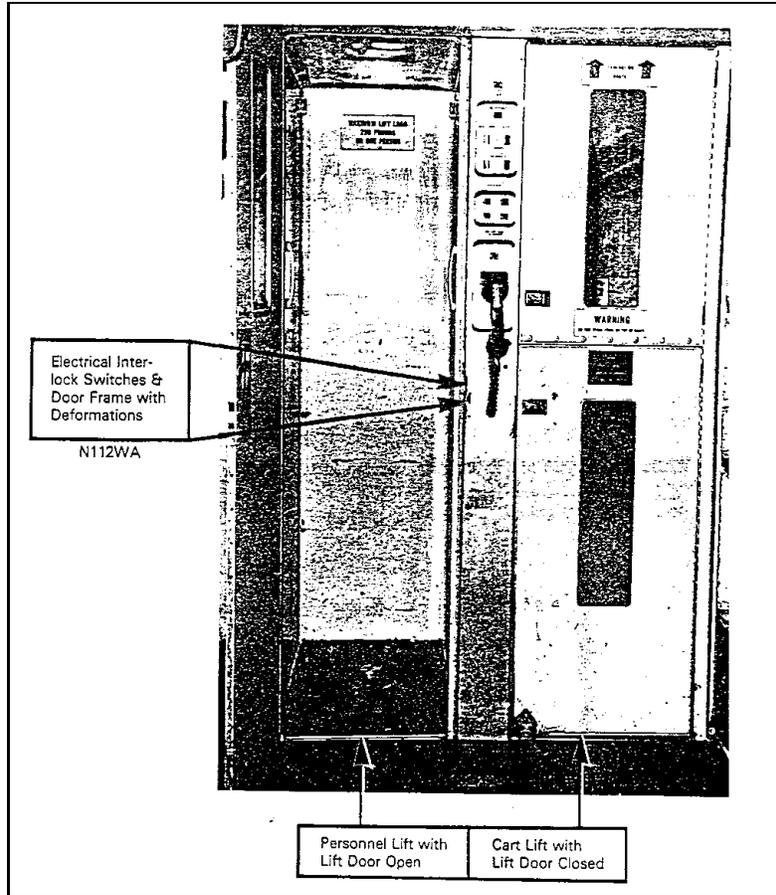
Figure 2.--Personnel and cart lifts.

The lower galley personnel lift door frame was deformed and battered in the area where the electrical interlock switches are mounted(see figure 2). The uppermost electrical interlock switch on the lower galley personnel lift door, S1-450(see figure 1), was found with the switch roller assembly twisted and the roller striker arm jammed in the depressed (switch closed) position. The damage to the lower galley lift door frames was the result of repeated bumping by food and liquor carts.

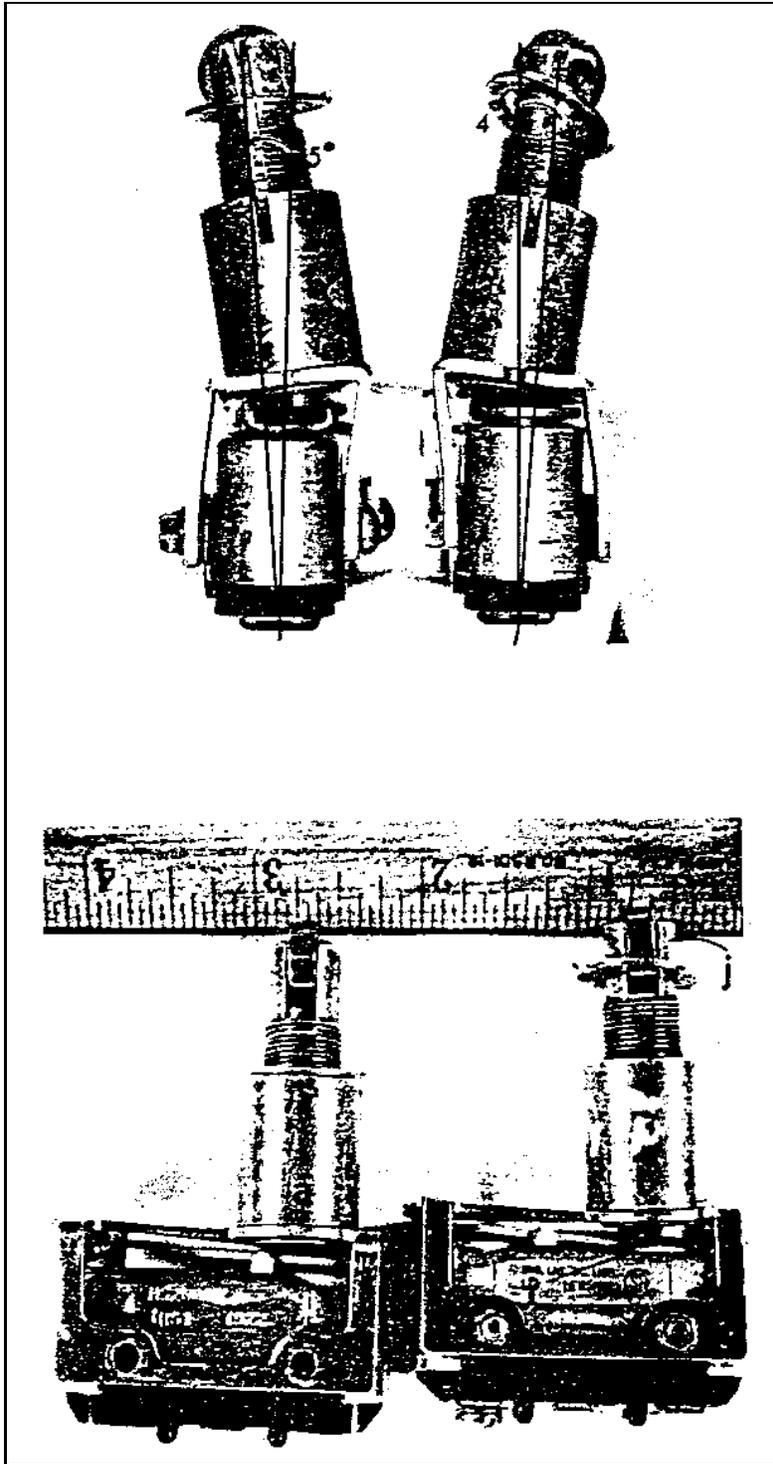
Figure 6.--Side view of S1450 (a) and S1-451 (b) switch assemblies, showing

In this accident, the Safety Board concludes that the deformation and subsequent jamming of the upper electric interlock switch (S1-450) on the lower galley personnel lift door was the direct result of damage to the door jamb area where the switches were mounted from recurrent contacts by galley carts. Although the deformation of the lower switch (S1-451) was of a lesser degree than that of the upper switch, the Board concludes that the damage to this switch was sustained under similar circumstances and caused intermittent jamming in the "closed" position. This conclusion is based on the results of the operational check at Gatwick after the accident, which disclosed lift operation at a normal speed with the lower galley personnel lift door open and the upper service center personnel lift door "closed." Electrical power to both personnel lift AC motors would have been necessary to cause the lift to operate at normal speed. This could only occur if both switches were closed. The results of the metallurgical examination of the switch assemblies further corroborate a probable malfunction of both switches at the time of the accident. The catering representative's statement that the lower galley lift door interlock switches had to be depressed in order to operate the lift cannot be reconciled with other evidence developed during the investigation.

Require a redesign of the DC-10 aircraft galley personnel and food cart lift doors and door frames to relocate the interlock switches to a position where they will not be susceptible to damage by food service carts, to inadvertant contact by personnel attempting removal of food service carts, and to contamination by foreign substance. (Class I, Urgent Action) (A-81-126)

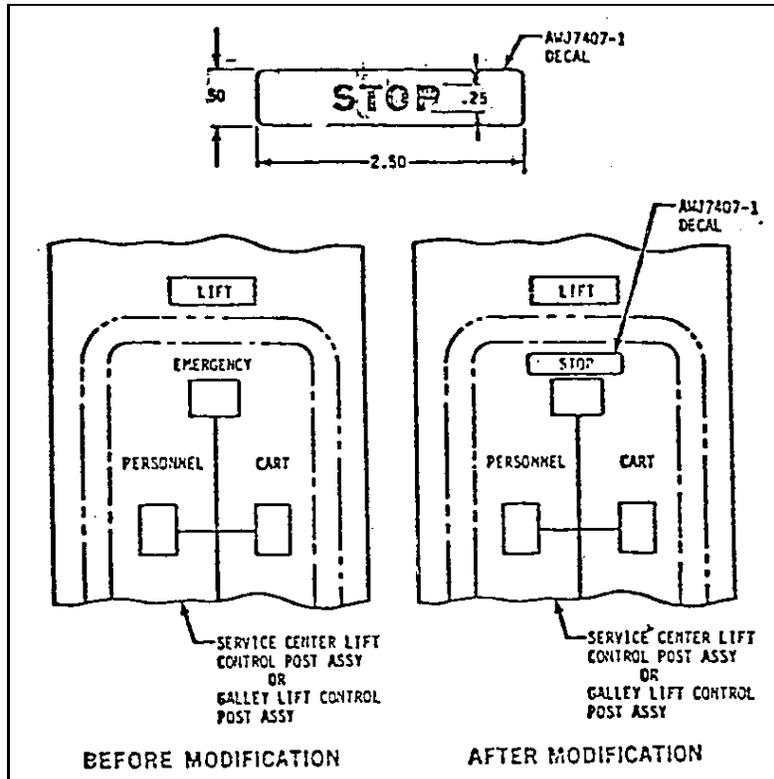
Analysis at DAC revealed the EMERGENCY terminology on the service center and lower galley lift stop switch placards is unsatisfactory. This condition exists due to the ability of the lift UP or DOWN switches to override the EMERGENCY stop switches. The word EMERGENCY is used to denote absolute priority over any normal operational modes. Present configuration permits the UP or DOWN operating switches to override the EMERGENCY switches, thereby invalidating the emergency mode. Installation of a STOP placard over the word EMERGENCY will provide the proper switch terminology and indicate the true function of the switches.

A. Fabricate two decals as shown, letters to be black on aluminum background.

- B. Identify each decal as AWJ7407-1 per operator's shop practice.
- C. Install AWJ7407-1 decals over engraved word EMERGENCY on service center lift control post assembly and galley lift control post assembly per operator's shop practice.
- D. Reidentify applicable lift control post assemblies per operator's shop practice as follows:
