**09/22/81 Air Florida Airlines**

**Report Number** NTSB-AAR-82-3

**Report Title** Air Florida Airlines, Inc., McDonnell-Douglas, Inc., DC-10-30CF, N101TV, Miami International Airport, Miami, Florida, September 22, 1981

**Report Type** Aircraft Accident Report September 22, 1981

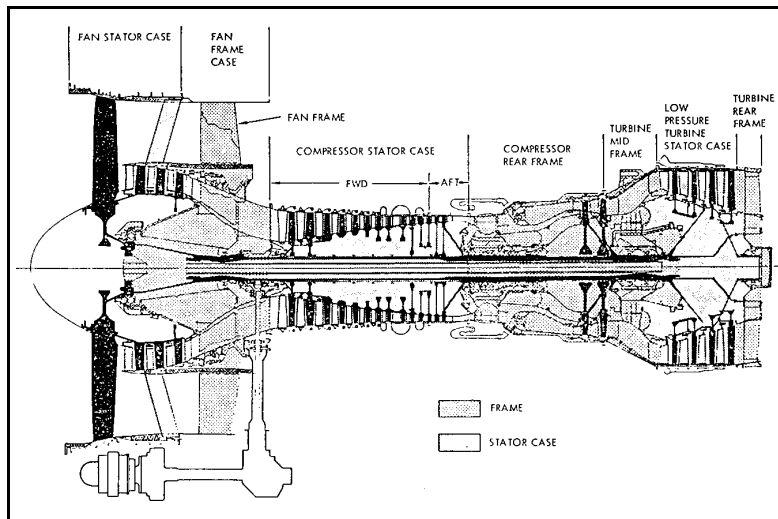
**Figure 3.--CF6-50/-45 frames and stator assemblies.**

The examination showed that the major damage to the engine was incurred aft of the high pressure turbine section. The low pressure turbine stator assembly case had separated circumferentially along the flange attaching its forward end to the turbine mid-frame housing. This separation, located at engine station (ES) 294, was just forward of the plane of rotation of the stage 1 low pressure turbine rotor. The stator case separated fore and aft along the top of the engine; it tore horizontally above its outboard split flange and the forward one-third of the inboard split flange had separated. The stator assembly case had split into three large segments and numerous smaller segments which separated from the engine and fell to the runway. (See figure 3.)

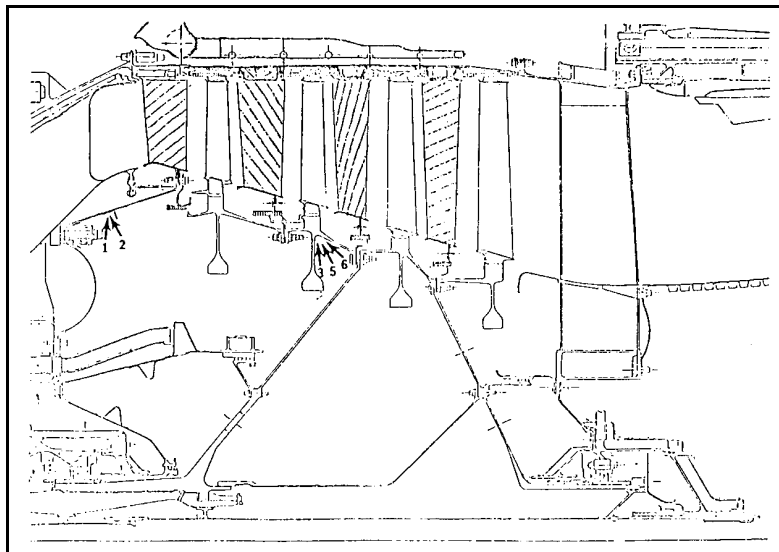
**Figure 4 Sketch of the low pressure turbine portion of CF6-50 engine S/N 455-123.**

Six additional pieces of ferro magnetic material were found: one piece was found on the runway; three pieces were found in the low pressure turbine stage 2 rotor cavity; and two pieces were found in the low pressure turbine's stage 1 toroid cavity. EDAX analysis identified the material as M-50 alloy steel. All six pieces were severely battered and oxidized. Five of the six pieces were measured for thickness. One piece was too battered for thickness determination. The thickness of one piece ranged from 0.140 to 0.150 inches; one piece was 0.148 inches thick; and three pieces were 0.149 inches thick. **(See figure 4.)**

These six pieces were compared to a typical CF6-50 No. 5 roller bearing inner race which is manufactured from M-50 alloy steel. The specified thickness for this inner race is 0.146 inches to 0.148 inches. In addition, two of these six pieces had retained evidence of beveling and the geometry appeared similar to that of a typical No. 5 engine bearing inner race.

After the low pressure turbine failure of this engine, six pieces of foreign material were recovered and submitted for examination. For identification purposes these six pieces were arbitrarily assigned numbers - #1 thru #6. Pieces #1 and #2 were found near the turbine mid frame

stiffener (see arrows #1 and #2). Pieces #3, #5, and #6 (see arrows #3, #5, and #6) were found in the cavity formed by the Stage 2 low pressure turbine disk and the forward low pressure turbine shaft. Piece #4 was recovered from the runway near the location where the engine failure occurred.

The five fragments of M-50 alloy steel found inside the low pressure turbine module were severely oxidized and battered indicating that they had been exposed to heat and impact damage for a considerable period. The main engine bearings of the CF6 engine fleet are made with M-50 alloy steel; however, all the main bearings forward of the low pressure turbine section were undamaged and all the engine bearings' inner races were intact. In addition, the part of the low pressure turbine section where these fragments were found is sealed from the path of gas flow through the engine. Consequently, this material could not have migrated either aft or forward into the low pressure turbine cavity while the engine was in operation. The evidence appears conclusive that either these fragments were inside the low pressure turbine module when it was installed on the engine or they got inside the turbine module the last time it was disassembled and were not detected during maintenance. Further, the battered condition of these fragments precluded all attempts to match them with the tools used in the engine build-up procedure, or with any other type M-50 alloy steel tool, consequently the Safety Board could not identify the source of these M-50 alloy steel fragments.
