09/22/81 Eastern Airlines

Report Number	NTSB-AAR-82-5
Access Number	PB82-910405
Report Title	Eastern Airlines Flight 935, Lockheed L-1011-385, N309EA, Near Colts Neck, New Jersey, September 22, 1981.
Report Date	June 1, 1982
Organization Name	National Transportation Safety Board Bureau of Accident Investigation Washington, D.C. 20594
WUN	3529
Sponsor Name	NATIONAL TRANSPORTATION SAFETY BOARD Washington, D. C. 20594
Report Type	Aircraft Accident Report September 22, 1981
Distribution Status	This document is available to the public through the National Technical Information Service, Springfield, Virginia 22161
Report Class	UNCLASSIFIED
Pg Class	UNCLASSIFIED
Pages	40
Keywords	Rolls-Royce RB-211 engine; inadequate lubricating oil supply; low pressure location bearing; oil leaks; coupling seal displacement; oil spray; fire; fan shaft overheat; fan shaft failure; fail-safe shaft failure.

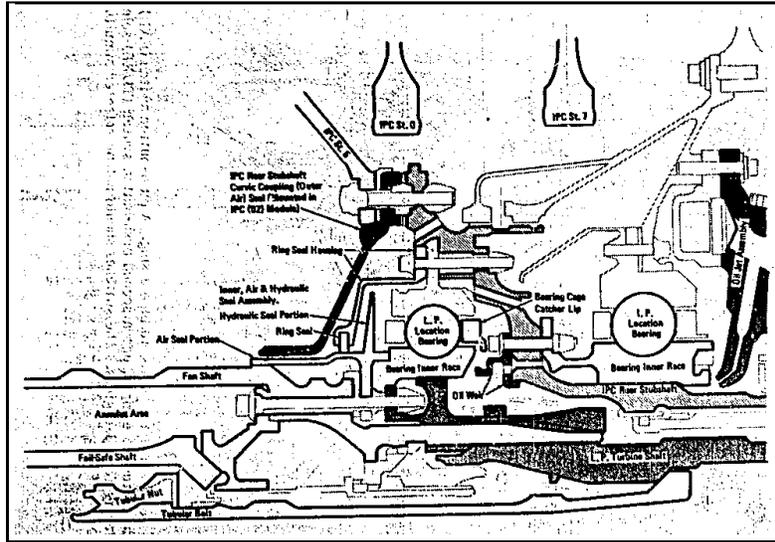
Figure 5. -- Installed Position of Components Associated with LPLB Failure.

The low-pressure location bearing had deteriorated from intermittent spalling of the bearing's outer race that encompassed 250° of its circumference. The area of apparent fatigue spalling was biased toward the rear side of the bearing's race track. The profile of the LPLB's inner race track was worn heavily and was elongated axially to a width of 1.250 to 1.375 inches; the forward and rear lands of the inner race adjacent to the track profile were also heavily worn. The bearing cage was extensively overheated. The bearing location lands were worn and the bearing cross grooves were filled with debris. The front half of the bearing cage was heavily rubbed on its front face from contact with the base of the hydraulic seal fin. Molten material produced from the inner track/ball wear and breakup had been deposited onto the front half cage bore for 160° of its circumference. The edge ball pockets were heavily worn. The rear oil catcher lip was distorted rearward from rear and rearward movement of the inner race; it had

The oil scavenge cavity located in the intermediate pressure compressor rear stubshaft contained a mixture of metal and oil sludge in the scalloped area of the cavity, although none of the oil scavenge holes was clogged. The mating abutment faces of the rear stubshaft of the IPC and the inner race front locating flange of the intermediate pressure location bearing exhibited paths of leaking oil and embedded fine metallic particles which had formed scoring paths.

The mating abutment faces of the LPLB oil weir and the IPC rear stubshaft also contained embedded fine metallic particles, particle scoring paths, and oil-stained leakage paths. Oil passages were not clogged.

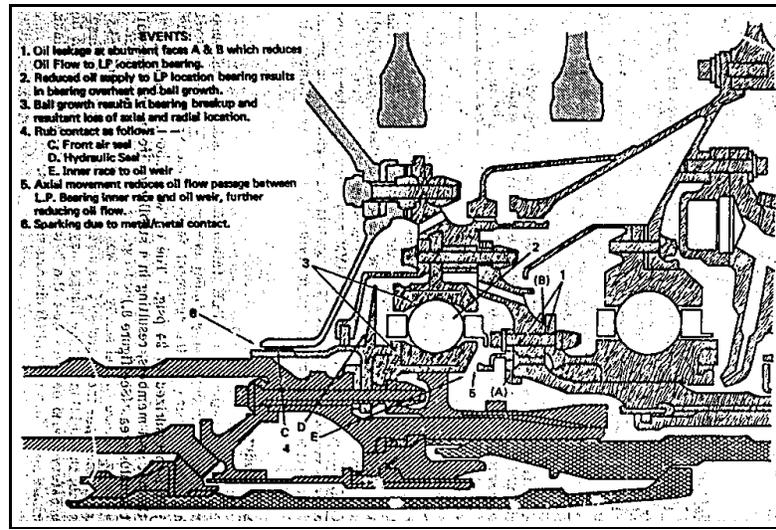
Figure 7. -- Initial Failure Sequence.

The inadequate supply of oil allowed the LPLB assembly to overheat and provided a temperature high enough to induce bearing outer race fatigue spalling, which in turn would have induced ball tightening and rubbing in the bearing cage pockets. The bearing cage and the bearing inner race lands also would have rubbed together, causing the cage to expand. These factors, in addition to high centrifugal force loadings, would allow the balls to grind and skid. The condition of the bearing's inner race and balls indicated that the balls were skidding and grinding into the bearing's inner race track in both the fore and aft directions, as shown by the contour match of the balls relative to the bearing's inner race track.

The predominant wear and damage pattern occurred at the front of the bearing's inner race. This failure pattern indicated that gross ball sliding took place when the engine was operating at a relative low power setting.⁵

Examination revealed that the inner rear face of the LPLB inner race and the forward lip of the oil weir had come into contact; the contact was caused by rearward axial movement of the inner race. These contact marks indicated that the LP system was rotating when the LPLB was displaced rearward. This would have further reduced oil flow between the LPLB bearing's inner race and the oil weir and thereby reduced oil flow to the LPLB itself.

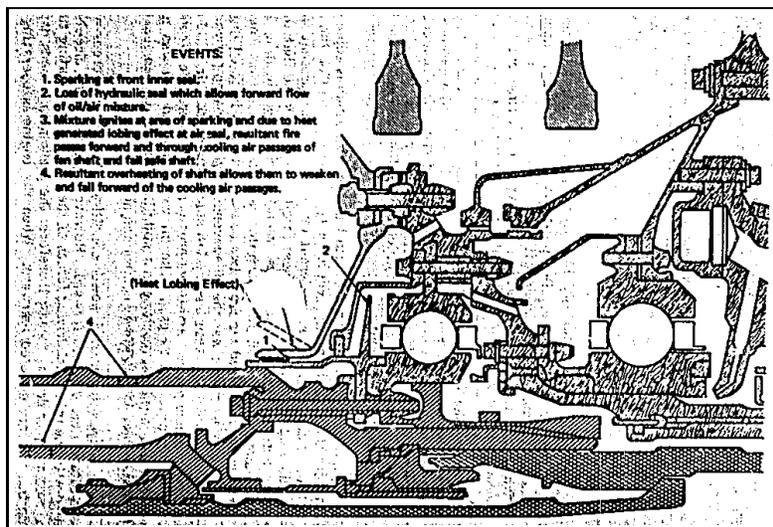
Figure 8. -- Engine Fire Sequence.

The ring (piston) seal housing and the ring (piston) seal which is adjacent to the hydraulic seal fin were also rubbed heavily. Oil level-type marks present on the rear face of the ring seal housing arm suggest that different levels of oil

were present in the ring seal housing/hydraulic seal cavity. The differences in oil levels indicated that the normal capillary-type seal between the hydraulic seal and the ring seal housing had been compromised, thus allowing LPLB oil to eject into the fan shaft area. The oil that escaped was mixed with pressurized air from two sources and was injected into the fan shaft annulus area. The first source was the oil scavenge cavity, located between the LP and IP location bearings, which is pressurized by 7th stage compressor air to 39 psig with the engine operating at climb power. Additional pressurized air is provided from the IPT pressure seal; it is pressurized to 24 psig. The oil was vaporized and was ignited by contact with the hot seal members, resulting in a stabilized fire in the fan shaft and the fail-safe shaft annulus area. (See figure 8.)

The stabilized fire degraded the material properties of the retained section of the fan shaft and caused the shaft to fail in a torsional and shearing mode. The degradation of material properties was evident by the discoloration patterns on the fan shaft fracture surface which indicated that the area adjacent to the fail-safe shaft fracture also reached a temperature probably in excess of 900° C. The recovered section of the fail-safe shaft exhibited rapid tensile/torsional overload fractures which also occurred as a result of exposure to these high temperatures.
