Official Accident Report Index Page

CRASH DURING EMERGENCY LANDING PHOENIX AIR
LEARJET 35A, N521PA FRESNO, CALIFORNIA DECEMBER
14, 1994

Accident NTSB ID	95-04
Airline	Phoenix Air Group, Inc.
Model aircraft	Learjet 35A, N521PA
Year shipped	1979
Aircraft manufacturer	Lear
Engine type	TFE731-2-2B turbofan
Engine manufacturer	Garrett
Date	12/14/94
Time	1146
Location	Fresno, CA
Country	USA
IFR or VFR?	IFR/VFR
Fatalities	2
Injuries	21 on ground
Fire during flight?	Y
Fire on the ground?	Y
Probable cause	(1) Improperly installed electrical wiring for special mission operations that led to an in-flight fire that caused airplane systems and structural damage and subsequent airplane control difficulties; (2) improper maintenance and inspection procedures followed by the operator; and, (3) inadequate oversight and approval of the maintenance and inspection practice by the operator in the installation of the special mission systems.
Weather conditions	Clouds, visibility 20 miles in light rain showers
Total crew size	2
Cockpit crew size	2
Report ID	NTSB/AAR-95/04

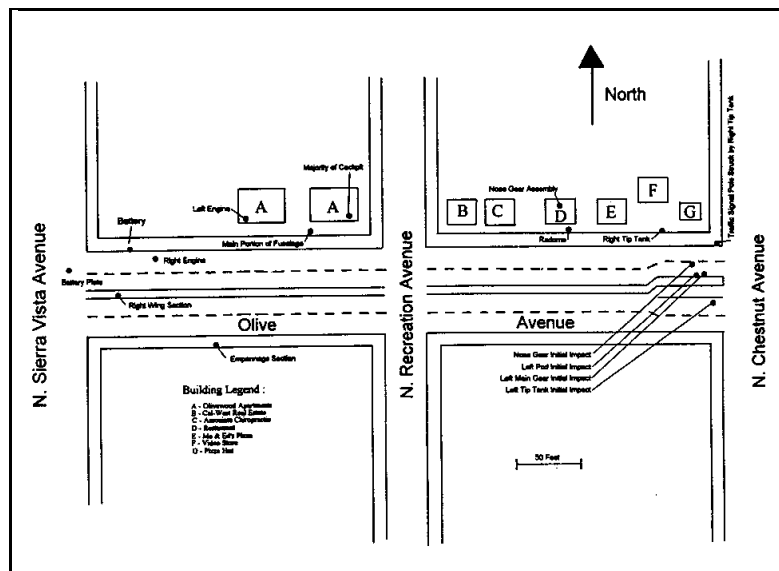
Figure 2c.--Wreckage path diagram.

The right wing and right engine came to rest, on fire, on E. Olive, approximately 100 feet east of the intersection with N. Sierra Vista and about 1,200 feet west of the initial impact marks. The right wing was fractured into several pieces. The inboard 10 feet of the wing came to rest near the center of E. Olive, immediately west of the right engine.

The ground fire was most severe along the north side of E. Olive, between N. Recreation and N. Sierra Vista. The remains of the left wing were combined with fuselage structure and found inverted in debris to the north side of E. Olive between the south-facing sides of the impacted apartment buildings. Most of the aluminum structure was melted, and the left wing was barely recognizable, except for the remaining steel components. Twelve vehicles, parked along the north curb of E. Olive, between N. Recreation and N. Sierra Vista, were ignited and destroyed by fire. Damage to structures along the south side of E. Olive was generally restricted to flash burns.

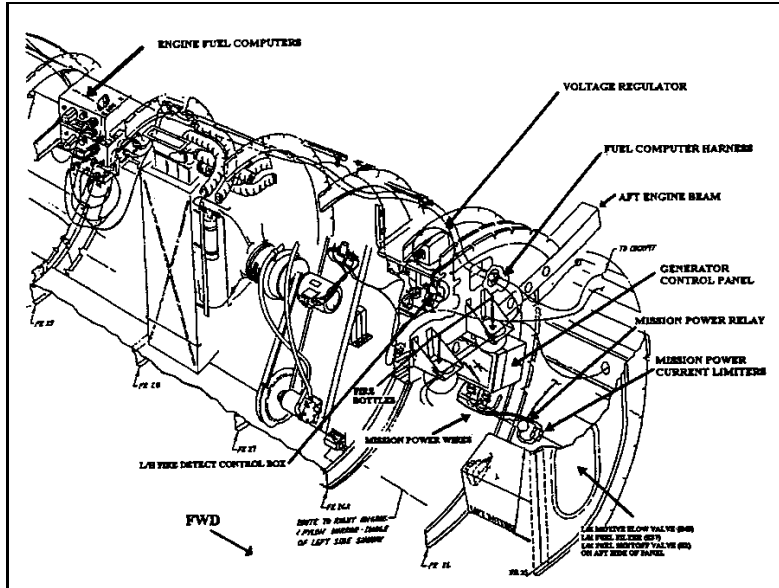
Figure 3a.--Components in tailcone.

The investigation found that in the actual mission equipment wiring of N521PA, the power wires were routed directly to the battery charging bus. (**Figure 3a** is a drawing of major components in the tailcone. **Figure 3b** shows the intended versus actual routing of the power wires in N521PA.)

The evidence found in the wreckage showed that the electrical power cables for the special mission equipment had not been installed in accordance with specifications. The improper installation left portions of the wires unprotected by current limiters. The two large-diameter DC power wires that were retrieved from the wreckage showed evidence of arcing and they were "welded" together in the area unprotected by the current limiters. This evidence indicates shorting and unlimited current flow for an extended period of time while the airplane was airborne.

The investigation revealed that the proper installation specified that the special mission wires were to be attached to fittings in the generator control panel, where they would have been protected from overload during shorts by current limiters. Instead, the wires had been routed directly from the battery charging bus to 150 amp limiters before being routed to the control relay. Segments of the wires were unprotected by current limiters for about 18 inches, and they were found fused together between the battery bus and the current limiters. As a result of the wiring arrangement, large amounts of current could travel to the ground.

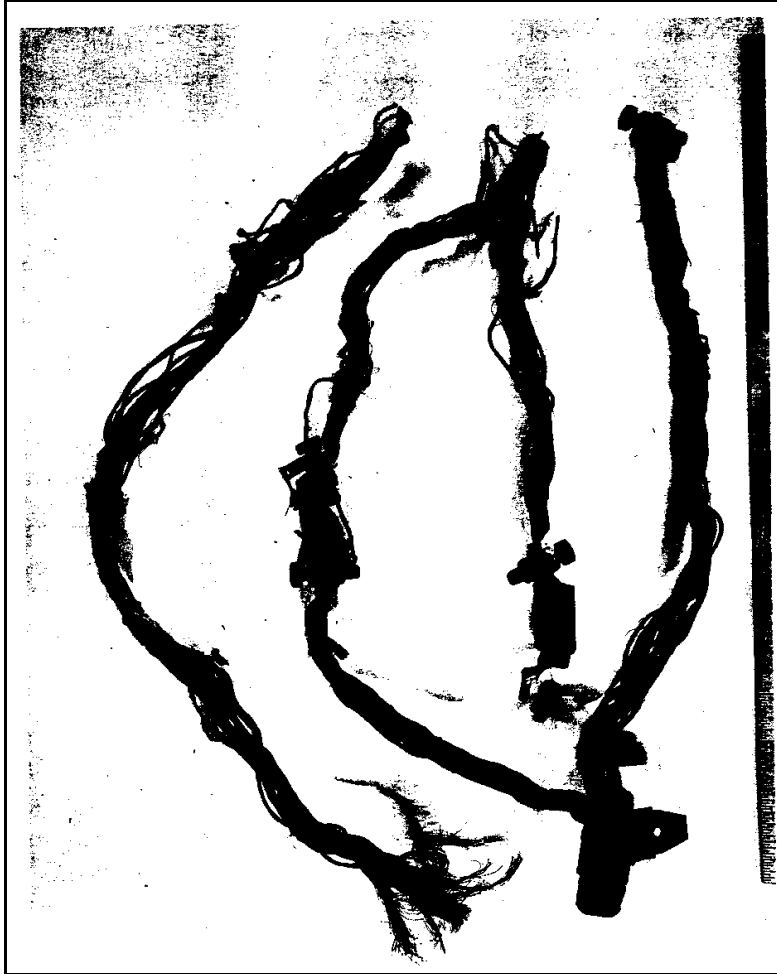
Figure 4.--View of cables as received for examination.

Portions of the wires, identified as part of the electrical power source for the special mission package, were size No. 0 awg and were found on E. Olive, near the wheel of an unburned vehicle. The wires had evidence of high heating prior to impact, including areas fused together for about 2 inches in length, and individual strands of the wires had a beaded appearance. (See figure 4.) Current limiters (fuses) were found attached to the nonwelded ends of one of the two sets of wires. In subsequent testing, the current limiters were found to provide electrical continuity (in the closed position).

Fire damage to the wire insulation precluded a determination of the reasons for the shorting of the wires; however, one of these wires may have been frayed, and a short to ground (probably an airplane frame) occurred. Nevertheless, the evidence is conclusive that while the airplane was airborne, a severe short occurred on the left side of the aft fuselage in the electronics bay. Without the protection of the current limiters, the short was not interrupted.
