Official Accident Report Index Page

GROUND SPOILER ACTIVATION IN FLIGHT/HARD
LANDING VALUJET AIRLINES FLIGHT 558 DOUGLAS
DC-9-32, N922VV NASHVILLE, TENNESSEE JANUARY 7,
1996

Facts of the Accident

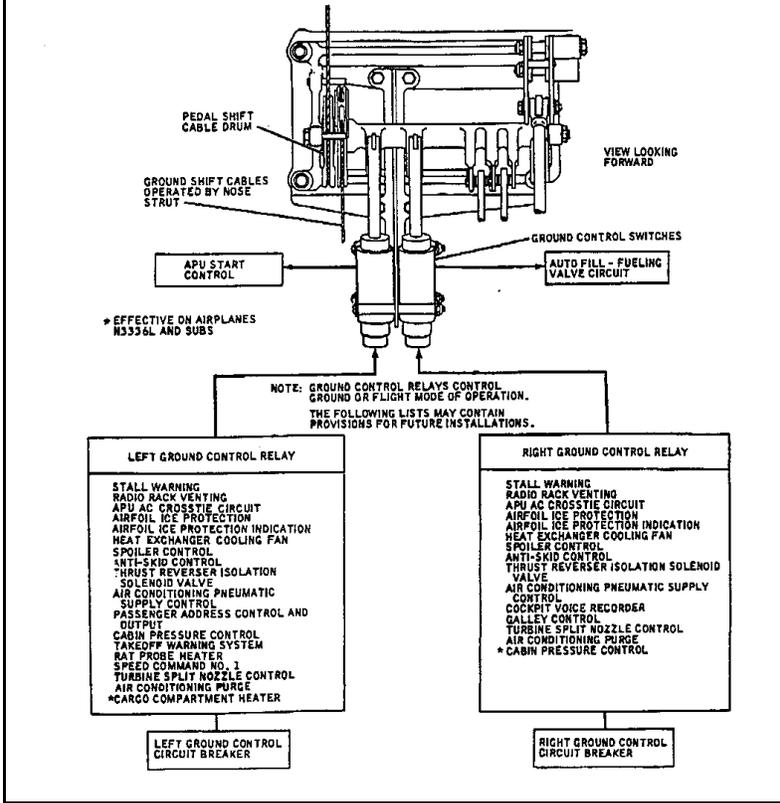
LANDING GEAR -- GROUND SHIFT MECHANISM FUNCTIONS

The ground shift mechanism, which is actuated by nosegear shock strut extension/compression, controls whether certain aircraft systems operate in the ground or flight mode.²¹ When the nosegear shock strut is compressed by the weight of the aircraft, the ground shift mechanism causes those aircraft systems to be operated in the ground mode. When the nosegear shock strut is extended after takeoff, it triggers the ground shift mechanism, electronically shifting the aircraft systems to the flight mode.²² In addition, when the aircraft is in the flight mode, the ground shift mechanism mechanically centers the nose wheel, locks out the rudder pedal nose wheel steering function, and releases the gear lever anti-retraction mechanism.

According to Douglas representatives, when the nosegear shock strut is underserviced/underinflated, strut extension after liftoff may not be sufficient to activate the ground shift mechanism to shift the aircraft systems into the flight mode and release the gear lever anti-retraction mechanism. Douglas representatives indicated that this is a commonly reported occurrence during cold weather operations. They stated that Douglas had issued numerous service bulletins (SBs) and all operator letters (AOLs) describing the anomaly and recommending maintenance procedures to avoid underserviced/underinflated nosegear shock struts during cold weather operations.²³

5. On next landing, during rollout (above approximately 30 kts.) momentarily release brakes and place the anti-skid switch to OFF and operate brakes manually.
6. Reset ground control relay circuit breakers during taxi and verify that electrical circuits (auto pressurization, air conditioning, ground blowers) are in the ground mode.
