## Official Accident Report Index Page

NORTHWEST AIRLINES FLIGHT 18 BOEING 747-251B,  
N637US NEW TOKYO INTERNATIONAL AIRPORT NARITA,  
JAPAN MARCH 1, 1994

| <b>Report ID</b> | NTSB/SIR-94/02 |

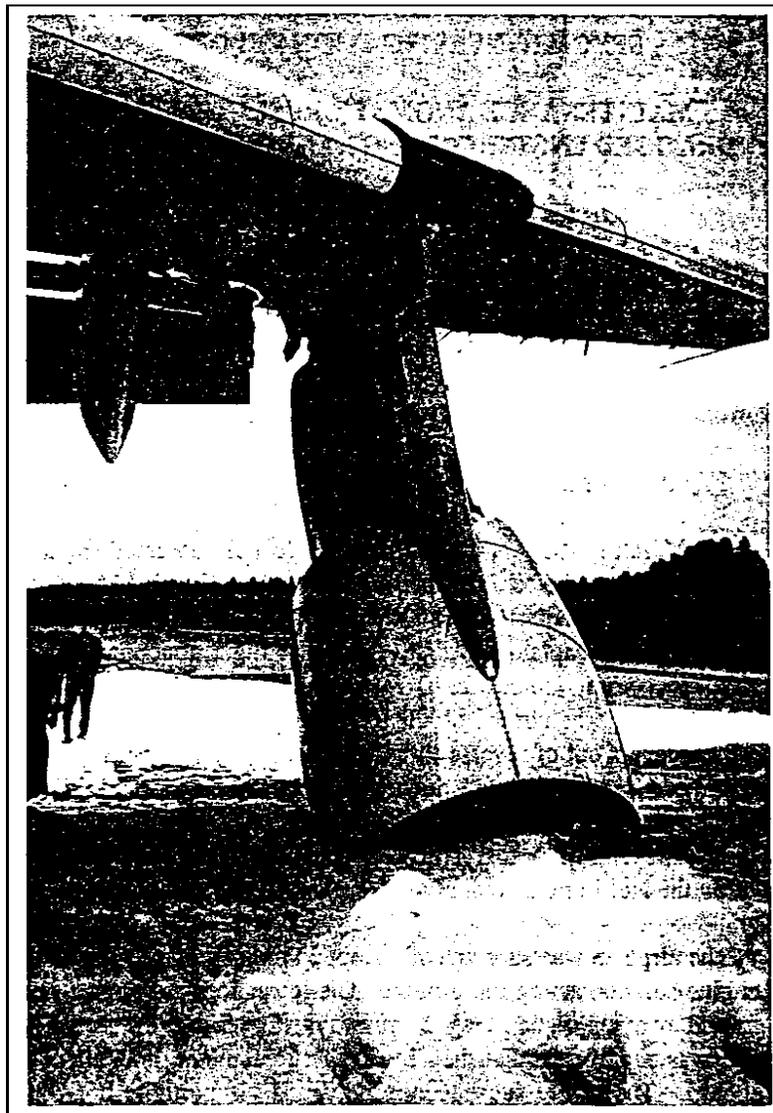
Narita, Japan. According to the captain and first officer, the flight, touchdown, and initial landing rollout at Narita, around 1340 Japanese Standard Time, were routine. Engine thrust reversing was normal on all four engines until the flightcrew moved the engine power levers out of reverse thrust at about 90 knots. During the rollout, the No. 1 engine and pylon rotated downward about the midspar pylon-to-wing fittings into a position in which the lower forward part of the engine nose cowl contacted the runway. The primary forward upper link fuse pin was later found fractured within the No. 1 engine pylon.

The airplane was subsequently stopped on a taxiway, with the front of the No. 1 engine still contacting the ground. The lower forward engine nose cowl had been ground away as it slid along the runway. (See figure 1). A fire near the No. 1 engine was rapidly extinguished by local fire fighters, and all passengers remained aboard. They were subsequently deplaned via portable boarding stairs about 30 minutes after the airplane was brought to a stop. There were no injuries.
