03/18/89 Evergreen International Airlines

Official Accident Report Index Page

Report Number	NTSB/AAR-90/02
Access Number	PB90-910402
Report Title	Evergreen International Airlines, McDonnell Douglas DC-9-33F, N931F, Saginaw, Texas, March 18, 1989
Report Date	April 23, 1990
Organization Name	National Transportation Safety Board Office of Aviation Safety Washington, D.C. 20594
WUN	5094A
Sponsor Name	NATIONAL TRANSPORTATION SAFETY BOARD Washington, D.C. 20594
Report Type	Aircraft Accident Report March 18, 1989
Distribution Status	This document is available to the public through the National Technical Information Service, Springfield, Virginia 22161
Report Class	UNCLASSIFIED
Pg Class	UNCLASSIFIED
Pages	85
Abstract	This report explains the crash of an Evergreen International Airlines McDonnell Douglas DC-09-33F, N931F, in Saginaw, Texas, on March 18, 1989. The safety issues discussed in the report include the cargo door closing procedures on DC-9 airplanes; the external cargo door markings on DC-9 airplanes; the door warning switch electrical wiring on DC-9 airplanes; and the actions of the carrier and the Federal Aviation Administration concerning these issues preceding the accident.

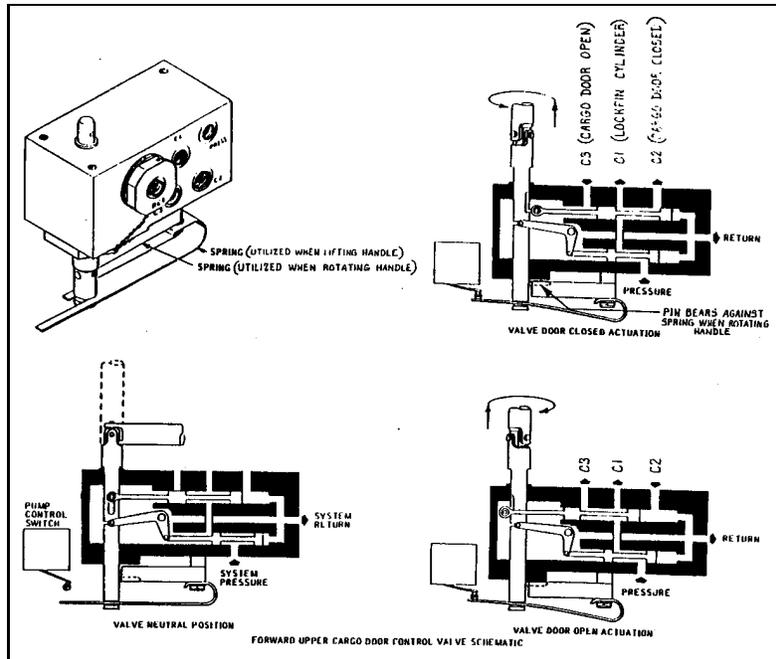
Figure 1.--Hydraulic routing within the cargo door hydraulic system.

1. The cargo door control valve - This valve was found in the "valve neutral" position (as opposed to the "door open" or the "door closed" position) within the wreckage. Damage to the valve did not allow testing in the "door open" or "door closed" positions. The valve was disassembled at its manufacturer's facility and no anomalies were found. **See Figure 1** for a cut-away diagram of this valve in its three operating positions.

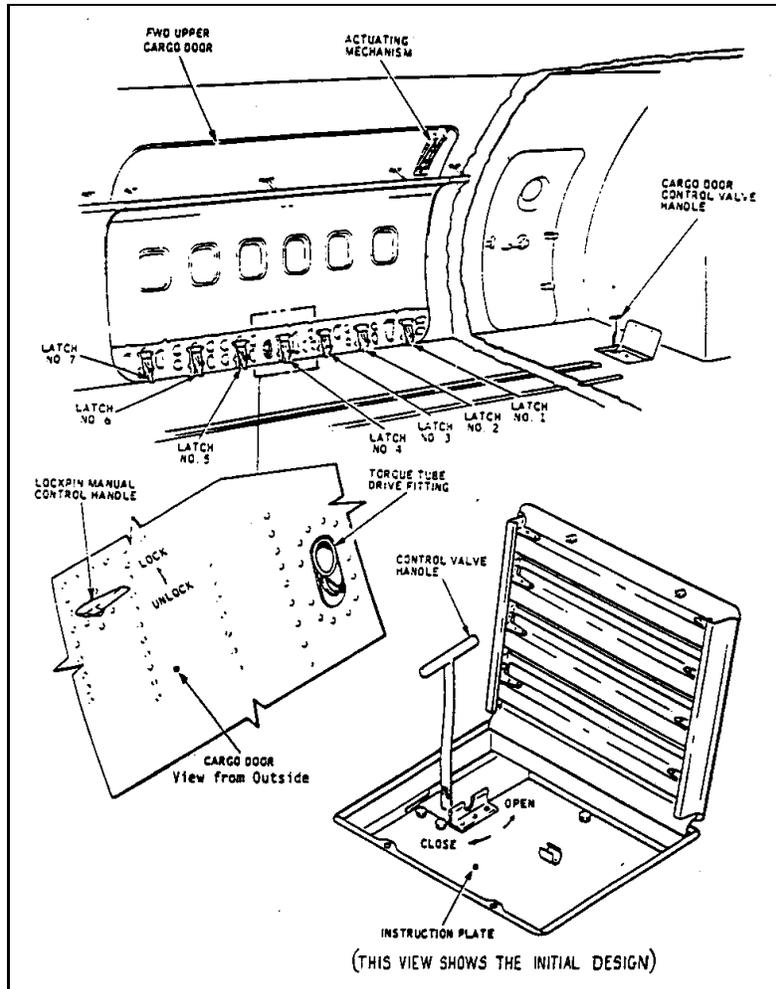
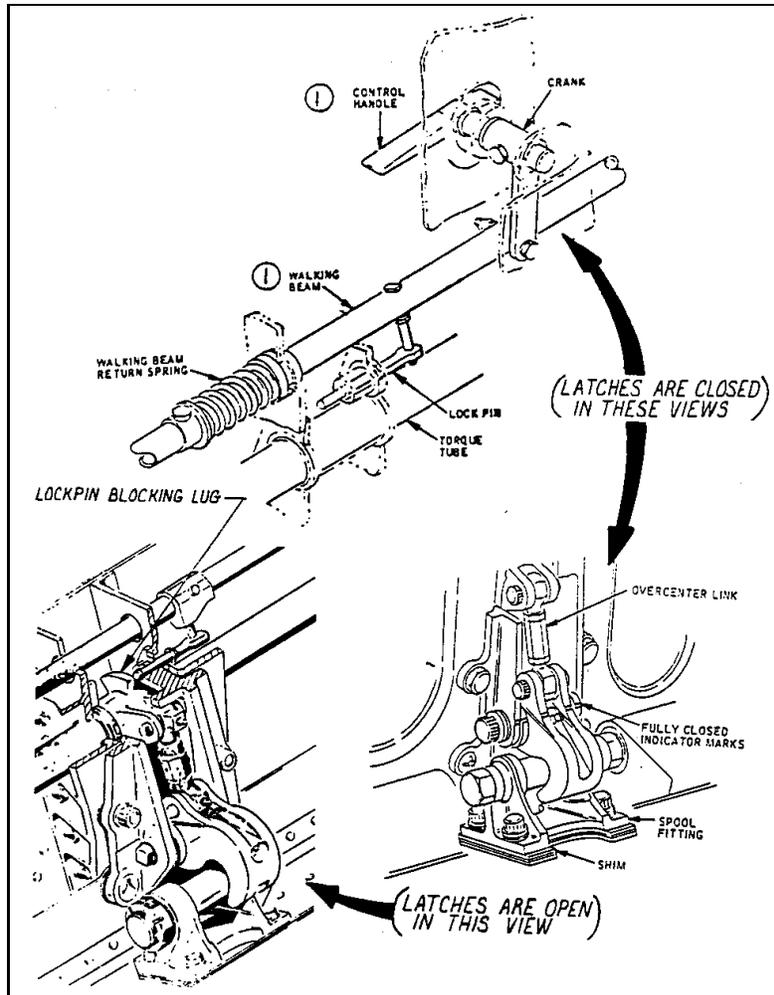
Figure 2.--Main cargo door components.

The open or closed status of the cargo door is also displayed by a cockpit warning light. The original 28 volt dc electrical circuit to illuminate the light consists of two switches wired in parallel. Both of the switches are spring loaded to the closed position. One is opened by mechanical actuation when the door lowers against the door jamb and the other is opened mechanically when the lockpin pushrod moves to a position where the lockpins are engaged in the latching hooks. Since the lockpins can engage only when the latching hooks are fully rotated over the door sill spools, an open switch indicates that the door is latched and locked. With either of the switches closed, the cockpit warning light is illuminated. When the door is properly closed, both switches open and the light is extinguished. The airplane manufacturer issued a service bulletin describing a modification to the cargo door warning circuit but the modification had not been accomplished on N931F as discussed in section 1.6.4. (See [figure 1](#) and [figure 2](#).)
