**Report Number** NTSB/AAR-86/02

**Report Title** Air Canada Flight 797, McDonnell Douglas DC-9-32, C-FTLU, Greater Cincinnati International Airport, Covington, Kentucky, June 2, 1983 (Supersedes NTSB/AAR-84/09)

**Report Type** Aircraft Accident Report June 2, 1983

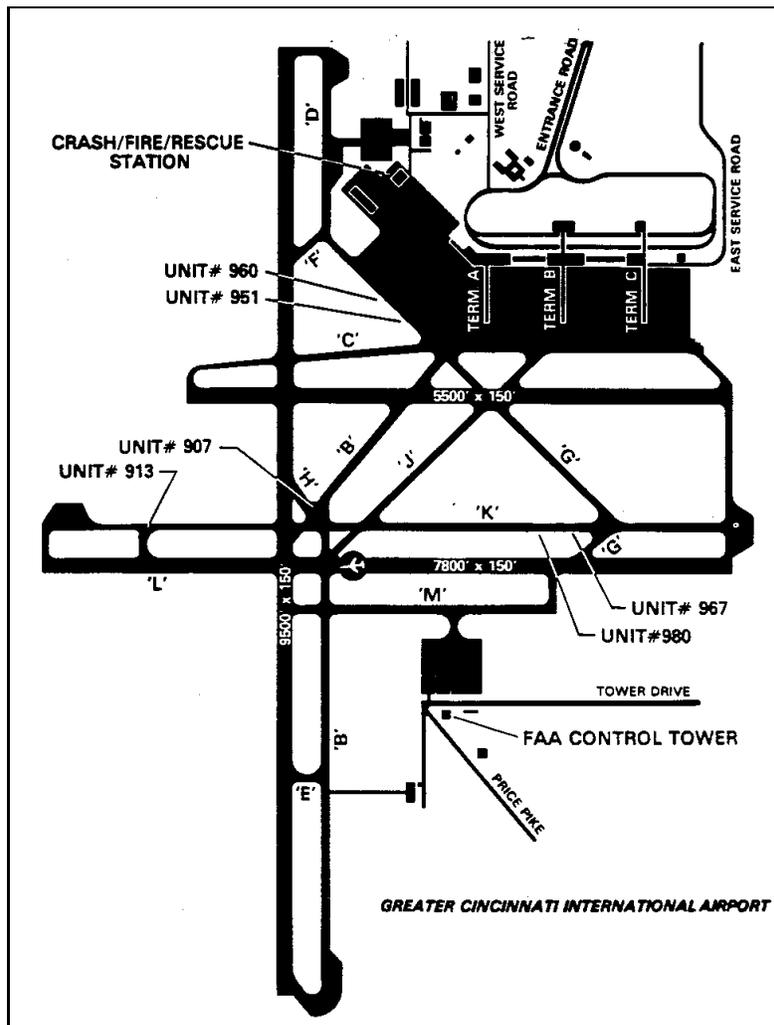
Figure 1.—Standby Positions of Crash/Fire/Rescue Units.

At 1913:38, after Flight 797 was unable to tell him its heading because its heading instruments were inoperative, the approach controller asked the flight to turn left. The controller said that this was an identification turn and that it was also designed to place the airplane closer to the airport. At 1914:03, after observing the target in a left turn, the approach controller said that Flight 797's primary target was now "fully identified." He then told the flight that this was a "no gyro"<sup>5</sup> radar approach for runway two seven left..." and cleared it to descend to 3,500 feet. He then told the flight that it was 12 nmi southeast of the Cincinnati Airport, cleared it to land on runway 27L, and informed it that the surface wind was 220° at 4 knots. He informed the tower of the change of landing runways and the tower directed the fire department to position its vehicles along runway 27L. (See figure 1.)

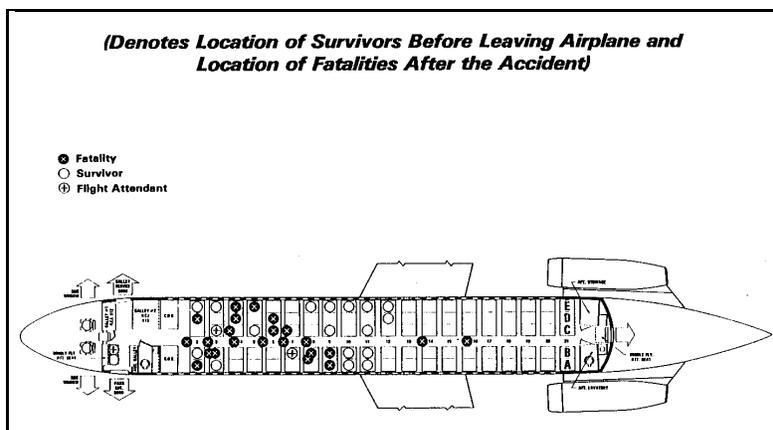
**Figure 12.—Diagram of passenger seat locations.**

moved forward in the cabin, and no passenger was seated farther aft than row 12. The two passengers in seats Nos. 12D and 12E refused to move forward because their seats were next to the right forward overwing exit window. (See figure 12.)

Except for two fatalities found in the aisle at rows 14 and 16, the majority of the fatalities were found either in the aisle or seated in rows 2 through 9. (See figure 12) The fatalities at rows 14 and 16 had been seated in seats 8-B and 9-B, respectively.

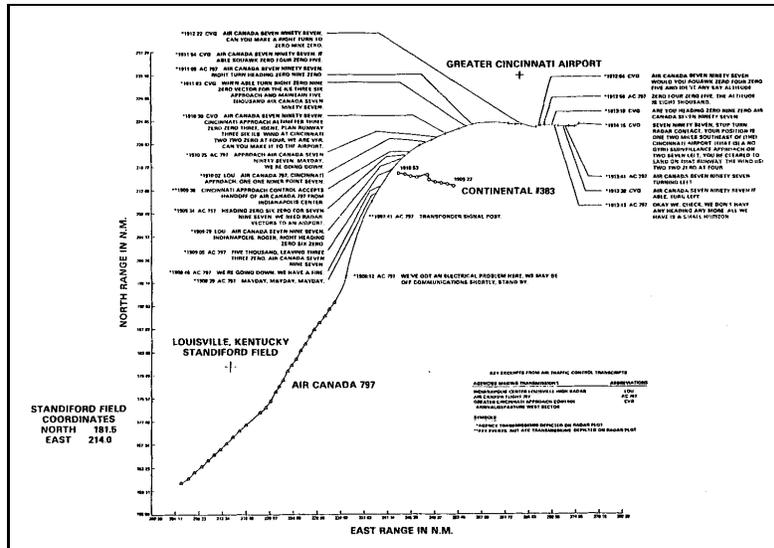
**Figure 13.--Ground radar tracks for Flights 797 and 383.**

Data Analysis Reduction Tool (DART) radar data information was obtained from the Indianapolis ARTCC. The data included airplane position information and available mode C altitude information for Flight 797 and for Continental Airlines Flight 383, which was transmitting on code 0662. The Safety Board's laboratory reconstructed the ground radar tracks of both Flights 797 and 383. Runways 9R-27L and 18-36 of the Greater Cincinnati Airport were digitized and plotted with the ground tracks. Times of key transmissions and selected key events were included along Flight 797's radar ground track. The last radar fix retrieved from the DART's data occurred at 1914:15, and the last transponder information from Flight 797 was received at 1906:12. (See figure 13.)
