Official Accident Report Index Page

UNCONTAINED ENGINE FAILURE/FIRE VALUJET AIRLINES
FLIGHT 597 DOUGLAS DC-9-32, N908VJ ATLANTA,
GEORGIA JUNE 8, 1995

Accident NTSB ID	96-03
Airline	ValuJet Airlines
Model aircraft	DC-9-32, N908VJ
Aircraft manufacturer	Douglas
Engine type	JT8D-9A
Engine manufacturer	Pratt & Whitney
Date	06/08/95
Time	1855
Location	Atlanta, GA
Country	USA
IFR or VFR?	VFR
Injuries	7
Fire during flight?	-
Fire on the ground?	Y
Probable cause	The failure of Turk Hava Yollari maintenance and inspection personnel to perform a proper inspection on a 7th stage high compressor disk, thus allowing the detectable crack to grow to a length at which the disk ruptured, under normal operating conditions, propelling engine fragments into the fuselage; the fragments severed the right engine main fuel line, which resulted in a fire that rapidly engulfed the cabin area.
Contributing causes	The lack of an adequate record keeping system and the failure to use "process sheets" to document the step-by-step overhaul/inspection procedures contributed to the failure to detect the crack and, thus, to the accident.

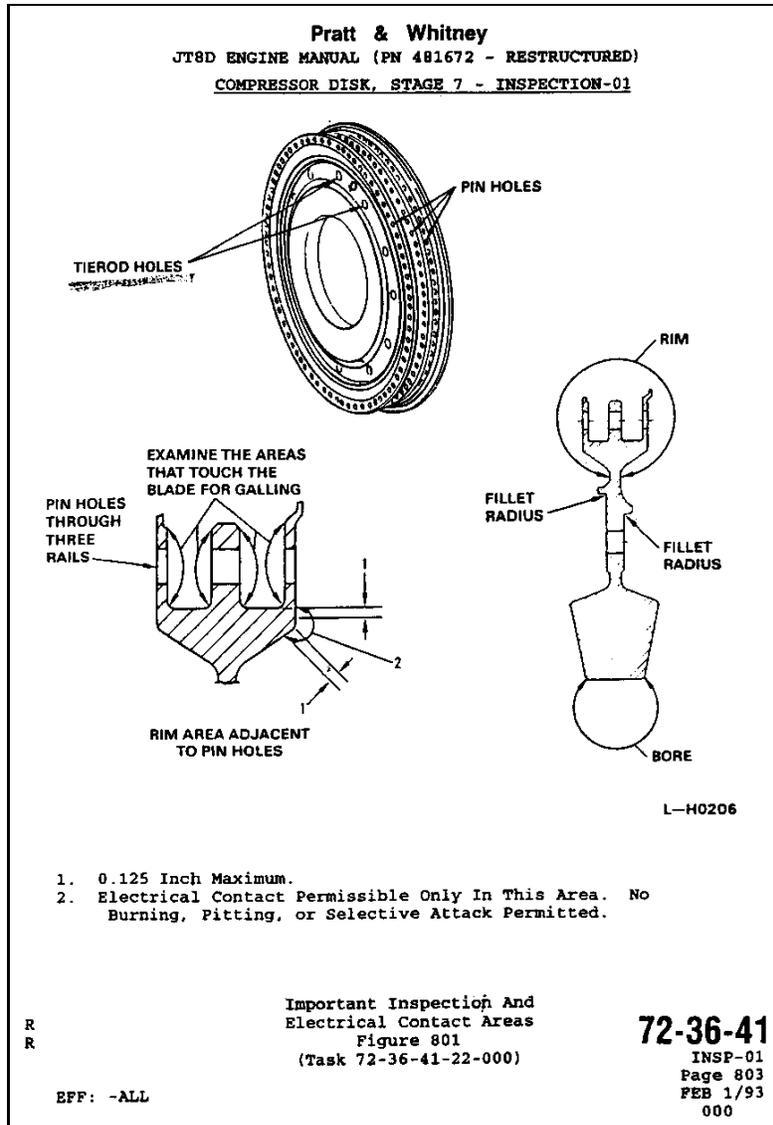
Figure 7—P&W JT8D Engine Manual—Compressor disk, stage 7 - Inspection 01

The 7th stage compressor disk inspection instructions from the P&W JT8D Engine Manual, Section 72-36-41, revision dated February 1, 1991, state that the following disk features must be inspected very carefully: bore, tierod holes, snap diameter (front and rear) fillet radius, pin holes, areas on the rim that touch blades, and for very early disks, balance flanges and balance flange rivet holes. Graphic illustrations in the instructions (listed as figure 801 in the P&W instructions) show the various features of the disk that were named in the text. (See figure 7.)

The P&W engine manual specifies that for area 7 of the P&W figure 802 (see appendix D), which is depicted as a tierod hole, no unrepaired damage can be allowed in any hole, or within 0.125 inch of the edge of the hole on adjacent surfaces, and that damage can be repaired to a depth of 0.005 inch by blending. The instructions further indicate that damage up to 0.003 inch is acceptable in the web area of the disk without blending. The cross-section of the 7th stage disk in P&W figure 802 depicts the tierod holes, but does not have the hidden lines,²⁹ which would depict the smaller diameter SR holes behind the tierod holes, or a separate cross-section of the disk, just through the SR holes.

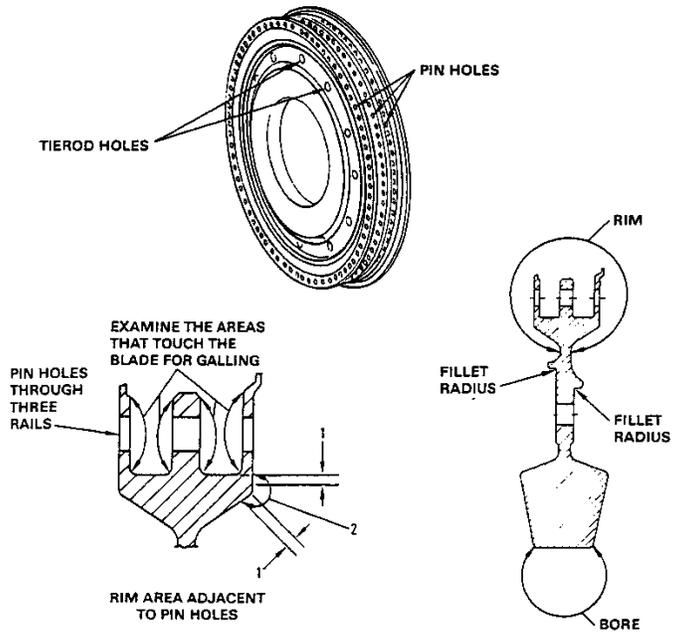
Pratt & Whitney
JT8D ENGINE MANUAL (PN 481672 - RESTRUCTURED)
COMPRESSOR DISK, STAGE 7 - INSPECTION-01

1. 0.125 Inch Maximum.
2. Electrical Contact Permissible Only In This Area. No Burning, Pitting, or Selective Attack Permitted.

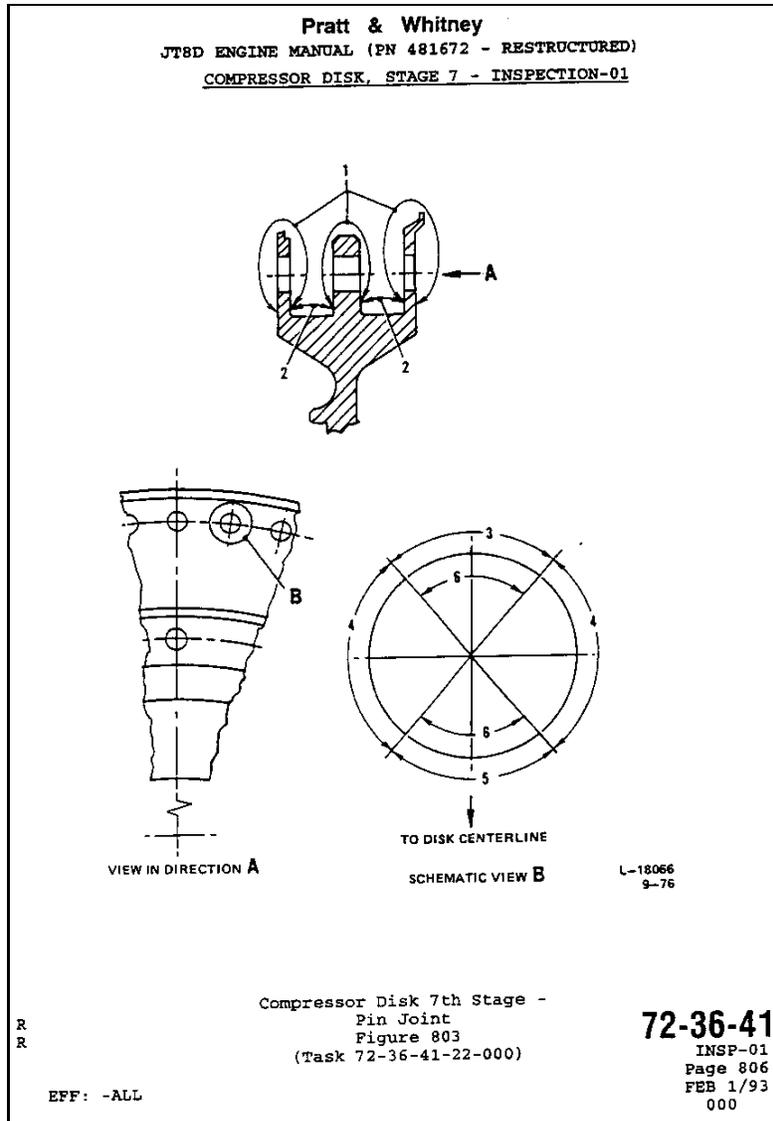
COMPRESSOR DISK, STAGE 7 - INSPECTION-01

1. NO Unrepaired Damage Is Allowed Except Galling On Rear Face Of Center Rim To Maximum Of 0.010 Inch Deep. May Be Blended Up To 0.005 Inch Deep Except OD Of Front And Center Rails. Damage on OD Of Front And Center Rails May Be Blended Up To 0.030 Inch Deep Provided Damage Is Not Within 1/4 Inch Of Radial Centerline Of Pinholes.
2. Scattered Surface Damage Up To 0.003 Inch Deep is Acceptable Without Repair. May Be Blend Repaired Up To 0.005 Inch Deep.
3. Scattered Surface Damage UP to 0.005 Inch Deep Is Acceptable Without Repair.

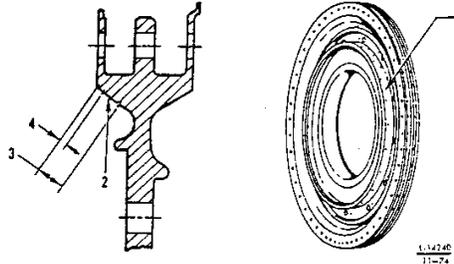
Disk Marking (Stage 7)
Figure 804
(Task 72-36-41-22-000)

- a. Inspect each disk for markings.
- b. Marking in areas other than disk OD tang and disk rim are unacceptable. Such areas must be blended out and remarked in acceptable area. **See Figure 804.**
- c. Use manual vibration peening method for permanent marking. See Standard Practices Manual.

1. Service Time Marking Area, Outboard Side Only
2. Service Time Marking Area For Disks Without Counter Weight Flange.
3. 0.400 Inch Maximum
4. 0.100 Inch Minimum
