07/19/89 United Airlines

Official Accident Report Index Page

Report Number	NTSB/AAR-90/06
Access Number	PB90-910406
Report Title	United Airlines Flight 232, McDonnell Douglas DC-10-10, Sioux Gateway Airport, Sioux City, Iowa, July 19, 1989
Report Date	November 1, 1990
Organization Name	National Transportation Safety Board Office of Aviation Safety Washington, D.C. 20594
WUN	5158D
Sponsor Name	NATIONAL TRANSPORTATION SAFETY BOARD Washington, D.C. 20594
Report Type	Aircraft Accident Report July 19, 1989
Distribution Status	This document is available to the public through the National Technical Information Service, Springfield, Virginia 22161
Report Class	UNCLASSIFIED
Pg Class	UNCLASSIFIED
Pages	126
Abstract	This report explains the crash of a United Airlines McDonnell Douglas DC-10-10 in Sioux City, Iowa, on July 19, 1989. The safety issues discussed in the report are engine fan rotor assembly design, certification, manufacturing, and inspection; maintenance and inspection of engine fan rotor assemblies; hydraulic flight control system design, certification, and protection from uncontained engine debris; cabin safety, including infant restraint systems; and aircraft rescue and fire

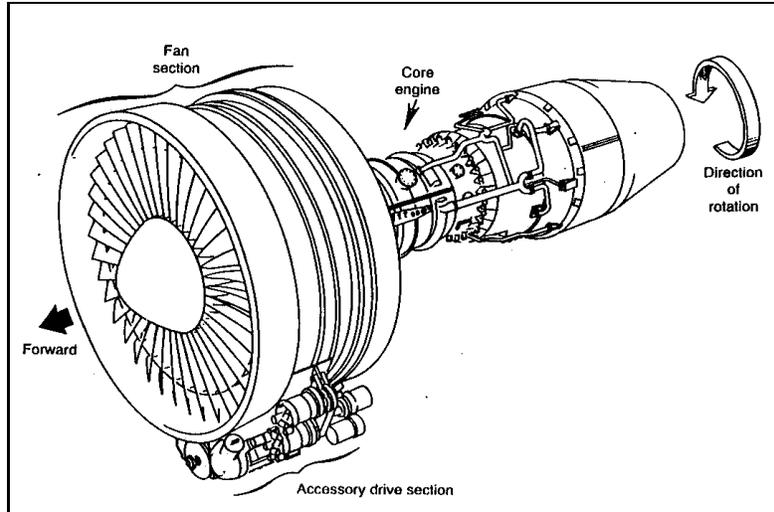
Figure 4.--CF6-6 engine.

Photographs of the airplane were taken by observers on the ground during its final approach to Sioux Gateway Airport. They showed that the No. 2 engine fan cowling and the fuselage tail cone were missing. The remainder of the No. 2 engine appeared intact. Postcrash examination of the wreckage revealed that the No. 2 engine fan rotor components forward of the fan forward shaft, as well as part of the shaft, had separated from the engine in flight.(See **figure 3**, **figure 4**, **figure 5**).

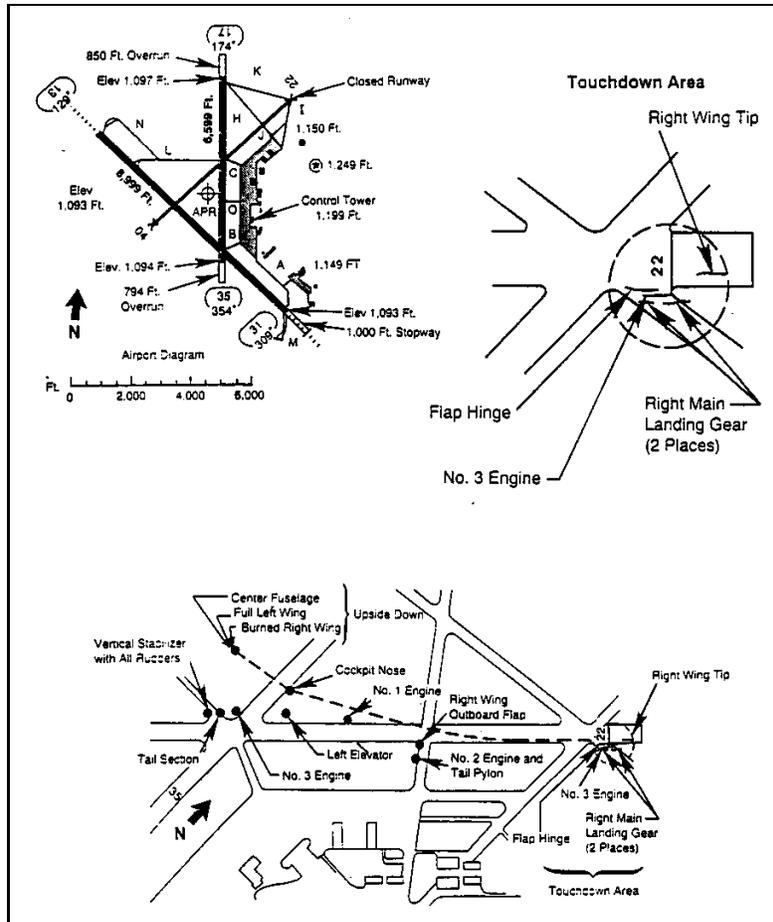
Figure 6.--Sioux Gateway Airport and wreckage path of UA flight 232.

3,500 feet from the point of first impact. (See figure 6.)

The No. 2 engine came to rest on taxiway "J" to the left of runway 22, about 1,850 feet from the point of first impact. The majority of the No. 2 engine fan module was not found at the airport.

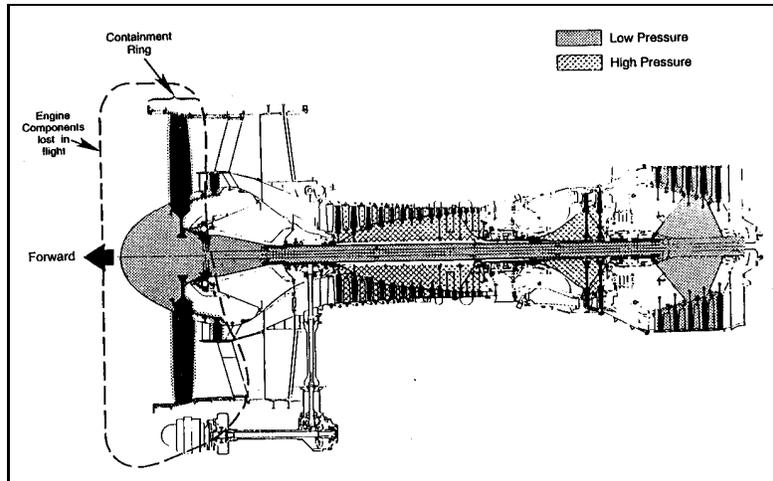
Figure 8.--CF6-6 rotating assemblies.

Figure 7 contains a cutaway sectional drawing of the flow path and construction of the CF6-6 engine. The figure also shows the fan and accessory drive sections. **Figure 8** displays the CF6-6 rotating assemblies. The portion of the No. 2 engine that departed the airplane is outlined by the dashed lines.

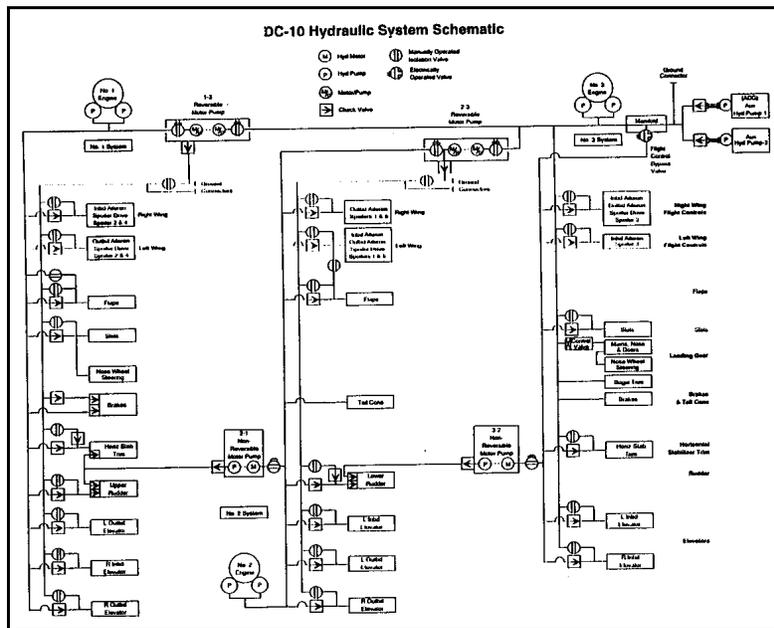
Figure 10.--DC-10 hydraulic system schematic.

The No. 1 hydraulic system provides power to the right inboard aileron and the left outboard aileron, the right inboard and outboard elevators, the left outboard elevator, the upper rudder, the horizontal stabilizer trim, and the captain's brake system. The No. 2 hydraulic system provides power to the right outboard aileron and the left inboard aileron, the inboard and outboard elevators on the left side, the outboard elevator on the right side, and the lower rudder. It also provides power to the isolated closed-loop system that operates the upper rudder. The No. 3 hydraulic system provides power to the right inboard and outboard aileron and the left inboard aileron, the inboard elevators on the right and left side, horizontal stabilizer trim, and the first officer's brake system. It also drives an isolated closed-loop system that powers the lower rudder actuator. These closed-loop arrangements allow for operation of the remaining parts of hydraulic systems No. 2 and No. 3 in the event of damage to the rudder hydraulic system. (See figure 10).

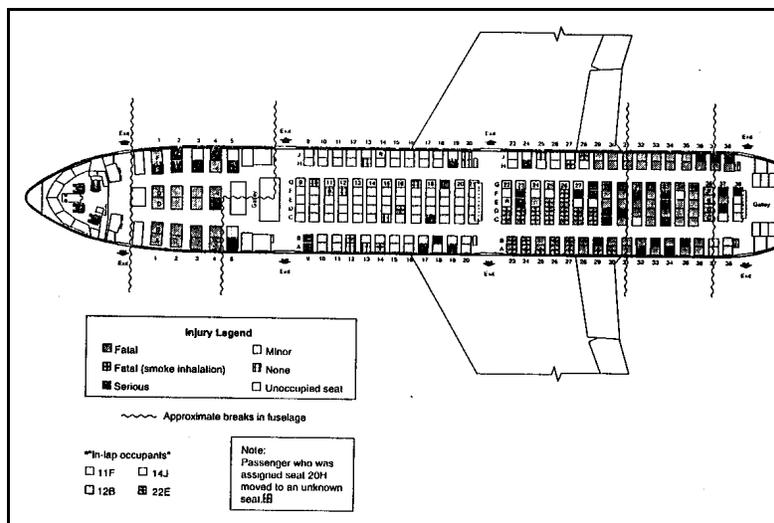
Figure 15.--Seating and injury information.

Of the 296 persons aboard the airplane, 110 passengers and 1 flight attendant were fatally injured. Autopsies revealed that 35 passengers died of asphyxia due to smoke inhalation, including 24 without traumatic blunt force injuries. The other fatally injured occupants died of multiple injuries from blunt force impact. Of the remaining 185 persons onboard, 47 sustained serious injuries, 125 sustained minor injuries, and 13 were not injured. (See figure 15).

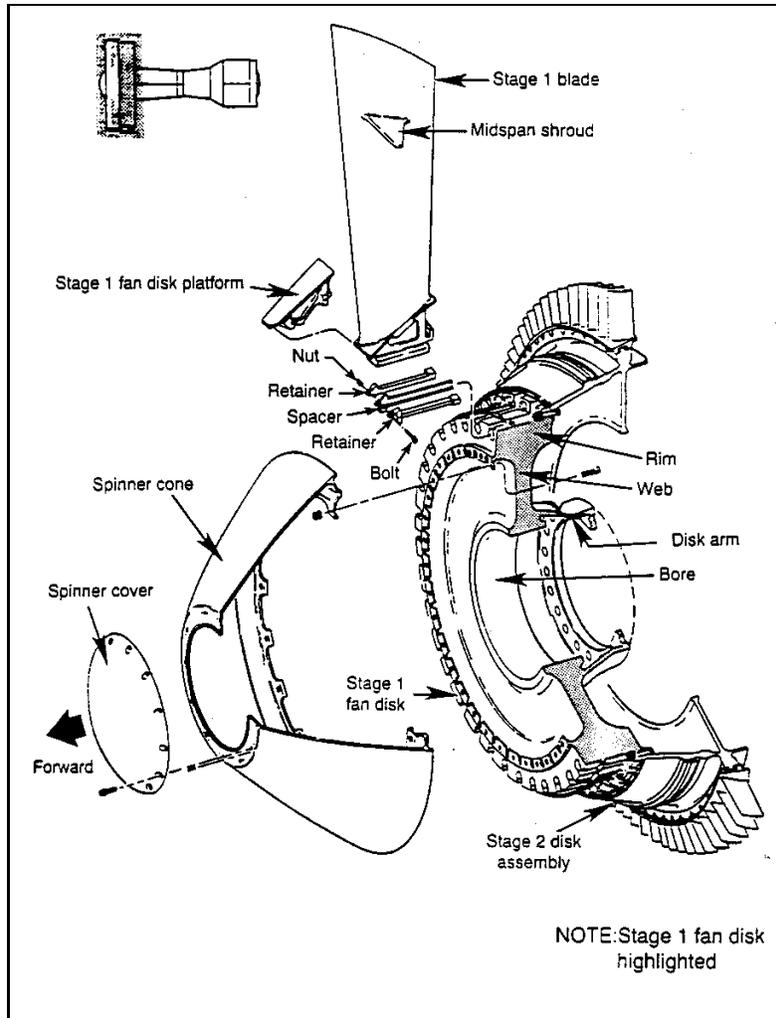
Figure 16.--Fan rotor assembly.

Figure 16 shows a drawing of a CF6-6 engine fan rotor assembly, most of which departed the No. 2 engine of the accident airplane inflight. The assembly consists of the large stage 1 disk and attached fan blades and retainers, the smaller stage 2 disk and attached blades, the spinner cone and cover, and various mounting and balancing hardware. A cutaway view of the engine in the area of the stage 1 disk is shown in **figure 17**.

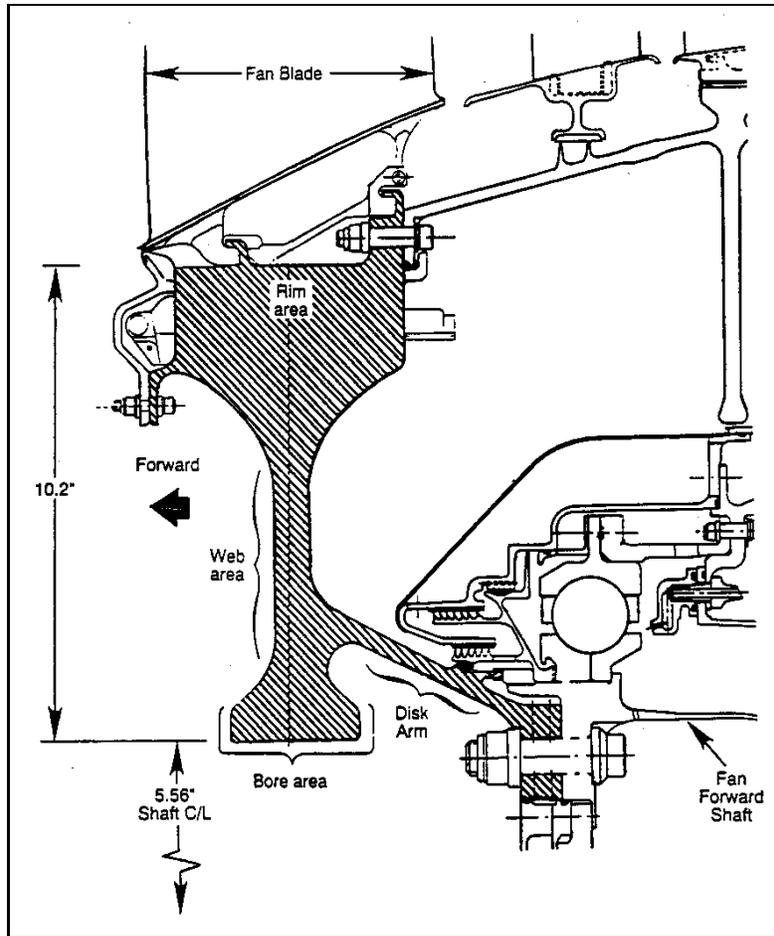
Figure 17.--CF6-6 engine stage 1 fan disk cutaway view - disk highlighted.

The stage 1 fan disk weighs 370 pounds and is a machined titanium alloy forging about 32 inches in diameter. GEAE convention refers to various portions of the disk as the rim, the bore, the web, and the disk arm, as labeled in **figure 17**. The rim is about 5 inches thick and is the outboard portion of the disk. The rim contains the axial "dovetail" slots, which retain the fan blades. Also, the stage 2 fan disk is bolted to the aft face of the rim. The bore is about 3 inches thick and is the enlarged portion of the disk adjacent to the 11-inch-diameter center hole.

Extending between the rim and bore is the disk web, which is about 0.75 inch thick. The conical disk arm extends aft from the web at a diameter of about 16 inches. The conical arm diameter decreases in the aft direction to about 10 inches at the disk arm flange where the disk bolts to the fan forward shaft (also labeled **in figure 17**).

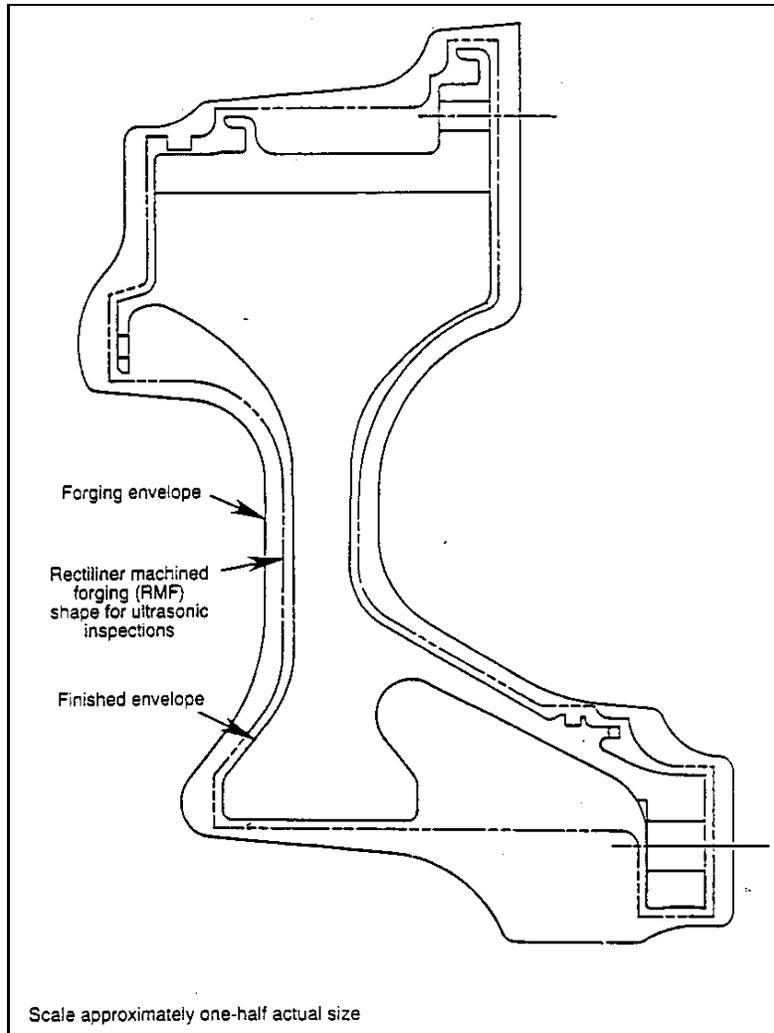
Figure 20.--CF6-6 stage 1 fan disk envelopes at various stages of manufacture.

During the records search for the manufacturing routing package of stage 1 fan disk S/N MPO 00385, it was learned that two rough machined forgings⁹ (referred to as disk "A" and "B") having this same serial number had been routed through GEAE manufacturing. Actual receiving documentation at GEAE could not be located. Figure 20 depicts the three shapes of the disk during the manufacturing process.

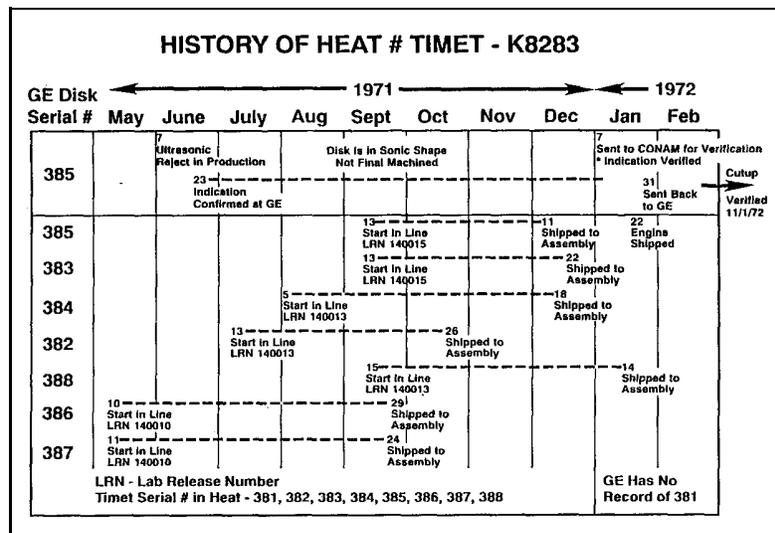
Figure 21.--Calendar history of manufacturing activity of heat K8283 prepared by GEAE.

heat K8283 is shown in tabular summary. (See figure 21). Although ALCOA records indicate that a forging S/N AJV 00381 was produced from TIMET heat K8283, no record of this forging or disk could be found at GEAE.
