Official Accident Report Index Page

ATLANTIC SOUTHEAST AIRLINES, INC., FLIGHT 529
EMBRAER EMB-120RT, N256AS CARROLLTON, GEORGIA
AUGUST 21, 1995

| Report ID | NTSB/AAR-96/06 |

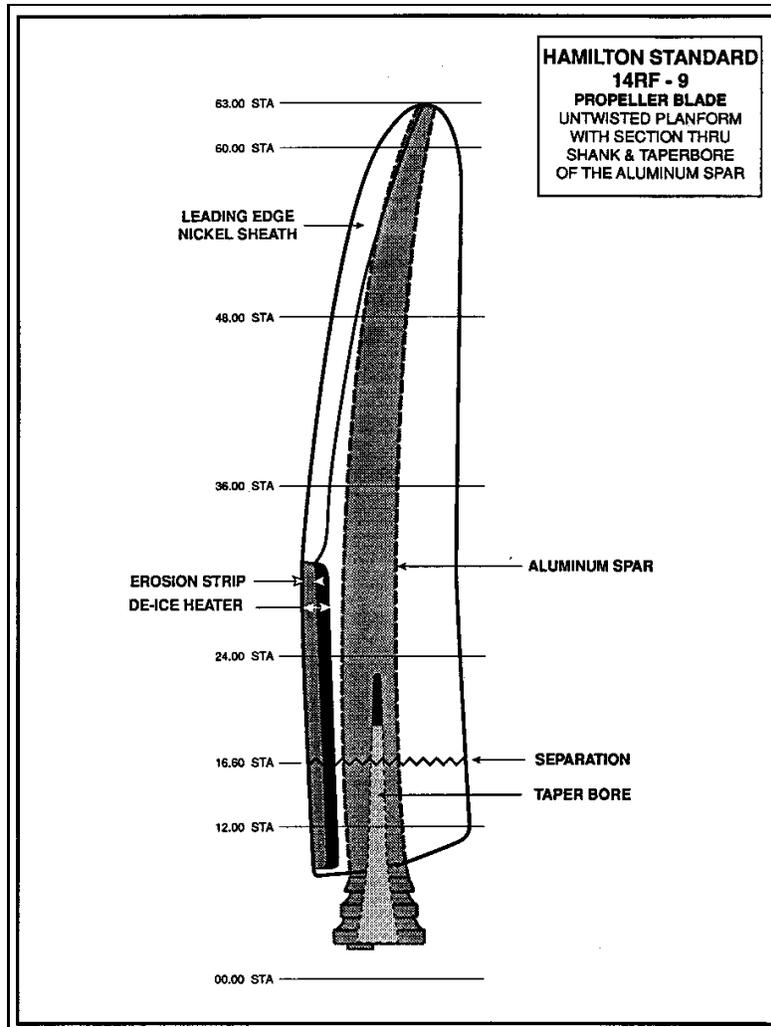
Hamilton Standard manufactures a family of composite propeller blades, including the 14RF (the accident propeller blade), 14SF, and 6/5500/F, that are intended for use on turbopropeller commuter airplanes. The solid, forged 7075-T73 aluminum alloy spar is the main load-carrying member. The airfoil shape of the blade is formed by glass fiber-filled epoxy and foam adhesively bonded to the spar (see Figure 2). A conical hole (taper bore) is bored in the center of the spar from the inboard end to blade station 21,¹² for weight reduction and balance weight installation. The taper bore on the 14RF blade can be one of two different shaped designs: straight taper bore known as the "M" style¹³ and a bellmouth shape (known as the "N" style). Also, during very early production, the taper bore was shotpeened.¹⁴ However, early in the production run, Hamilton Standard reviewed the production process, deemed shotpeening unnecessary, and, with FAA approval, it was discontinued. The accident blade was originally an N style blade, but it was rebalanced on customer request for ASA fleet standardization to the M style and reidentified as an M blade. The accident blade taper bore was not shotpeened during production.

Figure 2.--Illustration of a 14RF-9 propeller blade.

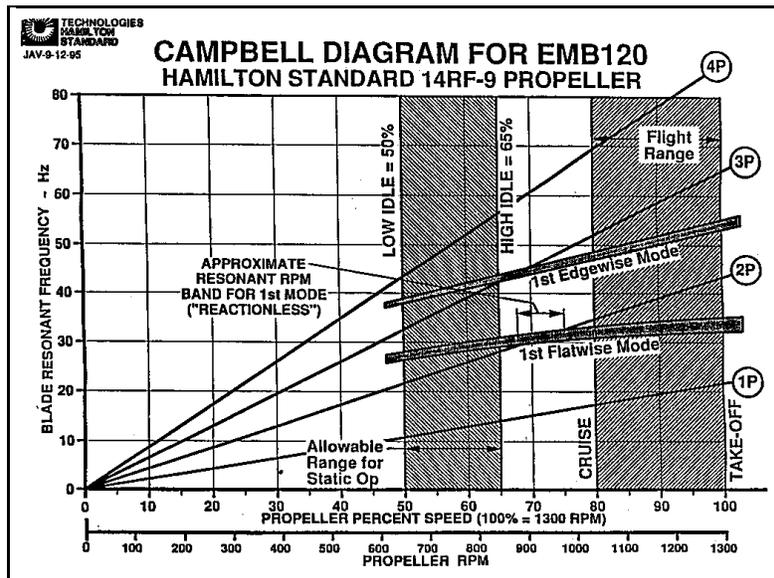
The Hamilton Standard 14RF-9 blade for the EMB-120 was designed so that its first flat-wise resonant frequency would not coincide with the 2P⁴⁸ excitation frequency during ground operation. However, the coincidence or close proximity of the ground rotational speed and the first flat-wise resonant frequency can place the propeller in a resonant condition and results in undesirable vibratory stress. (See Figure 4 for an illustration of the vibratory modes of the 14RF-9 propeller.)

Figure 4.--Vibratory modes of the 14RF-9 propeller.

When the first flat-wise vibration frequency and the 2P excitation frequency coincide, a four-bladed propeller, such as the 14RF-9, vibrates in the reactionless⁴⁹ mode. The reactionless mode of vibration is characterized as when two blades of a four-bladed, rotating propeller, 180 degrees apart, reach a negative stress peak at the same time that the other two blades reach their positive stress peak. This type of propeller vibration is called reactionless because the bending loads of the four blades are canceled at the propeller hub which consequently transmits little or no vibratory loading to the propeller mounting structure.
