09/20/81 World Airways, Inc.

Official Accident Report Index Page

Report Number	NTSB-AAR-82-1
Access Number	PB82-910401
Report Title	Airways Inc., Flight 32, McDonnell Douglas DC-10-30CF, N112WA, Over North Atlantic Ocean, September 20, 1981.
Report Date	January 12, 1982
Organization Name	National Transportation Safety Board Bureau of Accident Investigation Washington, D.C. 20594
WUN	3378A
Sponsor Name	NATIONAL TRANSPORTATION SAFETY BOARD Washington, D. C. 20594
Report Type	Aviation Accident Report
Sup Notes	The subject report was distributed to NTSB mailing lists: 1A, 8A and 8B.
Distribution Status	This document is available to the public through the National Technical Information Service-Springfield, Virginia 22161 (Always refer to number listed-in item 2)
Report Class	UNCLASSIFIED
Pg Class	UNCLASSIFIED
Pages	54
Keywords	DC-10, galley lift system, design deficiencies, operations procedures.

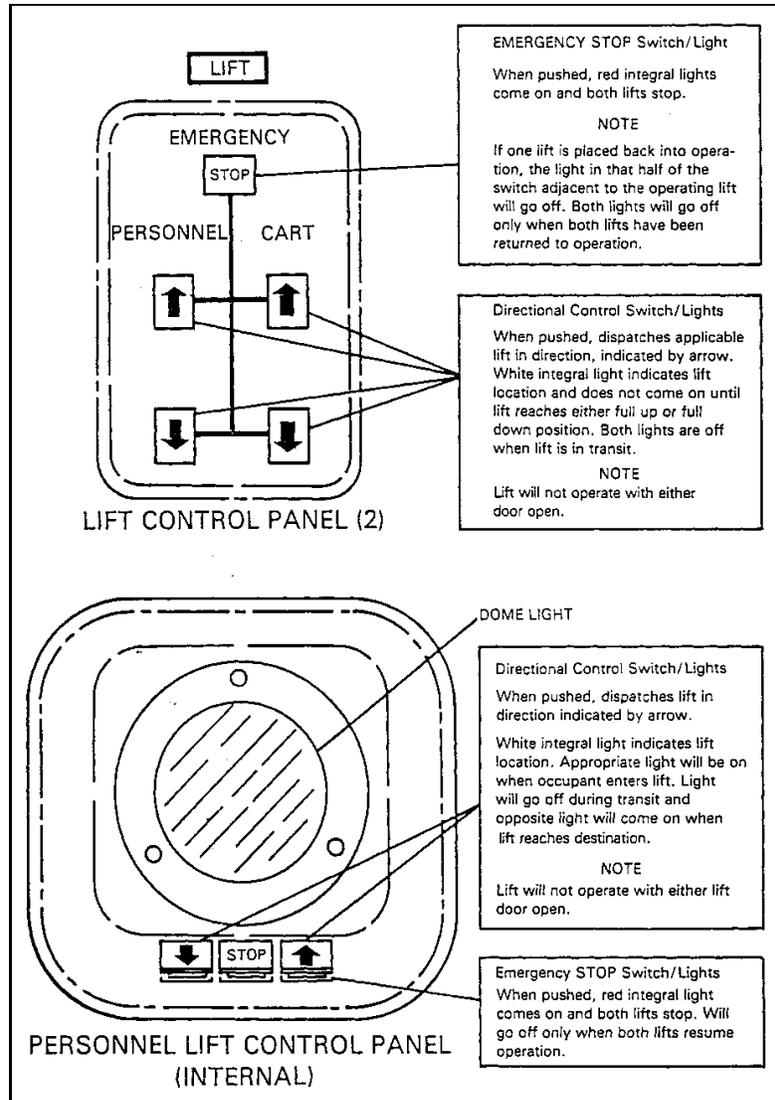
Figure 2.--Personnel and cart lifts.

The galley lift system consists of two lifts used to transport personnel and service carts between the lower galley and the cabin level service center. The system includes a personnel lift, a service cart lift, a drive unit for each lift with individual mechanisms, and controls for operation and safety. The personnel lift can transport personnel or service carts. The cart lift can be used only for service carts due to the reduced height of the lift compartment in the service center. The lifts operate independently. (See figure 2.)

The lower galley personnel lift door frame was deformed and battered in the area where the electrical interlock switches are mounted(see figure 2). The uppermost electrical interlock switch on the lower galley personnel lift door, S1-450(see figure 1), was found with the switch roller assembly twisted and the roller striker arm jammed in the depressed (switch closed) position. The damage to the lower galley lift door frames was the result of repeated bumping by food and liquor carts.

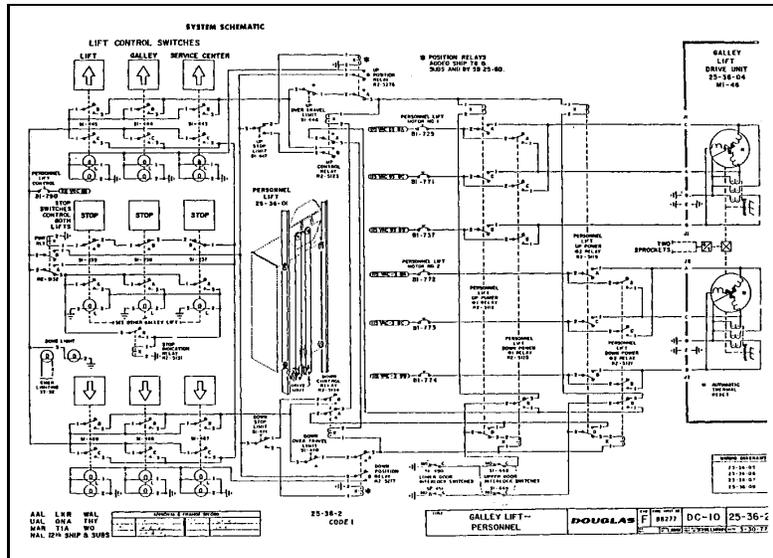
Figure 4.--Electrical diagram of galley personnel lift system.

Alternate Circuit - Each lift has two independent circuits to provide power to the system. Normally, both circuits operate; however, if an electrical malfunction occurs in one of the two circuits, the system should continue to operate at half (or partial) speed, thus allowing continuation of food service. Each system has its own set of upper and lower door interlock switches and its own up and down power relay. In addition, these components in each system are wired to up and down control relays common to both system. **(See figure 4.)**
