09/22/81 Eastern Airlines

Report Number	NTSB-AAR-82-5
Access Number	PB82-910405
Report Title	Eastern Airlines Flight 935, Lockheed L-1011-385, N309EA, Near Colts Neck, New Jersey, September 22, 1981.
Report Date	June 1, 1982
Organization Name	National Transportation Safety Board Bureau of Accident Investigation Washington, D.C. 20594
WUN	3529
Sponsor Name	NATIONAL TRANSPORTATION SAFETY BOARD Washington, D. C. 20594
Report Type	Aircraft Accident Report September 22, 1981
Distribution Status	This document is available to the public through the National Technical Information Service, Springfield, Virginia 22161
Report Class	UNCLASSIFIED
Pg Class	UNCLASSIFIED
Pages	40
Keywords	Rolls-Royce RB-211 engine; inadequate lubricating oil supply; low pressure location bearing; oil leaks; coupling seal displacement; oil spray; fire; fan shaft overheat; fan shaft failure; fail-safe shaft failure.

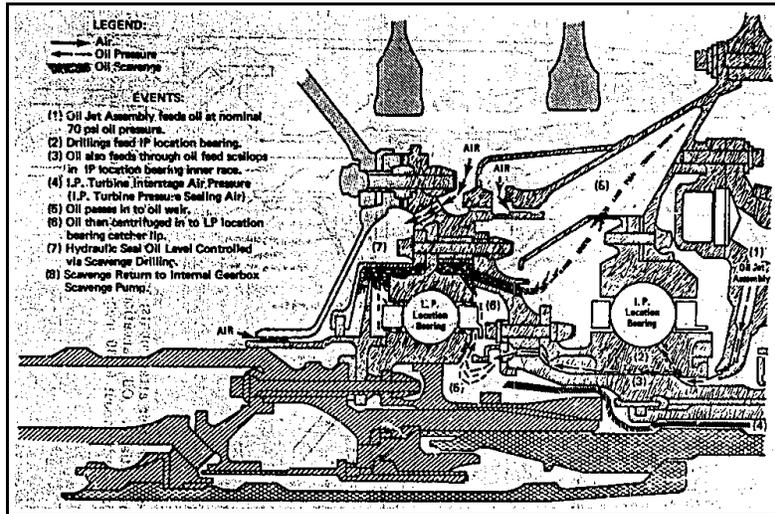
Figure 6. -- LPLB Normal Oil Supply and Scavenge.

Nominal total lubrication system capacity is 38.7 quarts of oil, including 23.7 quarts in the tank; consumption is 0.95 quarts/hour. A single-gear pump in the external gearbox supplies pressurized oil to the engine via a pressure filter. If the filter becomes blocked, the element is bypassed automatically and the engine oil filter pressure warning light illuminates on the flight deck. Low-pressure and intermediate-pressure location bearings are supplied by a single oil jet. **(See figure 6)** This jet sprays oil toward an annular slot formed between the IPC stubshaft and the IPLB inner race; typical catch efficiency is 60 percent for the RB-211 engine. Under centrifugal forces, part of the oil entering the slot passes outward through a passage in the IPLB inner race to supply the bearing; the remaining oil passes forward and outward to a weir through holes in the IPC stubshaft and in the weir flange. The oil supply must cross the two flanged joints between the IPLB inner race and the rear IPC stubshaft and between the stubshaft and the oil weir to reach the weir. A lip on the aft side of the LPLB cage catches oil being thrown outward after spilling over the weir lip for LPLB lubrication. Cage passages distribute oil within the bearing.
