Official Accident Report Index Page

CRASH DURING EMERGENCY LANDING PHOENIX AIR
LEARJET 35A, N521PA FRESNO, CALIFORNIA DECEMBER
14, 1994

Accident NTSB ID	95-04
Airline	Phoenix Air Group, Inc.
Model aircraft	Learjet 35A, N521PA
Year shipped	1979
Aircraft manufacturer	Lear
Engine type	TFE731-2-2B turbofan
Engine manufacturer	Garrett
Date	12/14/94
Time	1146
Location	Fresno, CA
Country	USA
IFR or VFR?	IFR/VFR
Fatalities	2
Injuries	21 on ground
Fire during flight?	Y
Fire on the ground?	Y
Probable cause	(1) Improperly installed electrical wiring for special mission operations that led to an in-flight fire that caused airplane systems and structural damage and subsequent airplane control difficulties; (2) improper maintenance and inspection procedures followed by the operator; and, (3) inadequate oversight and approval of the maintenance and inspection practice by the operator in the installation of the special mission systems.
Weather conditions	Clouds, visibility 20 miles in light rain showers
Total crew size	2
Cockpit crew size	2
Report ID	NTSB/AAR-95/04

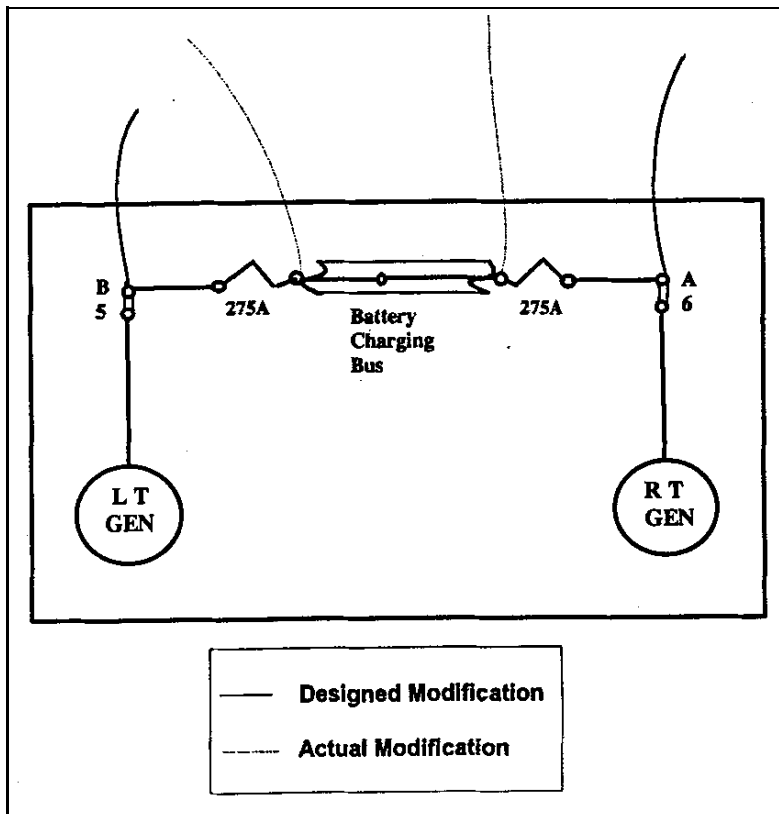
Figure 3a.--Components in tailcone.

The investigation found that in the actual mission equipment wiring of N521PA, the power wires were routed directly to the battery charging bus. (**Figure 3a** is a drawing of major components in the tailcone. **Figure 3b** shows the intended versus actual routing of the power wires in N521PA.)
